Failure Analysis and Repair of a Catastrophically Damaged Gas Turbine Compressor Disk Using SEM Technique and CFD Analysis

Abstract During a major overhaul of an 85 MW gas turbine unit in Iran-Rey power plant, 39 cracks were detected with different lengths and locations on the compressor disk of stage 11. All of the cracks initiated from the dovetail regions. Preliminary visual inspections and further microfractography using the scanning electron microscope demonstrated that the fretting fatigue phenomenon was the main cause of failure. Four repair methods were suggested to restart the unit. The first one was to remove all of the cracks from the disk by machining, or the so-called blending. The second, third, and fourth ways were to remove the entire rotor blades of stage 11, to remove the entire rotor and stator blades of the stage 11 simultaneously, and to remove those rotor blades of stage 11 corresponding to the damaged dovetails, respectively. Although the first way of solution was initially carried out on the damaged disk, the first author offered that restarting the unit with the blended disk is not reliable enough because of the presence of a large number of repair points

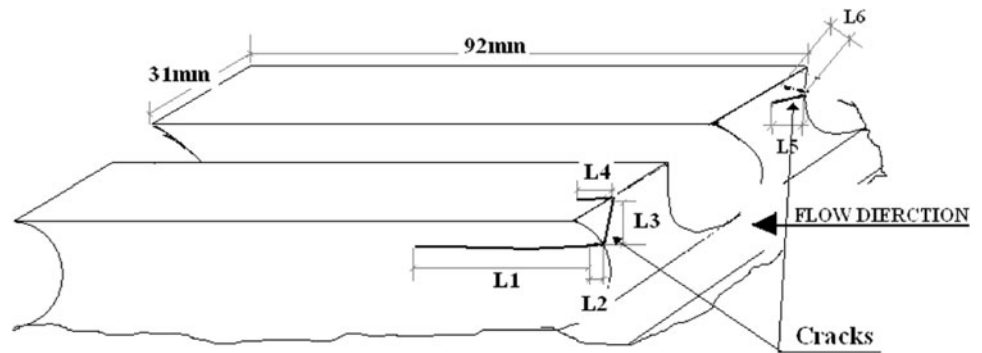
Note that the hypothetical cracks shown in Fig. 1 are presented herein to characterize more conveniently the real

Fig. 1 Disk dovetail region with six hypothetical cracks

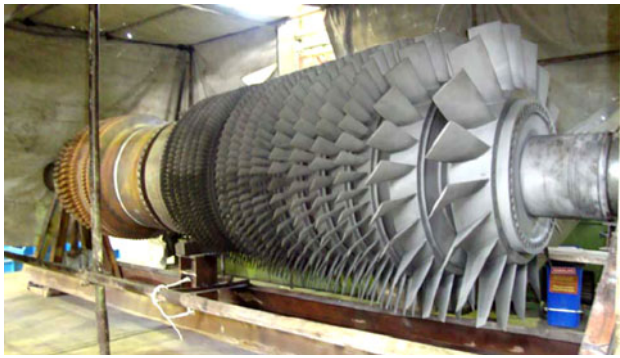
Figures 2 and 3 display the rotor part of the damaged compressor and some of the cracks detected in the dovetail regions, respectively. As shown in Fig. 3c, those cracks located in the back side of the dovetail region and hence could not be directly seen with eyes, were detected and characterized by means of a mirror.

Fig. 2 Damaged compressor rotor

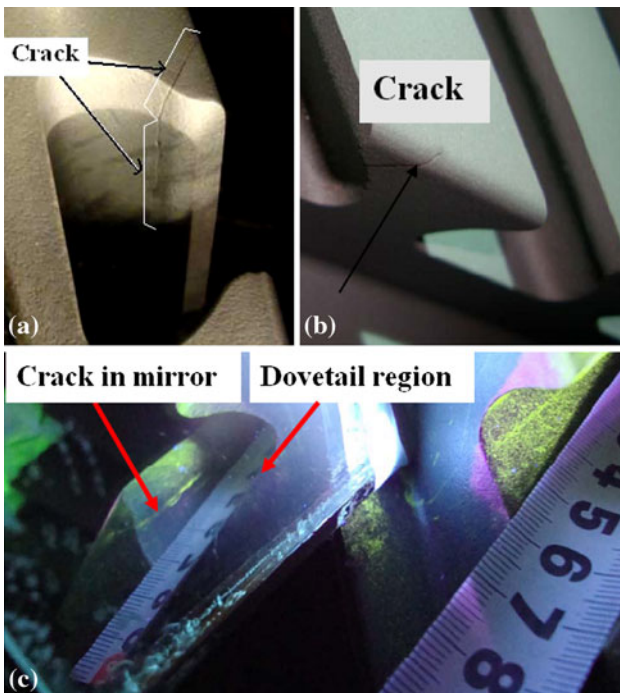
Fig. 3 Cracks detected in the dovetail region. (a, b) Directly visible with eyes. (c) Directly invisible and detected in mirror

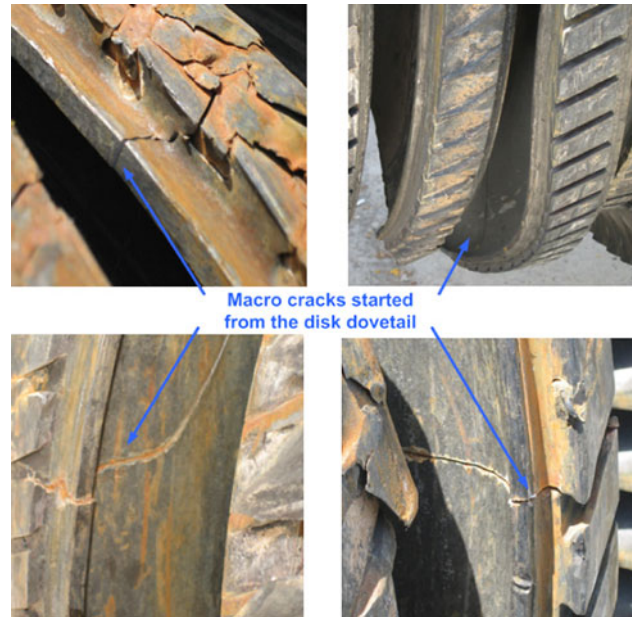
It is noteworthy that the dovetail regions on a gas turbine compressor disk are the places with a high risk of nucleating cracks due to the existing contact between rotor blades and disk. The nucleated cracks can be propagated by fatigue mechanism (because of the fluctuating nature of the loads applied to the components) till detection at overhaul or violent sudden fracture during operation. This type of failure has frequently occurred in the Rey power plant gas turbine units, the most recent of which has been investigated in [16], and the latest one is described in the present study. Figure 4 shows a few cracks initiated from the dovetail regions of the compressor disks of stages 17 and 18 in a 32 MW gas turbine unit in the Rey power plant [16].

Fig. 4 Cracks initiated from the dovetail regions on the compressor disks and propagated toward the disks body [16]

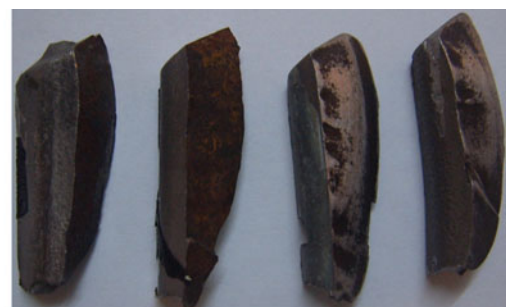
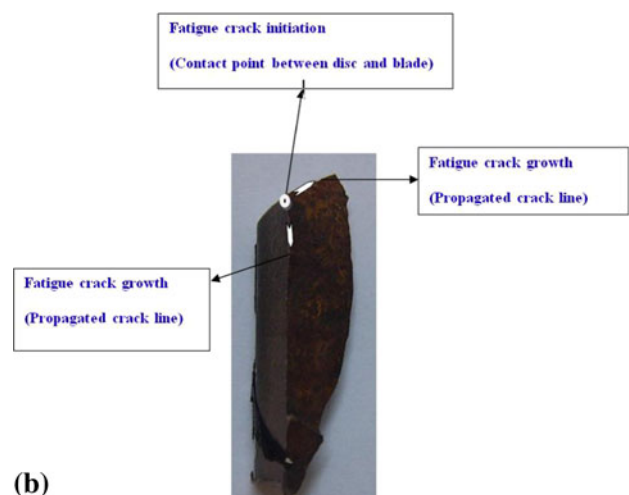
In order to investigate the cause of failure more accurately, several cracked pieces removed from the dovetails during blending process were subjected to micro-fractography by scanning electron microscope (SEM). Figure 5 reveals some of the studied pieces.

As seen in Fig. 5, each piece contains two crack lines branched from the crack origin. The cracked surfaces were studied by SEM and during investigations; the attention was mainly paid to find likely trace of fatigue failure. Relatively similar surface patterns were found for the pieces and all of them demonstrated clearly the fatigue failure mechanism. Figures 6 and 7 represent two micrographs of a cracked surface taken by SEM with different magnifications ($\times 500$ and $\times 3000$, respectively). Both the micrographs were taken from the zones of crack growth very close to the crack lines.

Fig. 5 (a) Some of the cracked pieces removed from the dovetails during blending. (b) The regions of crack initiation and crack growth

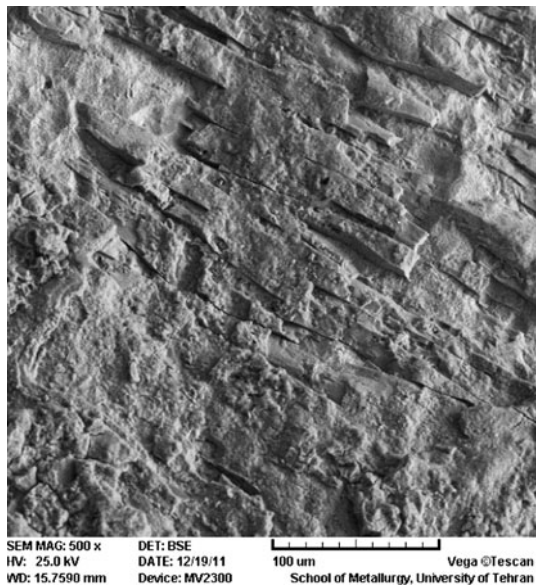
As seen in Figs. 6 and 7, obvious fatigue striations demonstrate the dominance of fatigue failure mechanism. The main difference between these figures is that Fig. 7 shows only the fatigue striations, but Fig. 6 represents both the fatigue striations and the surface effects of wear.

Fig. 6 Fatigue striations on the surface of a removed piece corresponding to the zone of crack growth near the short crack line (SEM magnification $\times 500$). The photo was taken from an area very close to the region of crack initiation

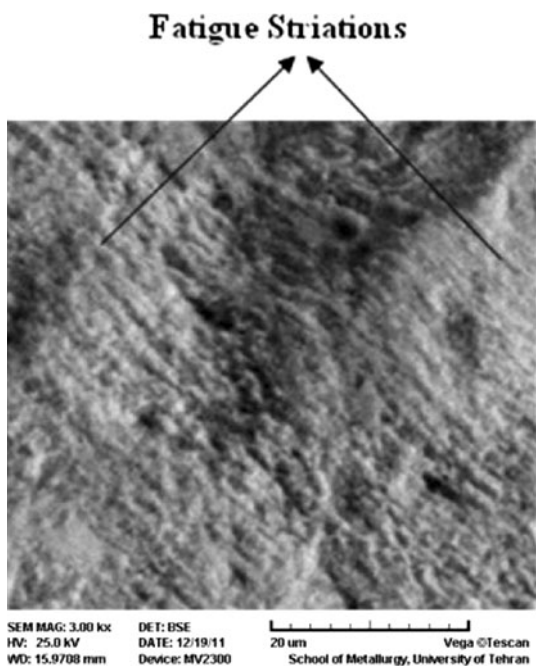
Fig. 7 Fatigue striations on the surface of a removed piece corresponding to the zone of crack growth very close to the large crack line (SEM magnification $\times 3,000$)

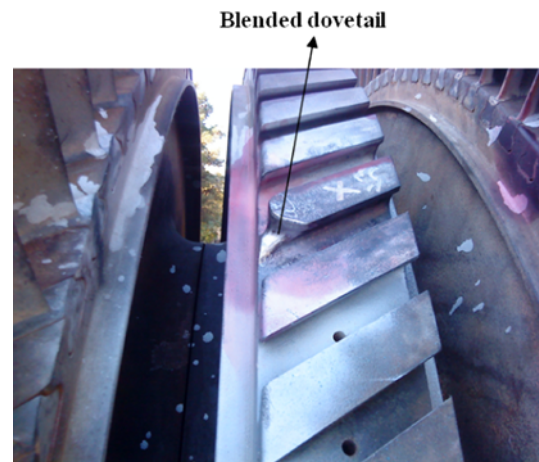
Fig. 8 A blended dovetail of the damaged disk of stage 11

After detecting the cracks on the compressor disk of stage 11, the Rey power plant maintenance and repair committee (RMRC) decided to repair the disk in a short time interval because, the need of the electric power was very serious and the disk replacement in a short time was not possible. The first repair procedure considered was to remove the entire cracks from the disk by means of a well-known process, called blending. A review of the guidelines prescribed in the maintenance manual of the gas turbine revealed that 37 detected cracks were allowable to be removed, and two cracks were not so because of having larger lengths than permitted. Therefore, the failure report was sent to the manufacturing company by the committee, and then, a positive response dealing with removing the entire cracks was received. The manufacturing company had also stated that the unit was not guaranteed to be safe in service because of the presence of two long cracks. Anyway, the entire cracks were removed from the disk by blending. Figure 8 shows a blended dovetail of the damaged disk of stage 11.

The first author, as the chief consultant of the RRC, stated that the blended disk was not reliable to be used because of the presence of a large number of crack removals on the disk. He suggested that the stage 11 to be removed from the compressor cascade. For this purpose, three repair options were offered, which comprised removal of (1) the entire rotor blades of stage 11, (2) the entire rotor and stator blades of stage 11 simultaneously, and (3) those rotor blades of stage 11 corresponding to the damaged dovetails. The RRC was deeply concerned with this serious question of whether the compressor would experience any severe instability, such as surge, stalls, etc.

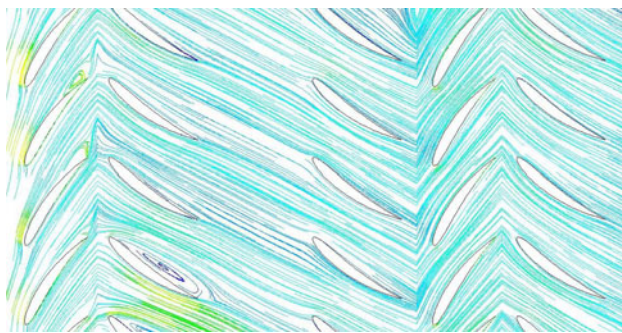
When removing the entire rotor blades of the middle stage, there are no blades in the gap between the first and the second stator vanes. This can be the result of increasing the incidence angle to second stator vanes. This condition might increase flow separation probability, but as seen in Fig. 14, this possibility seems to be low because the fluid flow travels in its proper path.

Fig. 14 Stream lines when removing the entire rotor blades of the middle stage

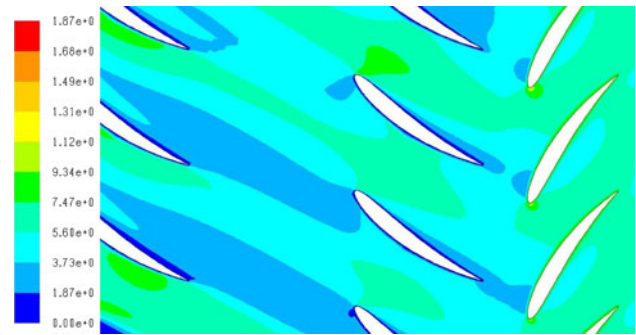
Figures 15 and 16 display the velocity contours and the static pressure distribution in the cascade, respectively, when the entire rotor blades of the middle stage are removed. The results showed that the total pressure rise decreased approximately by 9% because of the absence of the middle rotor that could increase the pressure and velocity in the space between the two stators. It is well believed that the diminishing of the total pressure rise will result in decreasing the compressor efficiency and trivially the output power of the gas turbine. Fortunately, no adverse pressure gradient or flow separation is seen in Figs. 15 and 16 and consequently, no instability is expected to occur.

Fig. 15 The velocity contours when removing the entire rotor blades of the middle stage

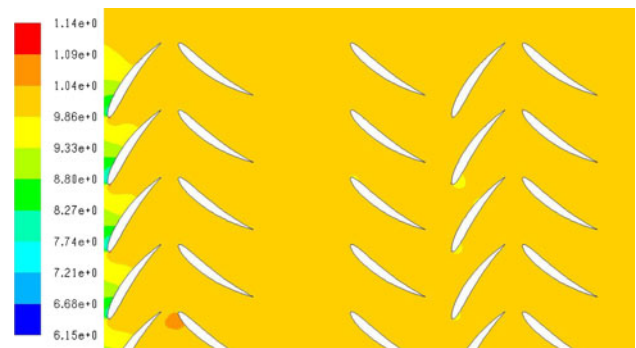
Fig. 16 Static pressure distribution when removing the entire rotor blades of the middle stage

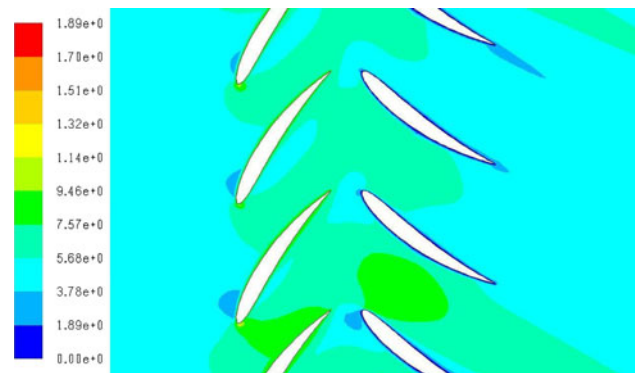
condition, flow regime is completely changed, and the incident angle raises up to nearly the stall angle. The velocity distribution in the cascade is shown in Fig. 17. The gap in the compressor cascade increases, and the rise in the loss of the total pressure reaches about 23%.

Fig. 17 Velocity contours in the cascade when removing one stage

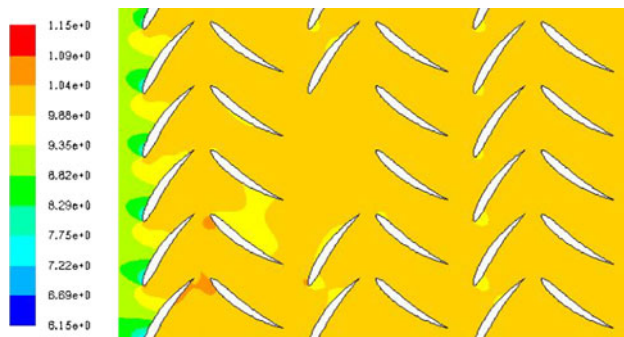
In the final simulation, only two rotor blades of the middle stage were removed. As shown in Fig. 18, there is no uniform flow as in prospect in axial compressor cascade. As seen in Fig. 19, there are many large eddies in the flow, and the rotational stall is seriously expected to occur.

Fig. 18 Static pressure contours when removing only two rotor blades of the middle stage

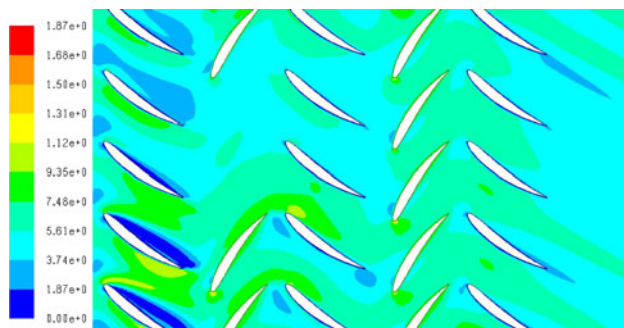
Fig. 19 Velocity contours when removing only two rotor blades of the middle stage
