7<sup>th</sup> International Conference on Fatigue Design, Fatigue Design 2017, 29-30 November 2017, Senlis, France

## The role of microconstituents on the fatigue failure of bone cement

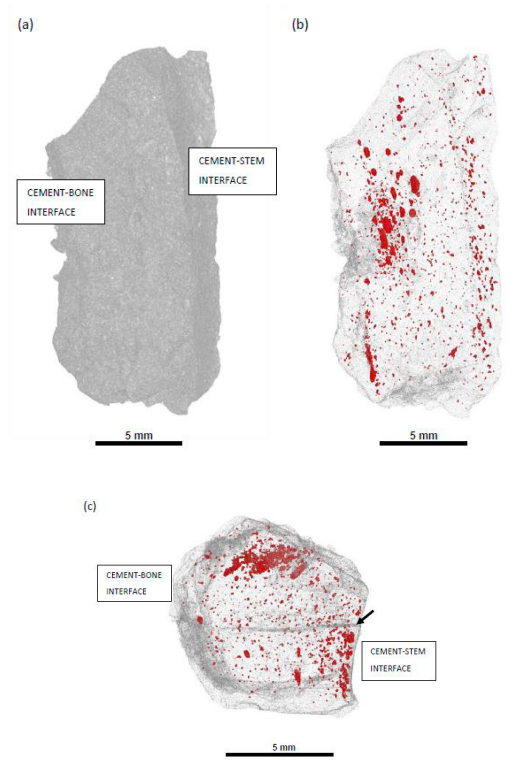
Fig. 1. CT reconstructions of (a) coronal view of retrieved cement specimen; (b) coronal view of distribution of voids (coloured red) within specimen; (c) transverse view of distribution of voids, showing position of pre-existing crack indicated by black arrow.

A CT reconstruction of the retrieved cement specimen highlighting the cement-bone and cement-stem interfaces is shown in Figure 1. Interestingly, the cement appeared to contain a crack that bisected the specimen in the coronal plane (Figure 1c).

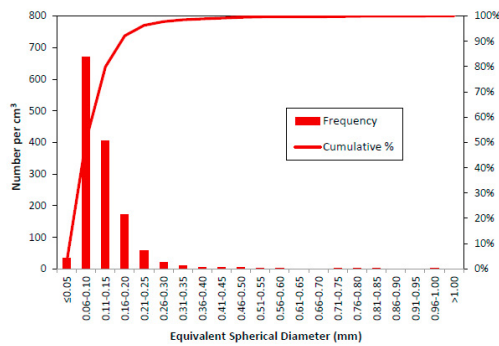
Fig. 2. Size distribution of voids in specimen of retrieved cement.

The size distribution of voids within the retrieved cement specimen is shown in Figure 2. Some directional void clustering was observed along the length of the specimen. Voids were concentrated at the cement-stem interface (Figure 1c), and appeared to be of a relatively consistent size ( $\sim 0.1$  mm diameter) and even distribution along the length of this interface. Significantly larger and more elongated voids (up to 1 mm diameter) were apparent in a cluster mid-way along the length of the specimen, towards the cement-bone interface. The modal void size was 0.06 – 0.10 mm equivalent spherical diameter (ESD), accounting for 48% of the total void population. Only 1% of the voids were larger than 0.40 mm ESD. The largest void was 0.96 mm ESD, accounting for 25% of the total void volume measured in this specimen.

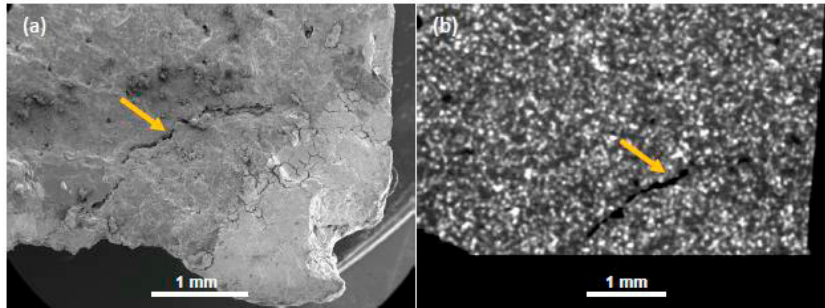
Fig. 3. (a) SEM micrograph (x25) of lower region of the cement fracture surface; (b) of corresponding CT slice through main crack plane. A secondary crack is evident in both images, indicated by yellow arrows.

The fracture within the explanted cement was extracted by immersing the sample in liquid nitrogen and then impacting it to separate the two surfaces. Inspection of the fracture surfaces via CT and SEM revealed evidence of secondary crack formation (Figure 3) that propagated approximately perpendicular to the main crack plane.

The absence of an identifiable crack origin on the fracture surface, and the evidence of secondary cracking suggests the main crack may have propagated as a result of coalescence of multiple smaller cracks. Damage accumulation due to the initiation and coalescence of cement micro-cracks is cited as a factor in the aseptic loosening of cemented implants, and has been replicated experimentally (McCormack and Prendergast 1999).

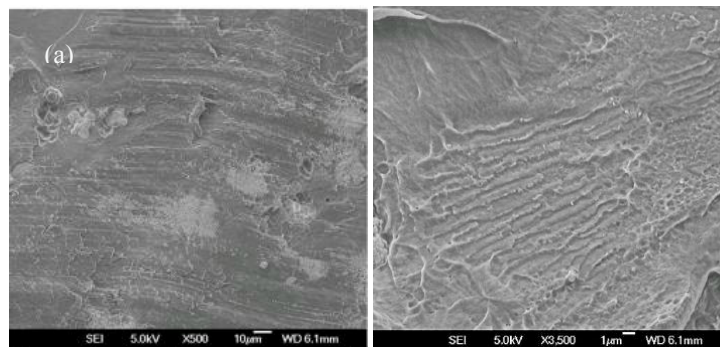
Fig. 4. (a) Fatigue striations and (b) evidence of crazing on the fracture surface.

SEM analysis revealed fatigue striations, of variable spacing but commonly  $\sim 1$   $\mu\text{m}$ , visible over an area of several square millimetres on the fracture surface in addition to extensive evidence of crazing (Figure 4).

The occasional irregular spacing of the striations may be explained by the non-uniform, discontinuous cyclic loading that would be expected to occur during normal patient activity. PMMA exhibits either true striations or discontinuous growth bands (DGBs), depending on load levels and loading history. Fatigue striations in glassy polymers typically form at higher stress levels than discontinuous growth bands, and unlike DGBs their presence does not appear to be dependent on the chemistry and molecular weight of the polymer [8]. Fatigue striations have a narrower inter-band spacing than DGBs, although the spacing of both these features increases further from the crack origin due to increasing  $\Delta K$ . DGBs were observed in the *in vitro* samples but not in the explanted samples. This may be related to the variation in environmental and loading conditions between the *in vitro* and *ex vivo* specimens, including frequency, temperature, humidity, variable amplitude loading and addition of gentamicin to the cement formulation.

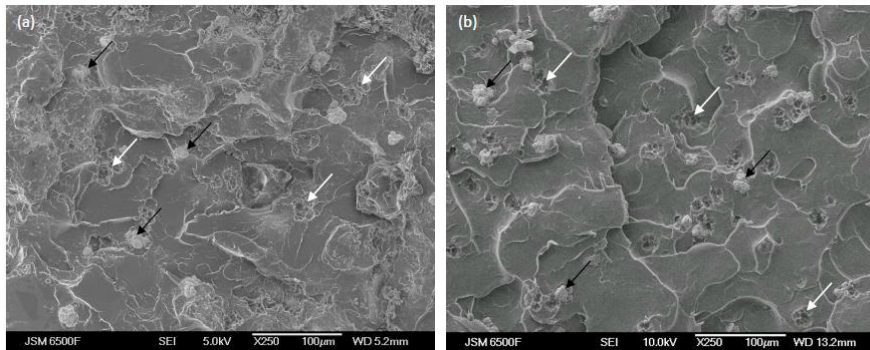
Fig. 5. (a) *ex vivo* and (b) *in vitro* fractures surfaces, highlighting stepped morphology, clusters of ZrO<sub>2</sub> particles (black arrows) and ZrO<sub>2</sub> pull-out (white arrows).

Comparison of the retrieved cement specimen with *in vitro* fracture surfaces revealed a number of similarities. (Figure 5). Regions of the *ex vivo* surface (Figure 5a) exhibited features that were typical of the early crack growth region near the initiation site of an *in vitro* specimen (Figure 5b). Both surfaces show a stepped morphology, consistent with a tortuous crack path and/or the coalescence of multiple micro-cracks. On both specimens, clusters of zirconium dioxide radiopacifier particles can be seen protruding from the fracture surface, while corresponding recesses in the polymer matrix indicate where these clusters have been pulled out of the polymer matrix during fracture. The process of ZrO<sub>2</sub> pull-out was not observed on the final failure regions of either the retrieved specimen or *in vitro* test specimens, and is thus considered to be indicative of slow crack growth.

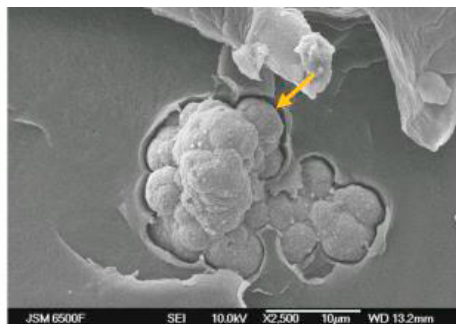
Fig. 6. Limited bonding of radiopacifier to surrounding polymer, with evidence of localised plastic deformation during fracture (yellow arrow).

While the absolute origin of fatigue could not be traced in the explanted sample, this study suggests that the microconstituents, in particular the larger pore sizes in the retrieved sample, play a role. Closer inspection of radiopacifier clusters (Figure 6) indicates limited bonding between the ZrO<sub>2</sub> and polymer matrix, with evidence of separation of the interfaces and localized plastic deformation during fracture. This limited bonding suggests that the agglomerations effectively act as pores and therefore may play an additional role early on in the crack growth process.
