Failure Analysis of Ultra-High Strength Bolt of Circuit Breaker

Ying Xiang Zou*, Bo Zhong Wang, Yi Zhou Jiang, Ming Wei Huang, Jin Yi, Jia Yi Yi

State Grid Hunan electric power company maintenance company, Changsha, 410014, Hunan, China

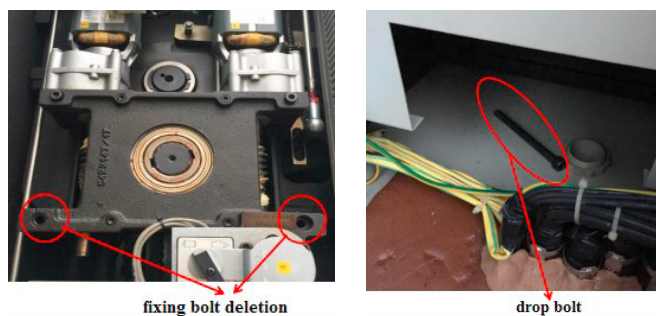
A 500kV spring mechanism breaker is the original imported product from Sweden. The production date is 2002. The energy storage motor of the circuit breaker mechanism is fixed with other parts of the mechanism through four M8 bolts. After running for a period of time, it was found that two of the circuit breakers broke during the inspection, as shown in Fig. 1.

Fig. 1. (a) A circuit breaker electrical energy storage module; (b) Drop bolt of a breaker mechanism.

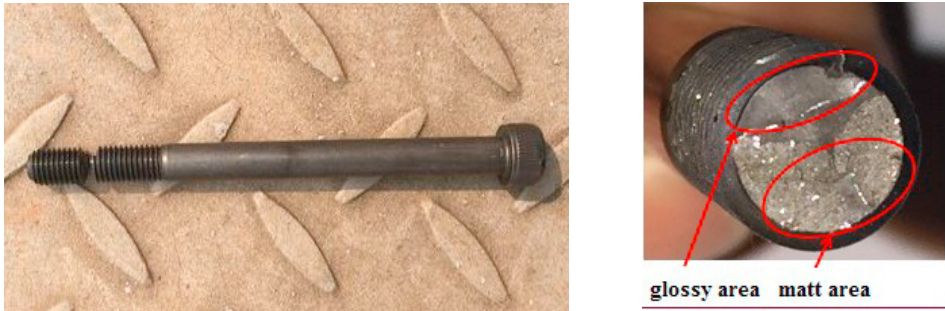
A comprehensive test analysis is carried out on the failed bolt samples. The failure bolt specification is M8, the performance grade is 12.9, and the surface is treated with blackening. Fig. 2 (a) shows the macro morphology of the failure bolt. It can be seen that the fracture position is located at the threaded position, the section is perpendicular to the axial direction of the bolt, the section of the bolt is flat, and there is no obvious macroscopic plastic deformation in the vicinity. Fig. 2 (b) shows a macro-photograph of the cross section after degreasing treatment. No shell-like fatigue front line is found, the shear lip is small, and there is no necking near the fracture. According to the section, it is divided into glossy area and matt area. The matt area is the crack propagation caused by the stress of the bolt. Due

to the large size of the area, the crack propagation process is relatively slow. When the crack spreads to a certain extent, it exceeds the bearing value of bolt stress, and then brittle, that is, the glossy area. The above phenomenon can be preliminarily judged that the fracture of the bolt is crack propagation and brittle fracture occurs under the action of stress.

Fig. 2. (a) Macro morphology of motor energy storage bolt; (b) Macro morphology of section.

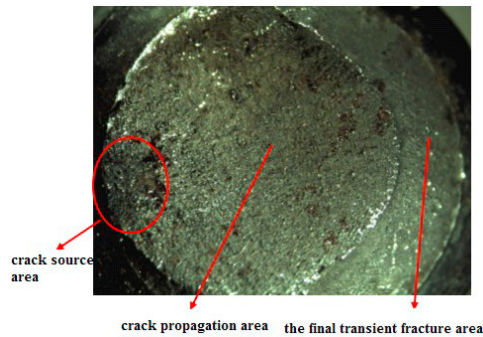
The fractured bolt is examined by the stereoscopic microscope, as shown in Fig. 3. It can be seen that the entire fracture consists of three parts: the crack source area (close to the root surface of the thread, there are obvious rusting marks, accounting for about 5% of the entire fracture surface area), the crack propagation area (accounting for about 75% of the entire fracture surface area) and the final transient fracture area (accounting for about 20% of the entire fracture surface area).

Combined with the service characteristics of less opening and closing times of circuit breakers and more intense vibration during operation, the bolt can be judged as high stress and low cycle fatigue fracture.

Fig. 3. Fracture of the fracture bolt.

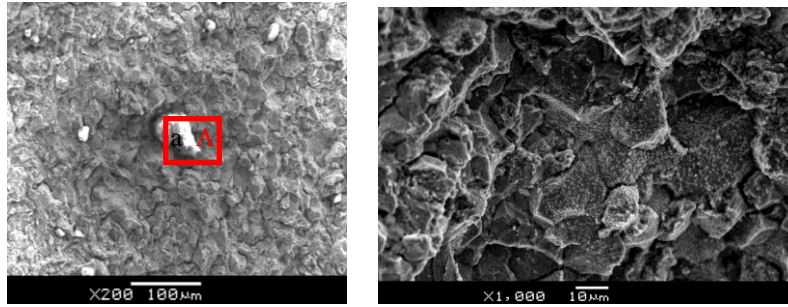
The fracture bolts are analyzed by SEM. The morphology of crack source area, crack propagation area and final transient fracture area are shown in Fig. 4(a), 4(b) and 5, respectively.

Fig. 4. (a) SEM morphology of crack source area; (b) SEM morphology of crack propagation area.

It can be seen that the particulate matter of point A is FeS inclusion, which is located in the crack source area, so it is likely to be the crack source of bolt fracture. In addition, a large number of secondary cracks exist in the crack source area and crack propagation area, and they propagate along grain boundary, which is consistent with the characteristics of hydrogen embrittlement fracture. In the final transient fracture area, there are a large number of small dimples, indicating that the bolt has low plasticity.

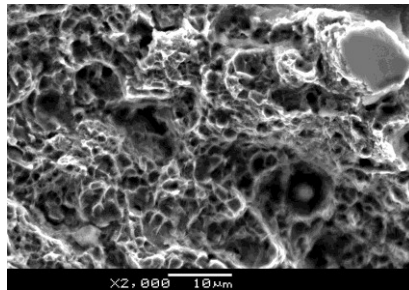
Fig. 5. SEM morphology of the final transient area.

The EDX is carried out for point A where impurities exist in Fig. 5, and the results are shown in Table 1.

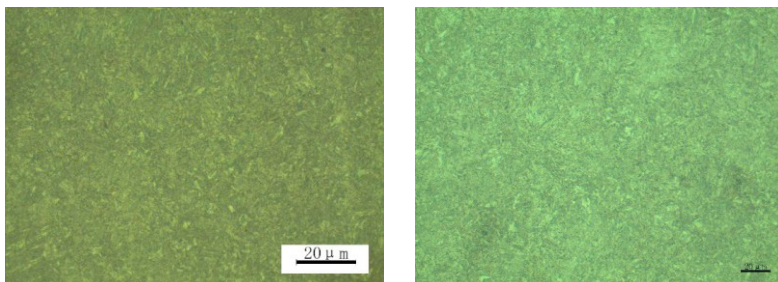
Fig. 6. (a) Metallographic structure of bolt matrix 500×; (b) Metallographic structure of thread root 500×.

It can be seen from Fig. 6 that the metallographic structures of bolt matrix and thread root are tempering sorbite.
