Engineering Structures

Repair assessment for distortion-induced fatigue cracks in a seismically retrofitted double-deck bridge complex

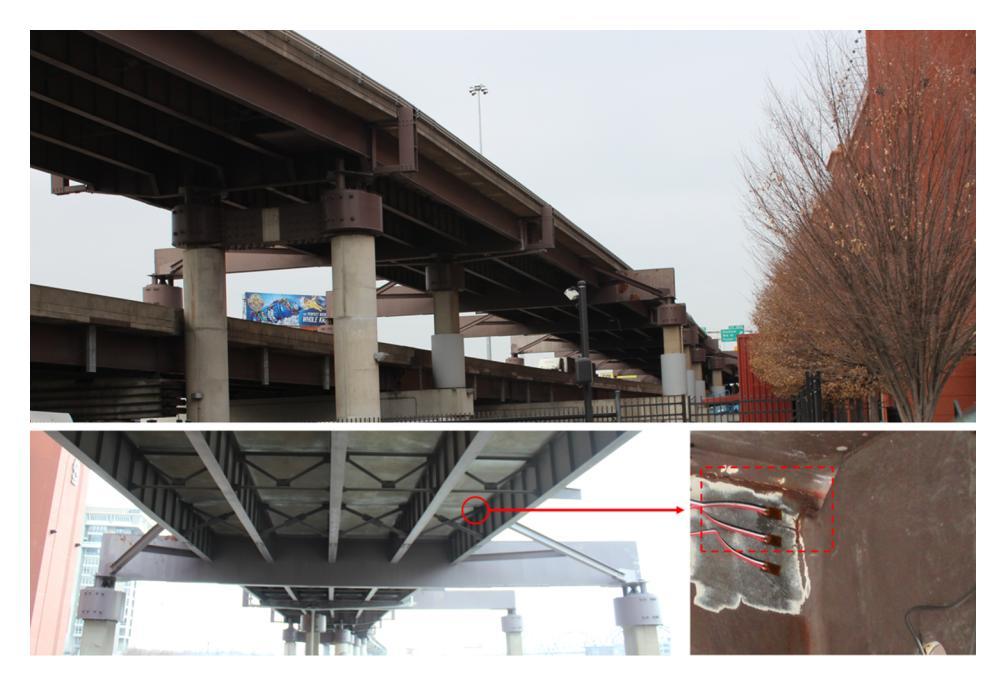
Within approximately one year following the completion of the seismic retrofit, the DOT inspectors identified several cracks in the webs of the longitudinal plate girders during a routine inspection. The cracks were a combination of horizontal cracks formed at the web to upper flange joint and horseshoe-shaped cracks originating from the stiffener-to-web intersection, as shown in Fig. 3. These cracks were pre-dominately located in the three interior girders at the location of the cross-girder retrofit and new cross-diaphragms, as shown in Fig. 2.

Fig. 3. Double-deck bridge complex and the location of horseshoe cracks and horizontal cracks.

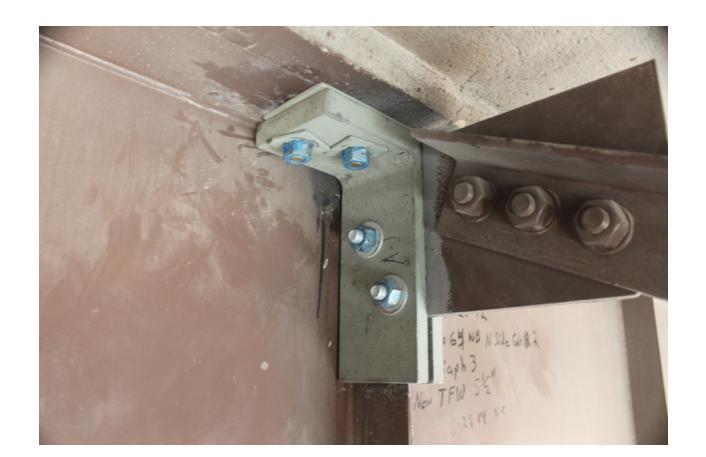
Fig. 4. Repaired web-gap view.

A repair solution was developed for the cracked region based on findings from previous analytical studies [25,26]. The repair strategy ultimately selected was to positively attach the connection plate (stiffener) to the upper flange [25] with WT 12 × 88 × 5 sections with the flange removed on one side, as shown in Fig. 4. Nelson HBL Full Base 3/ $4 \times 2-3/4$ thread studs were used to connect the angle section to the top flange and 3/4-in. diameter bolts were used to tighten the two angle flanges and the connection plate together.

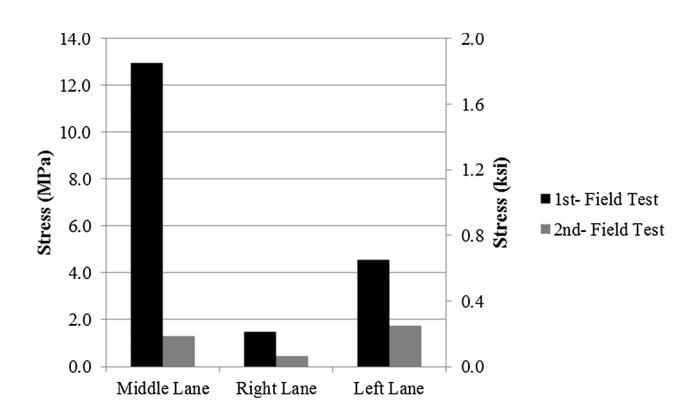
Fig. 10. Comparison between stress of a single gage in the web-gap of G2 before and after repair.

gap stress of G2 and G4 after repairing the bridge. The web-gap stress reduction in G2 for the three load cases are 90%, 129%, and 61% when the truck load is applied to the middle, right, and left lane, respectively.

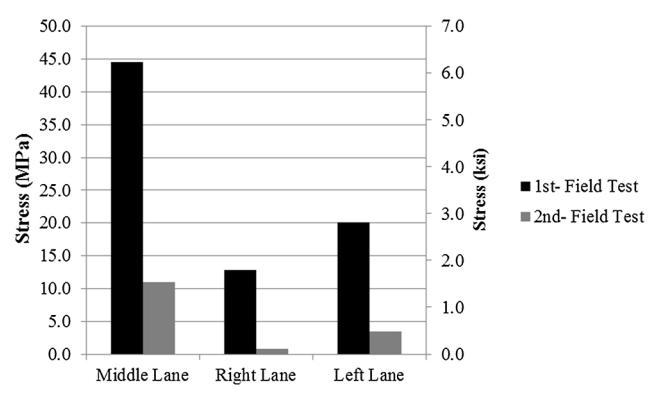
Fig. 11. Comparison between stress of a single gage at web-gap of G4 before and after repair.

Also, the readings from the single gage with the same location for both field tests showed a significant reduction in the web-gap stress for G4 with reductions of 75%, 94%, and 83% when the truck load was applied to the middle lane, right lane, and left lane, respectively. It is clear based on this comparison that the repair was effective in reducing stresses.

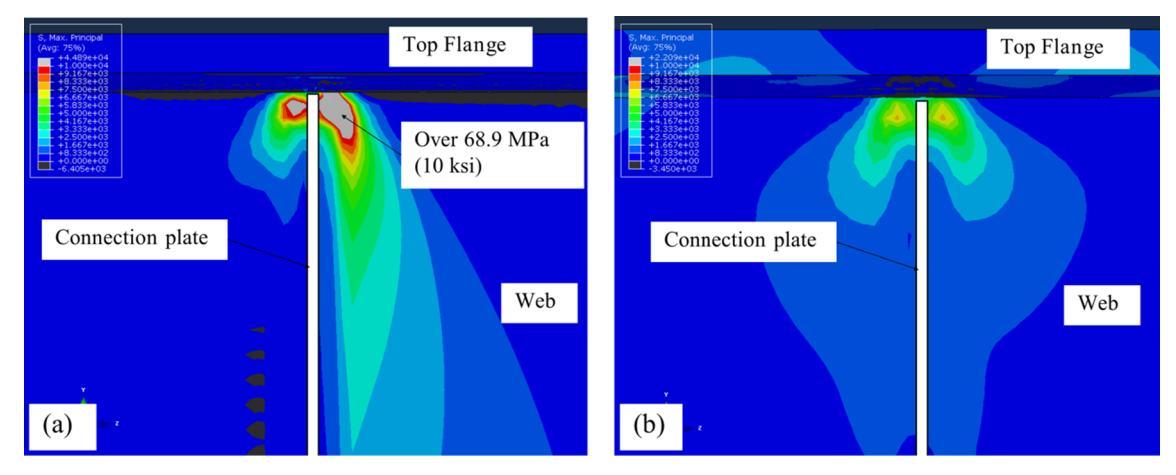
G2. Fig. 19 illustrates the stress distribution in the web-gap region of G2 before and after the repair. The localized maximum principal stresses after the repair occurred at the same location as before the repair and

they are smaller in magnitude and act over a much smaller area. These results demonstrate that the new load path through the repair angle section did not introduce a new critical fatigue sensitive area.

Fig. 19. Maximum principal stress contours in the web-gap region of G2 for the (a) before repair and, (b) after repair.

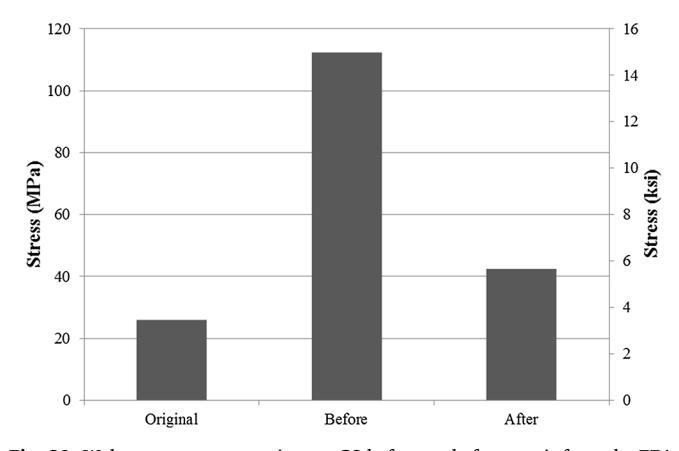
Fig. 20 shows the hot-spot stress for the web-gap of G2 prior to the seismic retrofit for the original bridge, after the seismic retrofit (before web-gap repair), and after the web-gap repair. The hot-spot stress is reduced by 62% from 103 MPa (14.9 ksi) to 39.0 MPa (5.65 ksi) which is slightly higher than the stress calculated for the original bridge.

For the unrepaired bridge, the results indicate that the hot-spot stress and the peak stress along the horizontal fillet weld of the web-toflange both exceed the constant amplitude fatigue threshold (CAFT) of 68 MPa (10 ksi) [31,32]. Consequently, distortion-induced fatigue cracks associated with the web-gap stress and the web-to-flange joint stress can occur after only a limited number of cycles. Also, the comparison between the results before and after the repair indicate that the web stresses are well below the CAFT and it is therefore expected to not experience new distortion-induced fatigue cracking.

Fig. 20. Web-gap stress comparison at G2 before and after repair from the FEA.

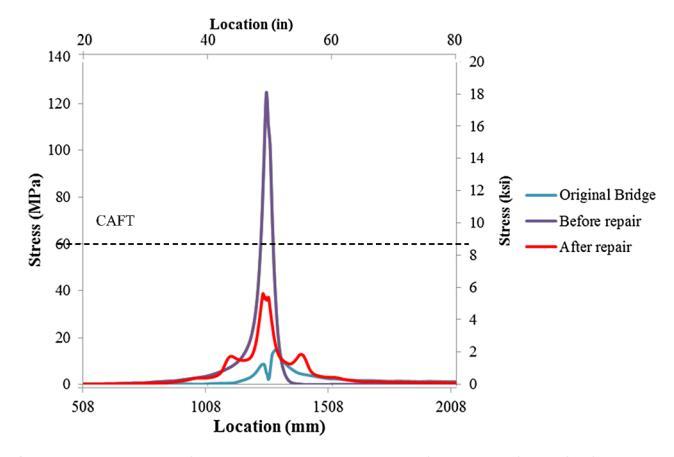
Fig. 21 shows the maximum principal stress along the horizontal fillet weld of the web-to-flange joint on the web surface for G2 when the middle lane of the bridge is loaded. As Fig. 21 shows, the peak stress along the web-to-flange joint drops dramatically from 125 MPa (18.1 ksi) to 38.6 MPa (5.60 ksi) when the repair strategy is implemented.

Fig. 21. Comparison between maximum principal stresses along the horizontal fillet weld of the web-to-flange joint before and after repair.
