First application of reinforced concrete in Spain and first European application in bridges: The rehabilitation of the Roman bridge of Alcántara

Juan Pedro Cortés-Pérez^{a,*}, Mario Núñez-Fernández^a, Alfonso Cortés-Pérez^b, Montaña Jiménez-Espada^a

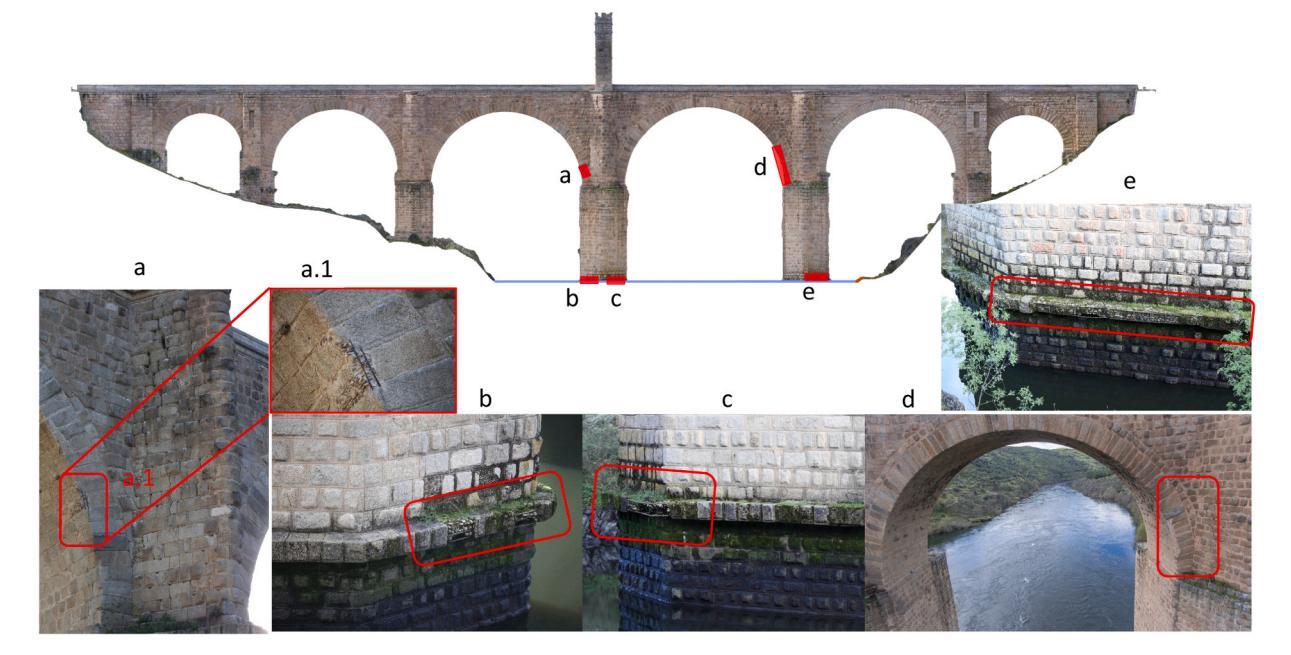
Therefore, in Fig. 2.a, the current damage to the left elevation of the buttress of the spandrel of the third or central pier can be seen, as well as the refilling of the ashlars. The detail image shows the stitched reinforcement on the right side of the third arch (Fig. 2.a.1). In Fig. 2. b and c reinforcement can be seen in the cornice of pier 3. In Fig. 2.d refilling and repairs appear in arch 4. Finally, in Fig. 2.e the reinforcement of the cornice of pier 4 is shown in the cutwater area and the inner face of the side of arch 4.

Fig. 2. The central figure shows the orthophoto of the upstream elevation in which some of the areas where concrete and reinforced concrete have been used are highlighted. Figures a) to e) show detailed images of these interventions.

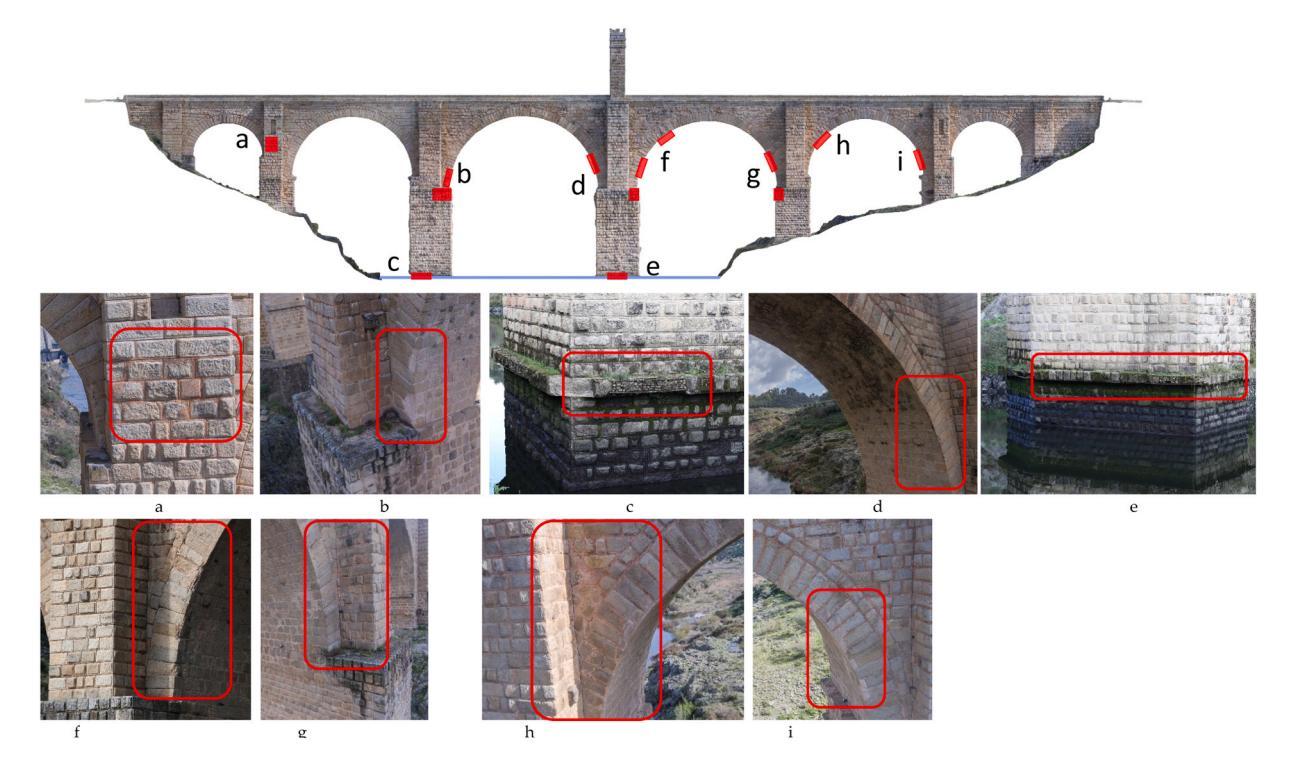
In Fig. 3. a detail of the refilling and a possible repaired ashlar in the buttress on pier 5 is shown. In the Fig. 3.b a change in the tone of the ashlars of the coping of pier 4 is observed, as well as repairs to the nozzle on the left side of arch 4 and mortar refilling of the interior of the arch and pier. In Fig. 3.c there is a break in the ashlar of the cornice of the shaft of pier 4 and reinforcement visible in the part of the cornice on the face parallel to the downstream elevation. Fig. 3d shows the repairs of the damage in the arch ring of the fourth arch. Fig. 3.e shows the current damage to the cornice of pier 3 in the repaired areas, leaving the reinforcement visible. Fig. 3, and g present the mortar repairs of the arch ring of the third arch and the interior of the arch, as well as the repairs of the pier's cap of pier 2. Finally, Fig. 3h and i, show the work on the arch ring and the refilling of the spandrels of the second arch.

Fig. 3. The upper figure shows the downstream elevation highlighting some of the areas with concrete and reinforced concrete interventions. The lower figures a) to i) show detailed images of these interventions.

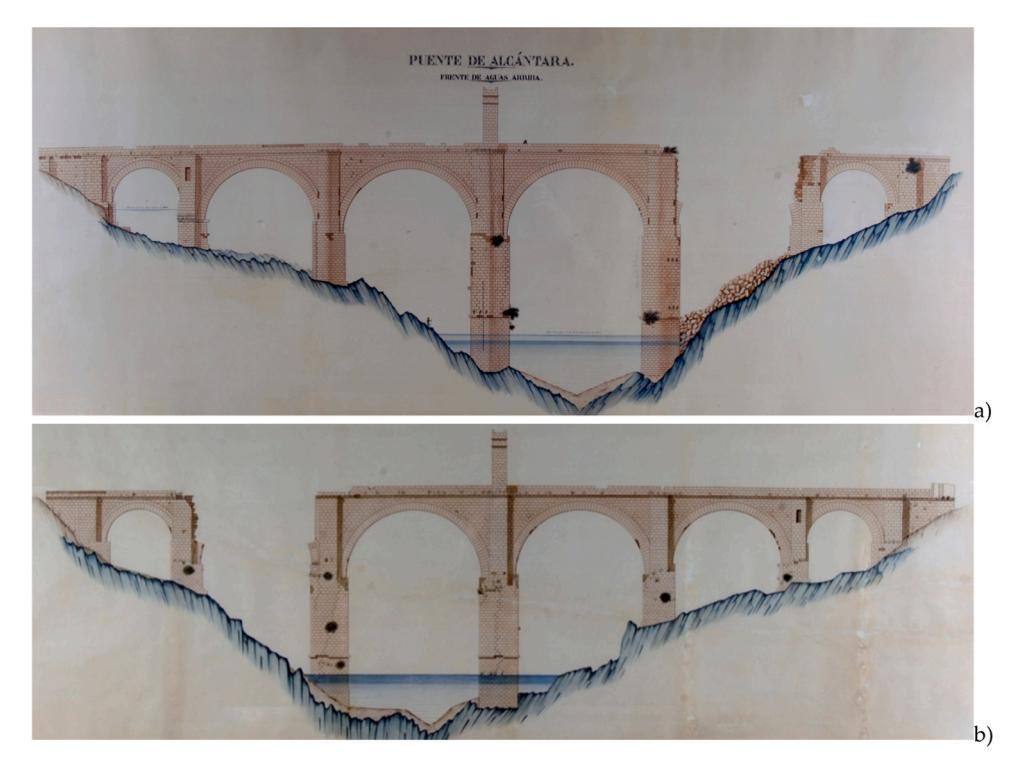
For the project to rebuild the fifth arch and the general rehabilitation of the bridge, Millán drew up plans with an exhaustive survey of the state of the bridge prior to the intervention [40]. In Fig. 3.a and b the upstream and downstream elevations are shown, respectively, highlighting in dark areas where ashlars are missing or where there are cavities that need to be repaired, as well as vegetation.

Fig. 4. Plans of the upstream elevation, upper, and downstream elevation, lower, with the damage survey by Millán [40].

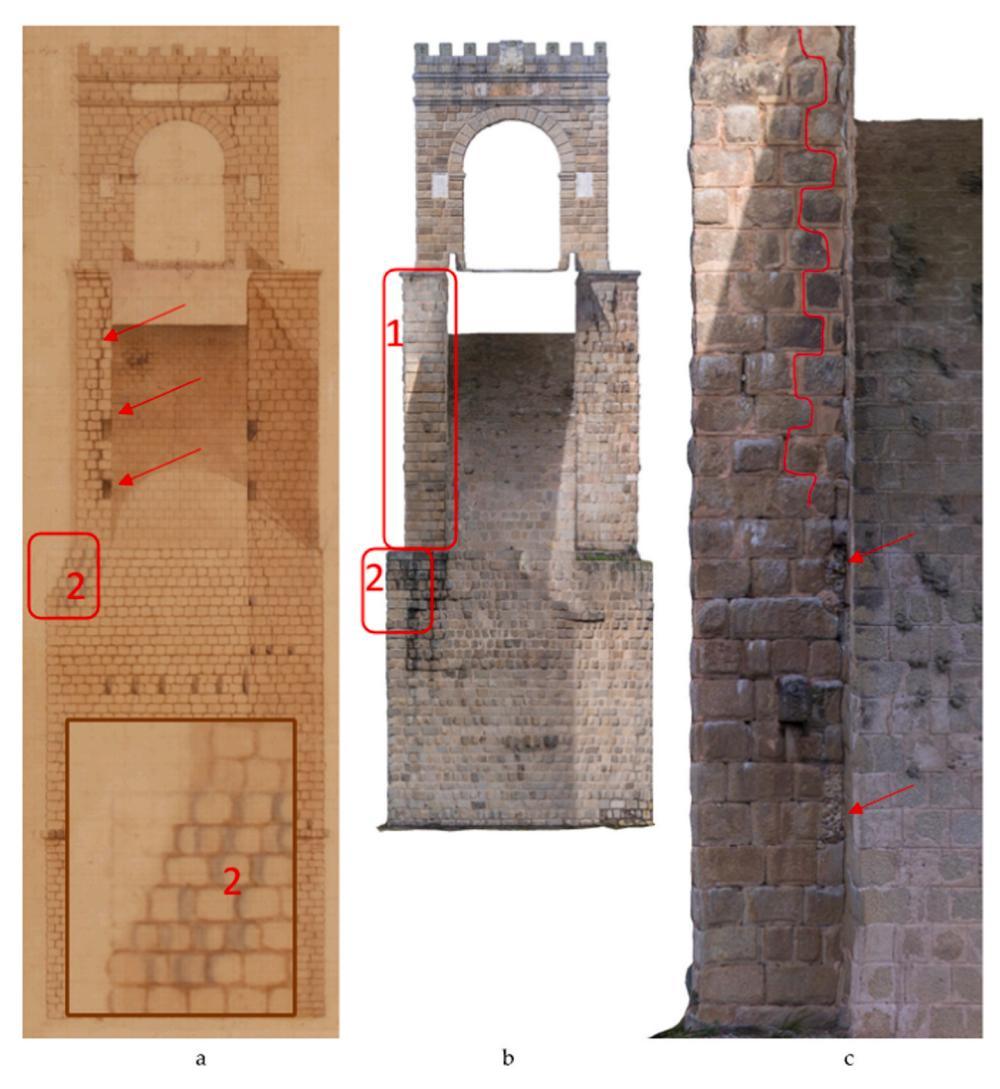
Fig. 5. Elevations of the central pier (3) as seen from arch 3: (a) survey by Millán [40], in zone 2, the pier cap heightening is faintly profiled (b) orthophoto of the drone survey and (c) detail of orthophoto with the repairs that have been carried out in zone 1 marked in (b).

cracks in the buttress in the spandrel area, as well as the symmetrical shaded areas on both sides, possibly points of support for the formwork used by the Romans. In Figs. 4b and 5b, orthophotographs of the 2017 survey are shown from the third and fourth arch respectively.

Regarding Figs. 4c and 5c, it is shown that the shaded areas in Figs. 4a and 5a have been filled with concrete, even identifying the type of aggregate used in the manufacture of the concrete.

Moreover, in zones 2 of both pictures (Figs. 4a and 5a), is observed in a fainter line which what has to be the final geometry of the pier cap, which is materialised in Figs. 4b and 5b.

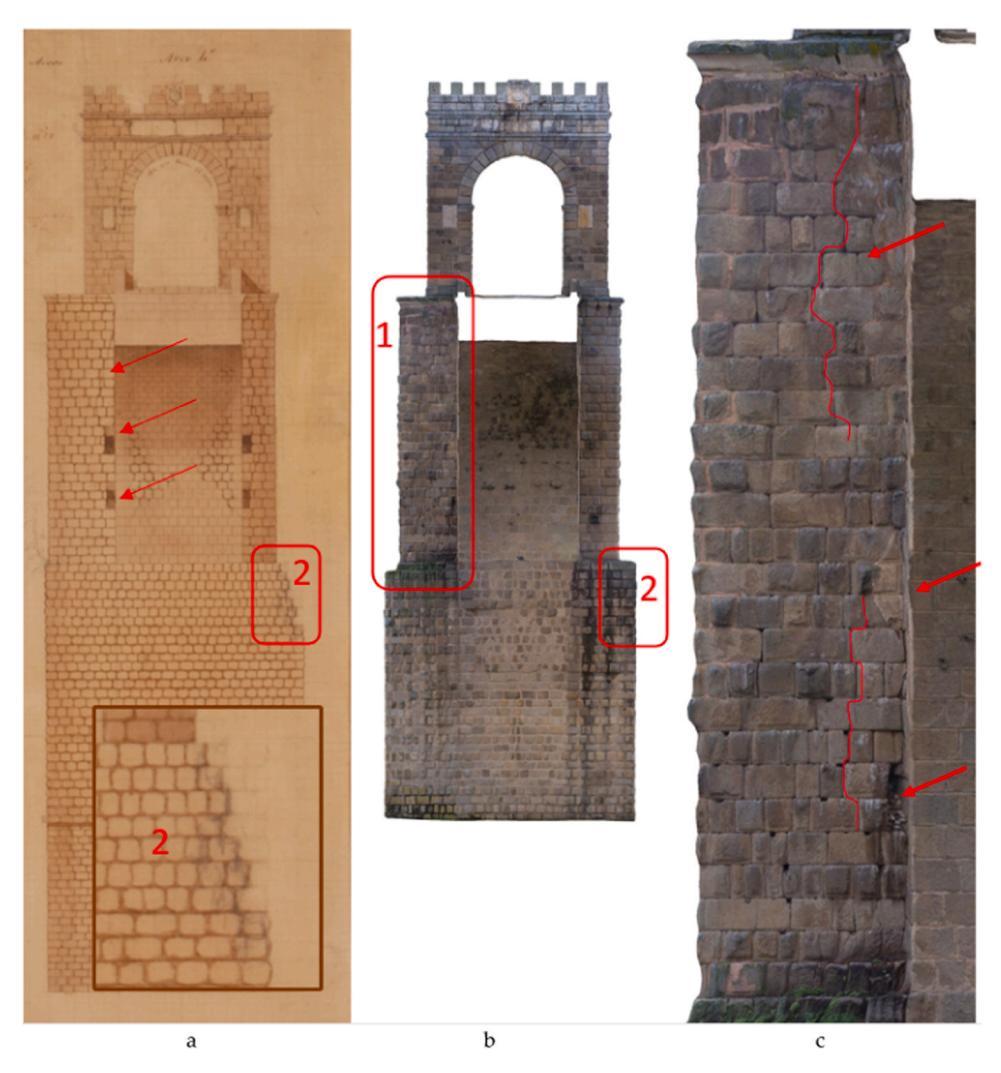
Fig. 6. Elevations of the central pier (3) as seen from arch 4: (a) survey by Millán [40], b) orthophotography of the drone survey and c) detail of orthophotography with the repairs that have been carried out in zone 1 of b).

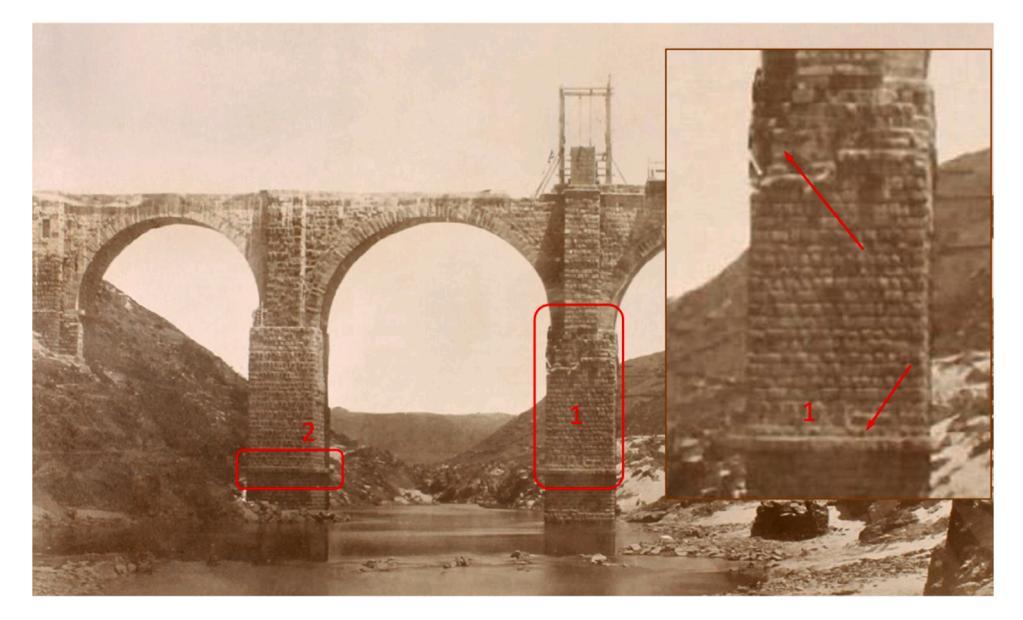
The restoration work is reflected in a photograph taken in 1858 by Clifford [48], which Millán sent to the academy and which shows the state of the works in 1858, such as the dismantling of the triumphal arch (Fig. 6). It shows that the stepped section of the central pier cap (zone 1) has not yet been reconstructed, while that of pier 4 has been executed, both of which are shown in the plans prior to the work (Fig. 3.a and b). In addition, in Fig. 6 it can be seen that the cornices of piers 3 and 4 (zones 1 and 2) have been reconstructed with respect to what Millán reflected in his survey (Fig. 3.a and b).

Fig. 7. Photograph of arches 4 and 5 as viewed from downstream by Clifford [48] and sent in 1858 by Millán to the Real Academia de Bellas Artes de San Fernando. In zones 1 and 2, the cornices have been repaired. However, the pier cap 3 in zone 1 is still unrepaired.

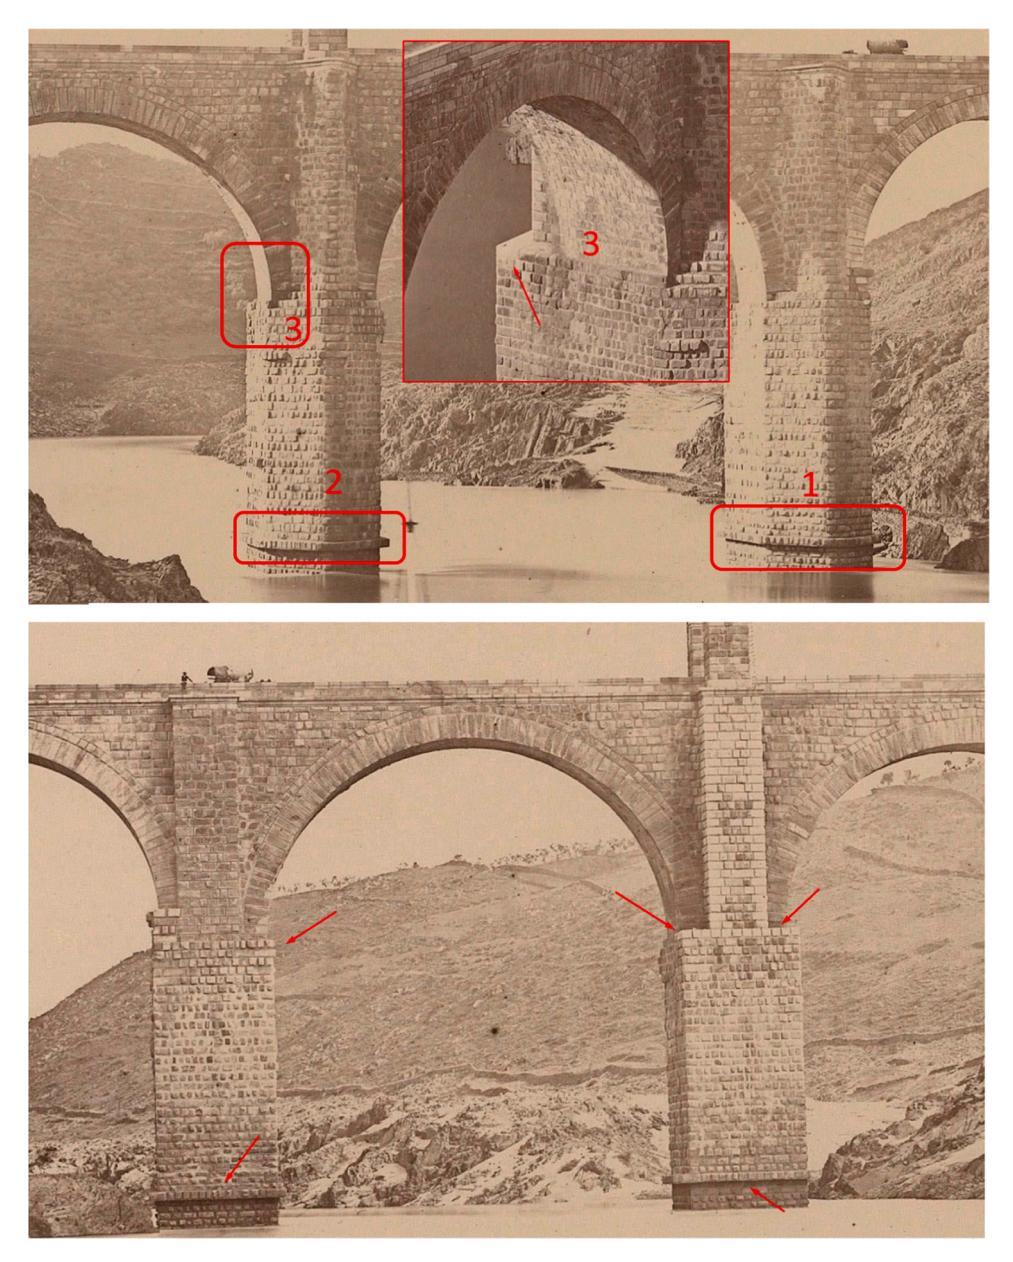
On completion of the works in 1859 Clifford [49] also took photographs (Fig. 7). They show the reconstruction of the pier caps 3 and 4 and their cornices (Fig. 7.a and b). Another photographer, who travelled around Spain and took photographs of different monuments, among them the Alcántara bridge (Fig. 8), was Jean Laurent [50]. This photograph shows the same situation of the bridge as the one shown by Clifford in 1859, with the cornices repaired (1 and 2 in Fig. 8), the pier caps heightening (3 and 4 in Fig. 8) and repairs to the arch rings of arches 3 and 4 (5, 6, 7 and 8 in Fig. 8). The following documented photographs of the bridge date from 1925 [51] to 1929 [52], which do not show any additional interventions or damage to cornices or arches. The following photograph is from 1969 and was taken during the repair work on the foundations of piers 3 and 4, when the bed of the Tajo river dried up during the

Fig. 8. Photographs taken by Clifford in 1859 of the finished works [49]: (a) upstream elevation and (b) downstream elevation, where all the areas marked on Millán's 1856 plans are repaired.

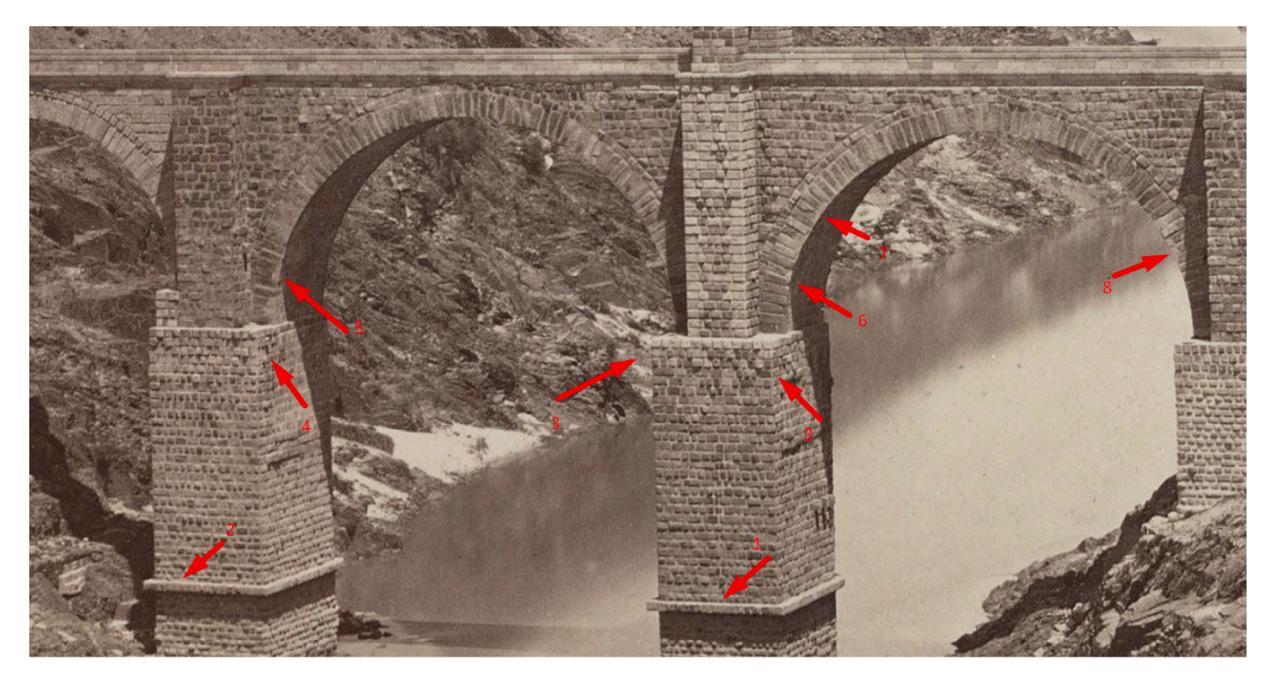
filling of the Alcántara reservoir, whose dam is 600 m upstream from the bridge (Fig. 9, on the top). This figure shows the erosion of the ashlars in the lower part of pier 3, as well as the presence of reinforcement visible in the cornice of the pier, which, given the level of loss of concrete covering, denotes a significant age. Furthermore, comparing this photograph with current photographs (Fig. 9, on the bottom), the areas with reinforcement can be perfectly traced back to those currently observed and to the damage shown by Millán in his plans (Fig. 3.a and b).

Fig. 9. Photograph taken by Laurent [50] of piers 3 and 4 and arches 3, 4 and partly 5, from downstream.

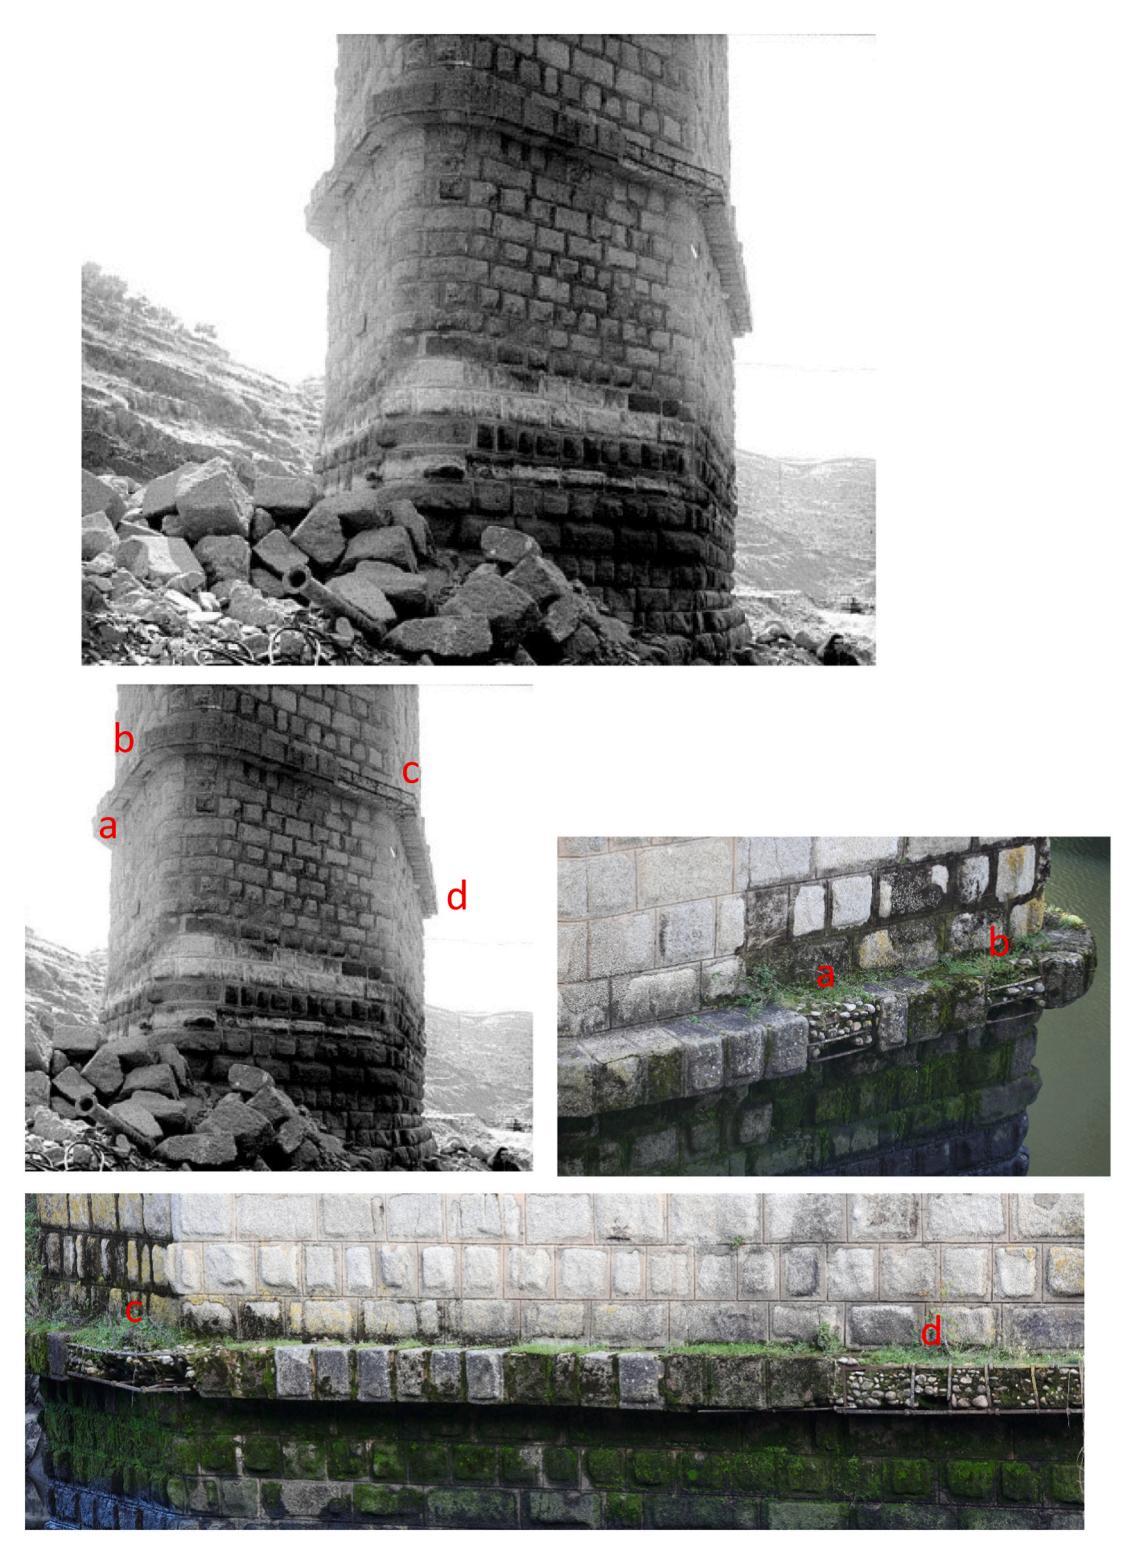
Fig. 10. The top left image is Calleja's photograph of pier 3 [55] in 1969 marking the areas where reinforcement was already present at that time. The top right is a current photograph of the left elevation of the shaft of the pier. The lower image is a 2017 photograph of the right elevation of the shaft of the pier.

With regard to the effect of the repair on the structural behaviour, it should be pointed out that as it was located on the cornices, it did not affect the overall safety of the structural bridge [9], the only local effects being due to the connection of the reinforcement to the ashlars (Fig. 10).

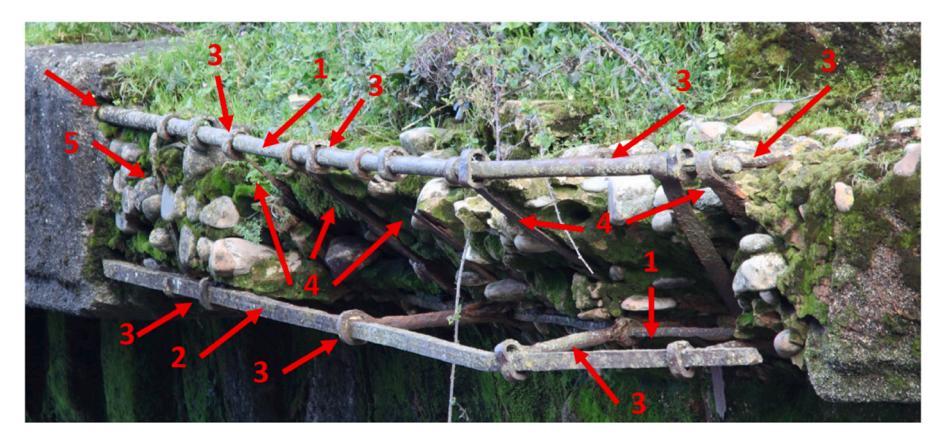
Fig. 11. Description of the reinforcement of the cornices of pier 3 with the designation of each type of reinforcement.

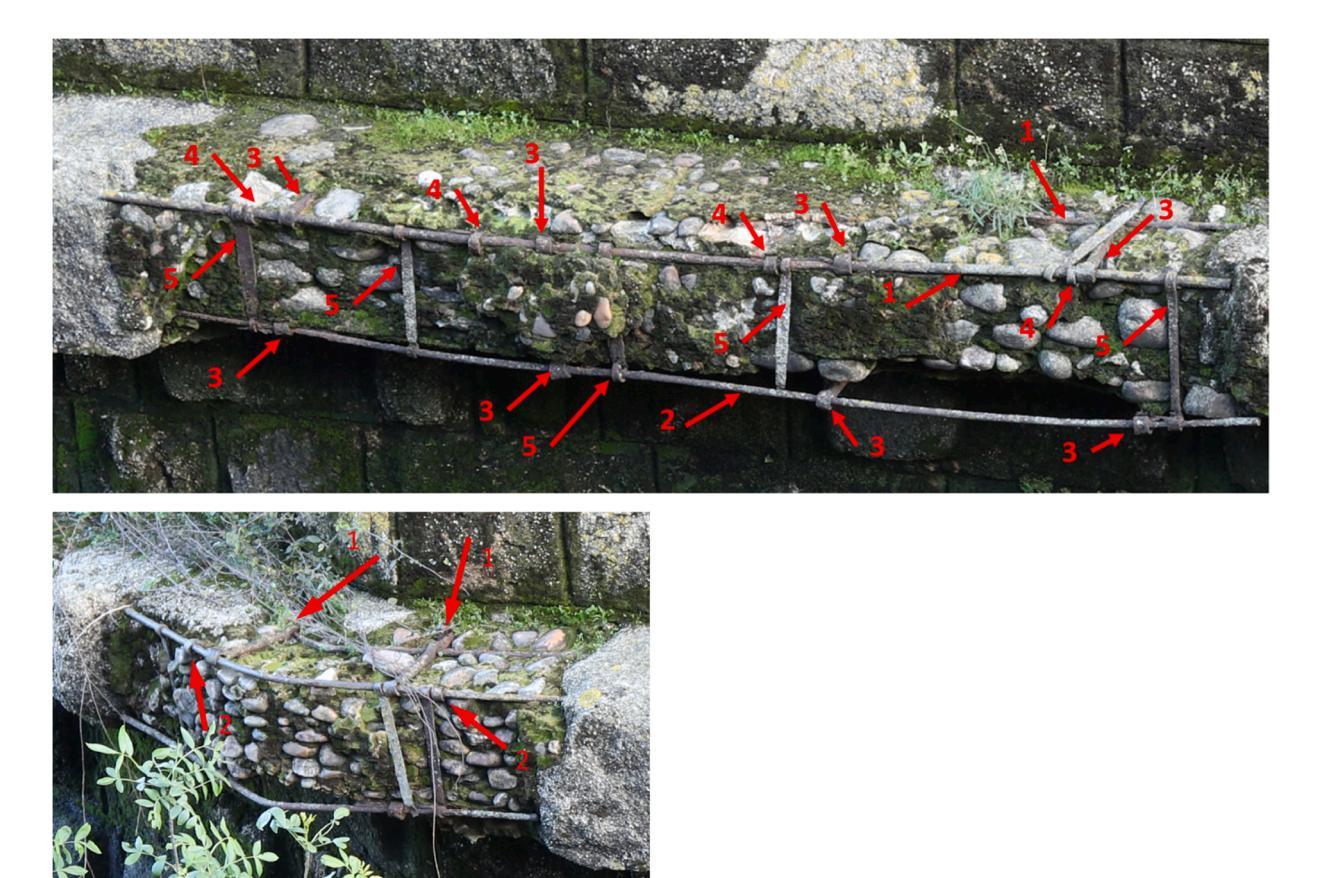
The reinforcement of the cornice of pier 4 (Fig. 11) does not appear as complete as in pier 3, but it can be seen that it follows the same scheme as that one with some differences that are indicated below. The number of type 5 bars is higher and therefore the spacing between them is smaller; type 4 bars are less numerous and therefore more widely spaced and the outermost lower longitudinal reinforcement is circular in section, unlike the previous one, which was square in section. Regarding type 3 and 4 reinforcement of the cornice of pier 4, they have been deduced from the information observed in the cornice of pier 3. To this end, it has been considered that in pier 3 the type 3 reinforcement has an eyelet at the end to join with the longitudinal reinforcement and that the upper and lower ones coincide on the same vertical. Based on this, in pier 4, the upper reinforcement type 3, which is not visible, has been marked on the basis of the lower ones, which are visible, and the type of connection with the type 1 reinforcement. On the other hand, given that in the cornice of pier 3 it has been verified that the connection of the type 4 reinforcement to the longitudinal reinforcement is by bending the end, the type 4 reinforcement in pile 4 has been marked on the basis of this fact, as its inclination was not observed.

Fig. 12. Description of the reinforcement of the cornices of pier 4 with the designation of each type of reinforcement in the straight work a) and in the break zone b).
