# **Engineering Failure Analysis**

## Structural damage assessment of reinforced concrete buildings in Adıyaman after Kahramanmaraş (Türkiye) Earthquakes on 6 February 2023

## Ozan İnce

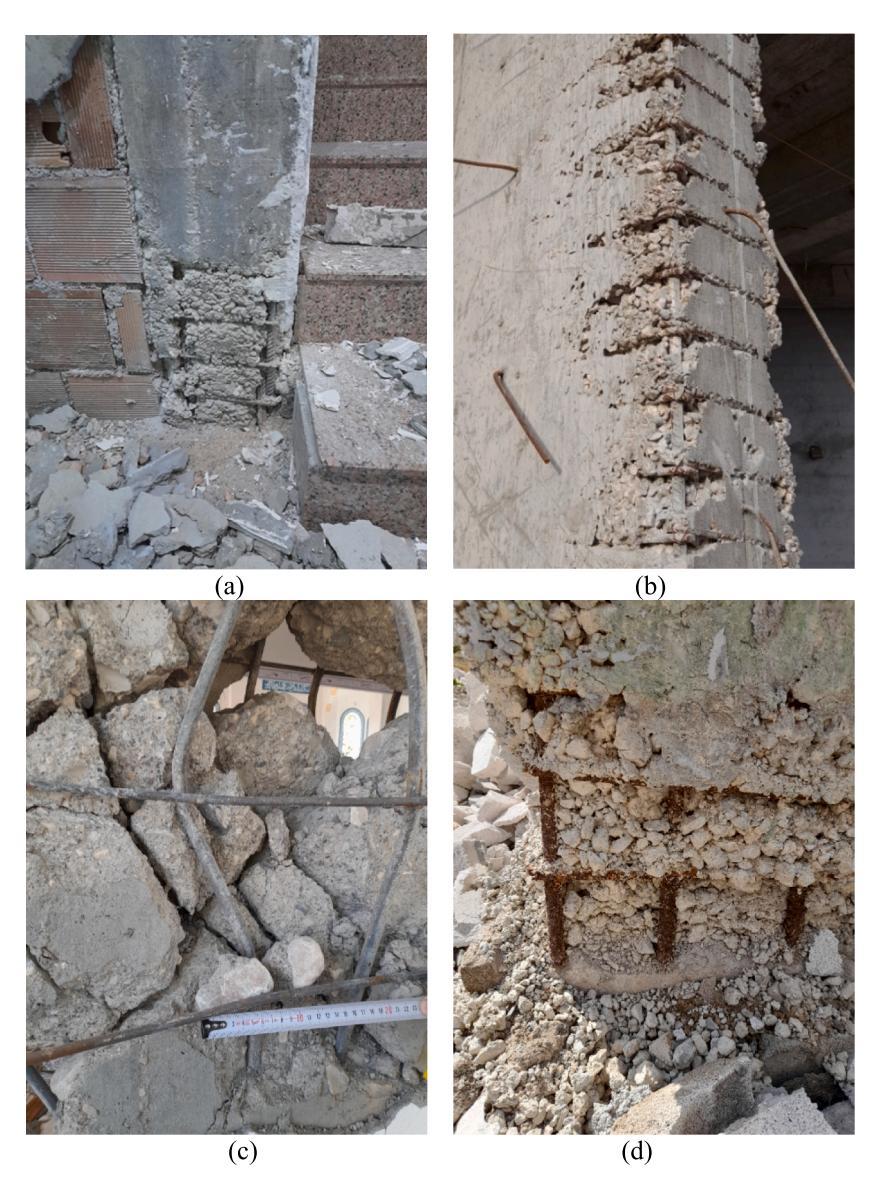
Fig. 10. Poor concrete quality and corrosion.

In the design of a reinforced concrete building, the design is made by assuming that the concrete provides the project strength, is homogeneous and works together with the reinforcements. However, during field observations, concrete strength is reduced by segregation in concrete, use of unsuitable aggregate in granule, inability of concrete to settle due to dense reinforcement have been encountered frequently (Fig. 10).

Corrosion of the reinforcement due to insufficient concrete cover causes a weakening of the bond between the concrete and the reinforcement. With the progression of the corrosion level, the diameter of the reinforcing bar decreases, thus reducing the bearing capacity of the reinforced concrete element. In addition, the volume of rusting steel increases, causing cracks in the shell concrete of the reinforced concrete element. During the field investigations, reinforcement corrosion was frequently encountered in reinforced concrete elements.

- Poor concrete quality is one of the most common defects found in the investigated buildings. Greater attention should be paid to the diameter and granulometry of the aggregate used in concrete. To prevent segregation in concrete, the concrete should be carefully settled using a vibrator. Additionally, corrosion is another issue affecting the buildings. To prevent steel corrosion, the concrete cover should provide sufficient protection against corrosion.

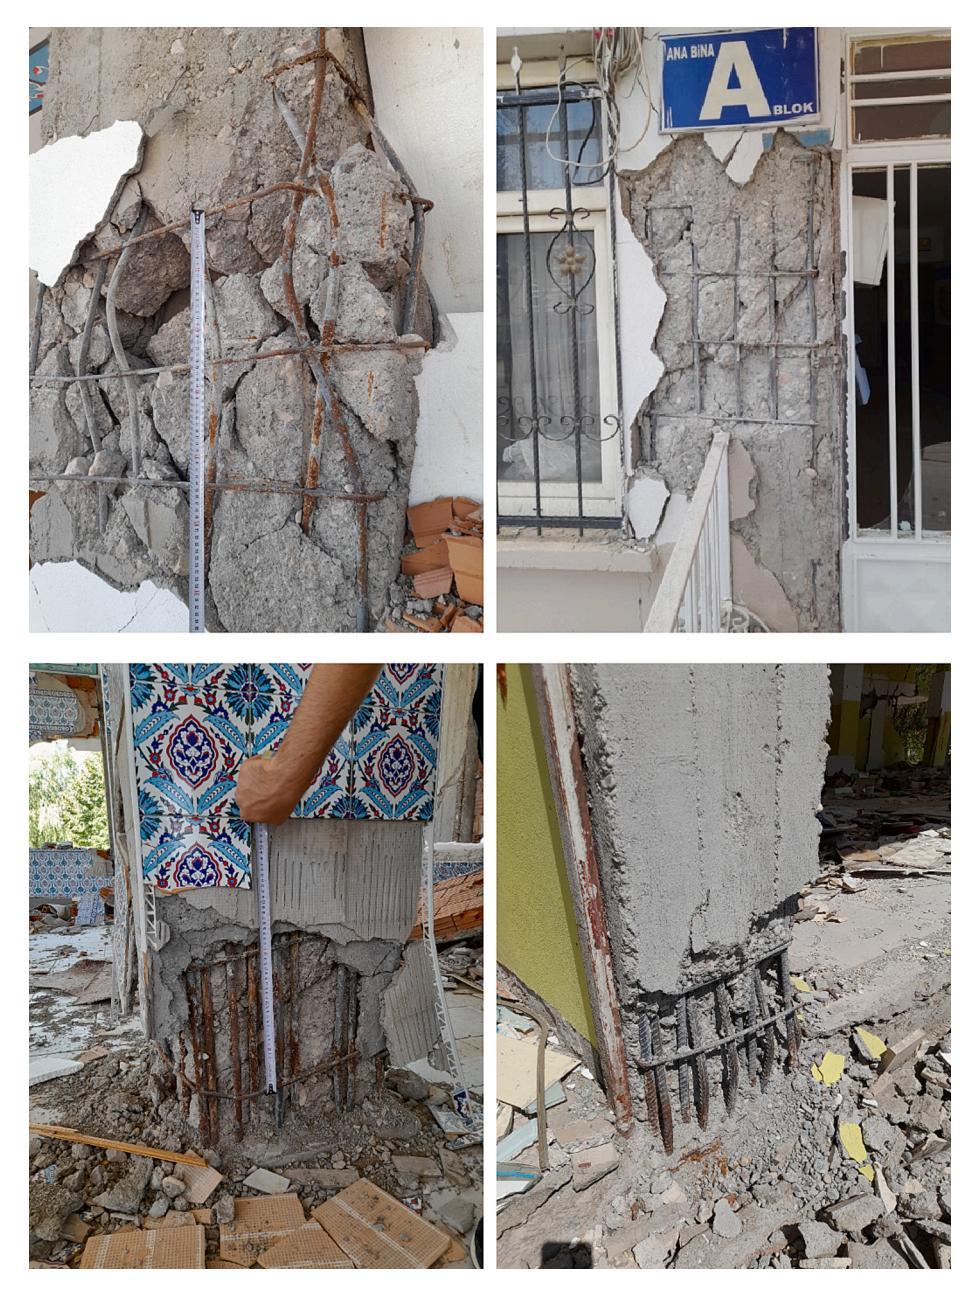
Fig. 11. Insufficient transverse reinforcement in RC elements.

proper and sufficient. In addition, there are more precautions to be taken in order to provide ductile behavior during extreme loading situations such as strong column-weak beam and avoiding short column effects. It is necessary to increase the transverse reinforcement ratio in the plastic hinge region with crossties and 135° hook angle. However, in the field observations, it was frequently observed that severely damaged buildings have up to 40 cm spacing of transverse reinforcement even in plastic hinge region (Fig. 11).

- Insufficient spacing of transverse reinforcement, especially in the plastic hinge region, the absence of transverse reinforcement in column-beam connections, and the lack of crossties (insufficient spacing of transverse reinforcement arms), have caused serious damage to buildings. Additionally, more attention should be given to the 135° hook angle and ensuring a sufficient hook length for the effective performance of transverse reinforcement.

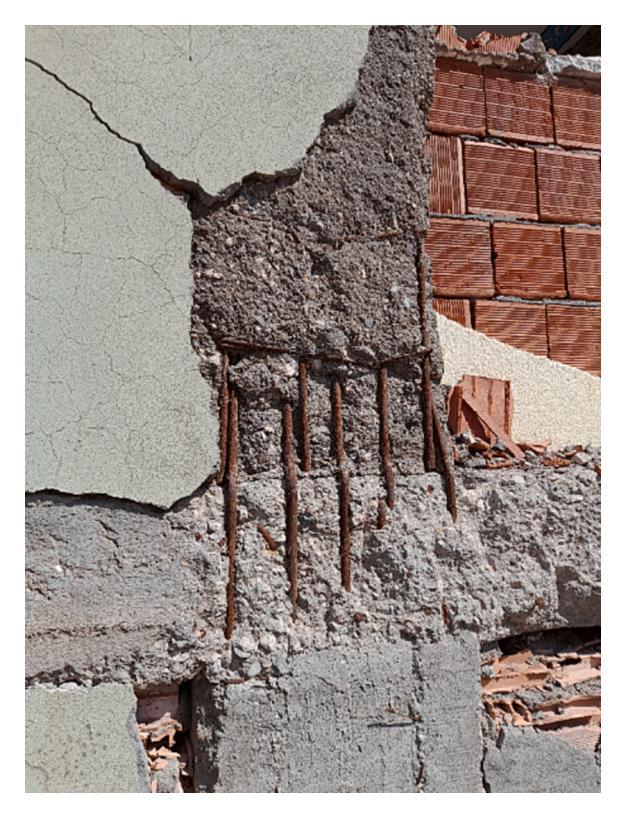
Fig. 13. Lack of transverse reinforcement in column-beam connection.

Türkiye Earthquake Codes (TEC-1975, TEC-1998, TEC-2007 and TEC-2018) defines there region for reinforced concrete elements. Column-beam connection region, confinement region and mid-span region is defined in these codes (Fig. 12). Türkiye Earthquake Codes requires that column transverse reinforcements should be continued within the column beam connection area. However, even in buildings constructed after 2010, lack of transverse reinforcement of column-beam connection was frequently observed (Fig. 13).

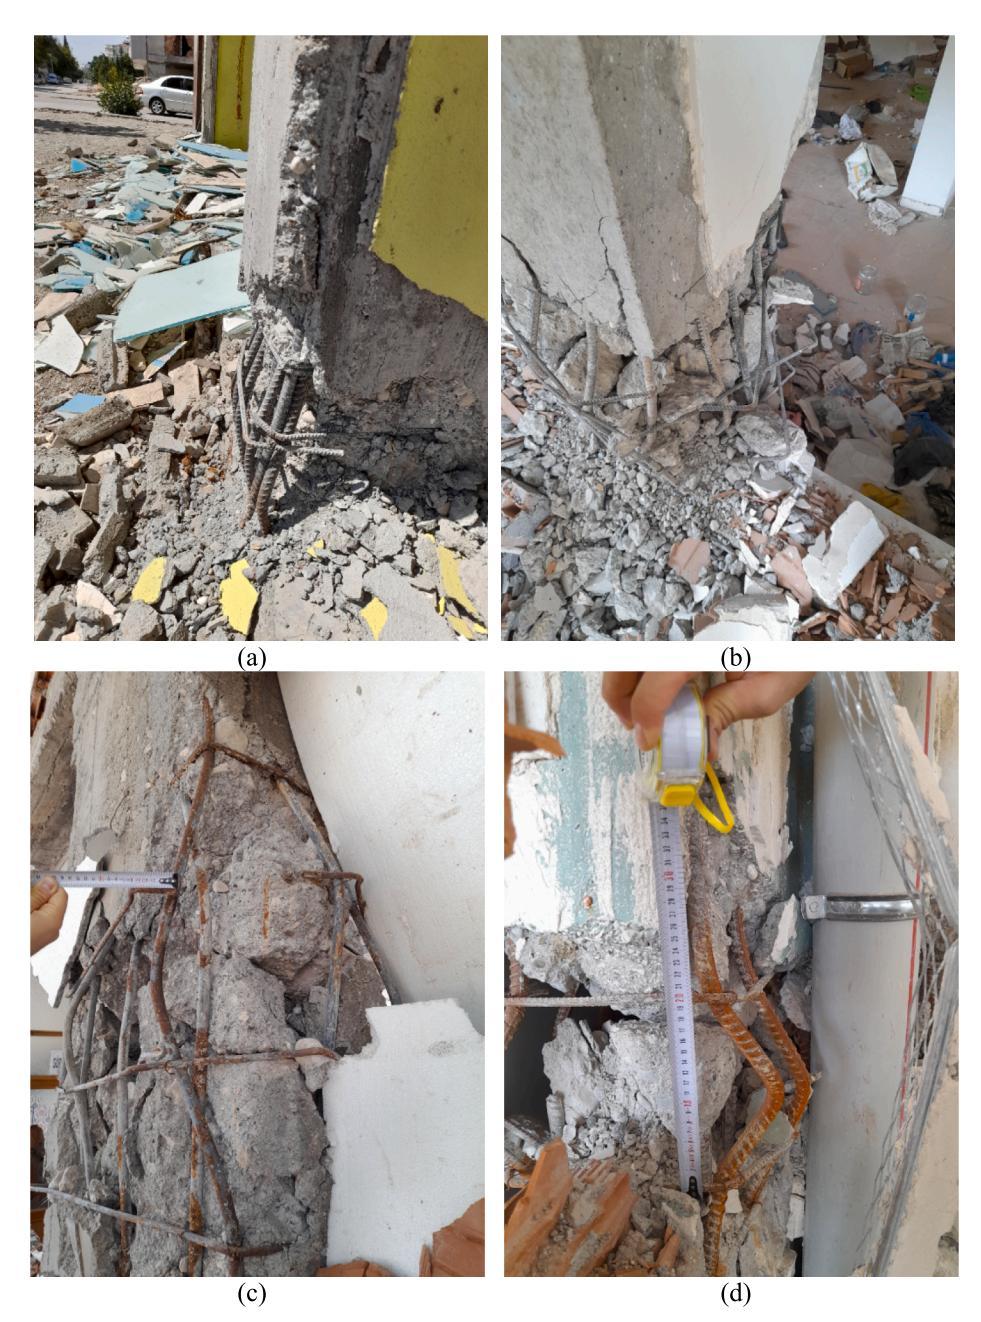
Fig. 14. Opened transverse reinforcement and buckling of longitudinal bars.

Transverse reinforcement hooks must be  $135^{\circ}$  and their lengths must be sufficient to effective working (TECs). Otherwise, the transverse reinforcements are opened under the effect of earthquake loads because of  $90^{\circ}$  hooks and insufficient hook lengths (Fig. 14). In cases where the transverse reinforcement spacing is insufficient in the plastic hinge regions of the columns and column-beam connection region, it is frequently observed that the longitudinal reinforcements buckling and the thrown out of cover concrete

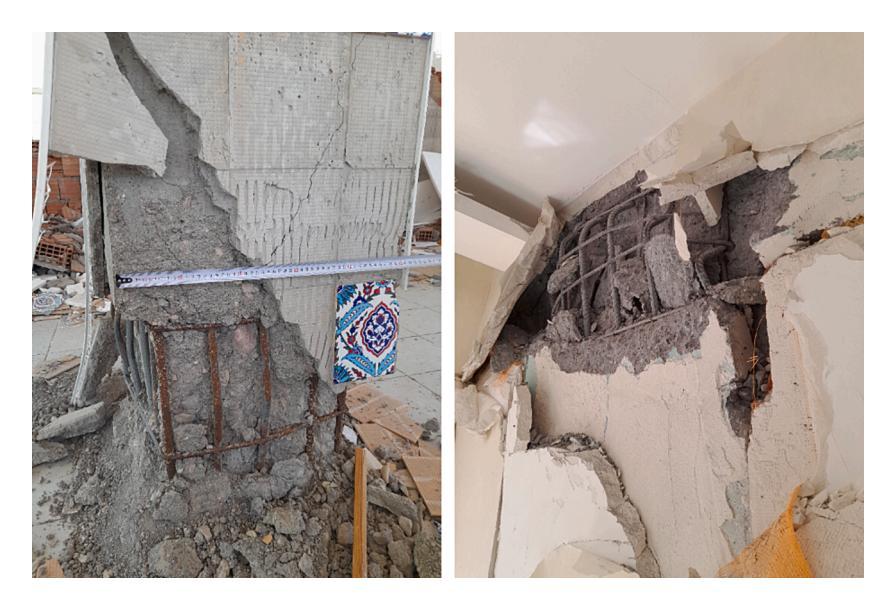
Fig. 16. Lack of crossties in columns.

Türkiye Earthquake Codes requires that distance between transverse reinforcement arms should not exceed 25Ø (Ø: diameter of transverse reinforcement) (Fig. 15). However, in field observations, transverse reinforcement generally observed only around of column (Fig. 16).

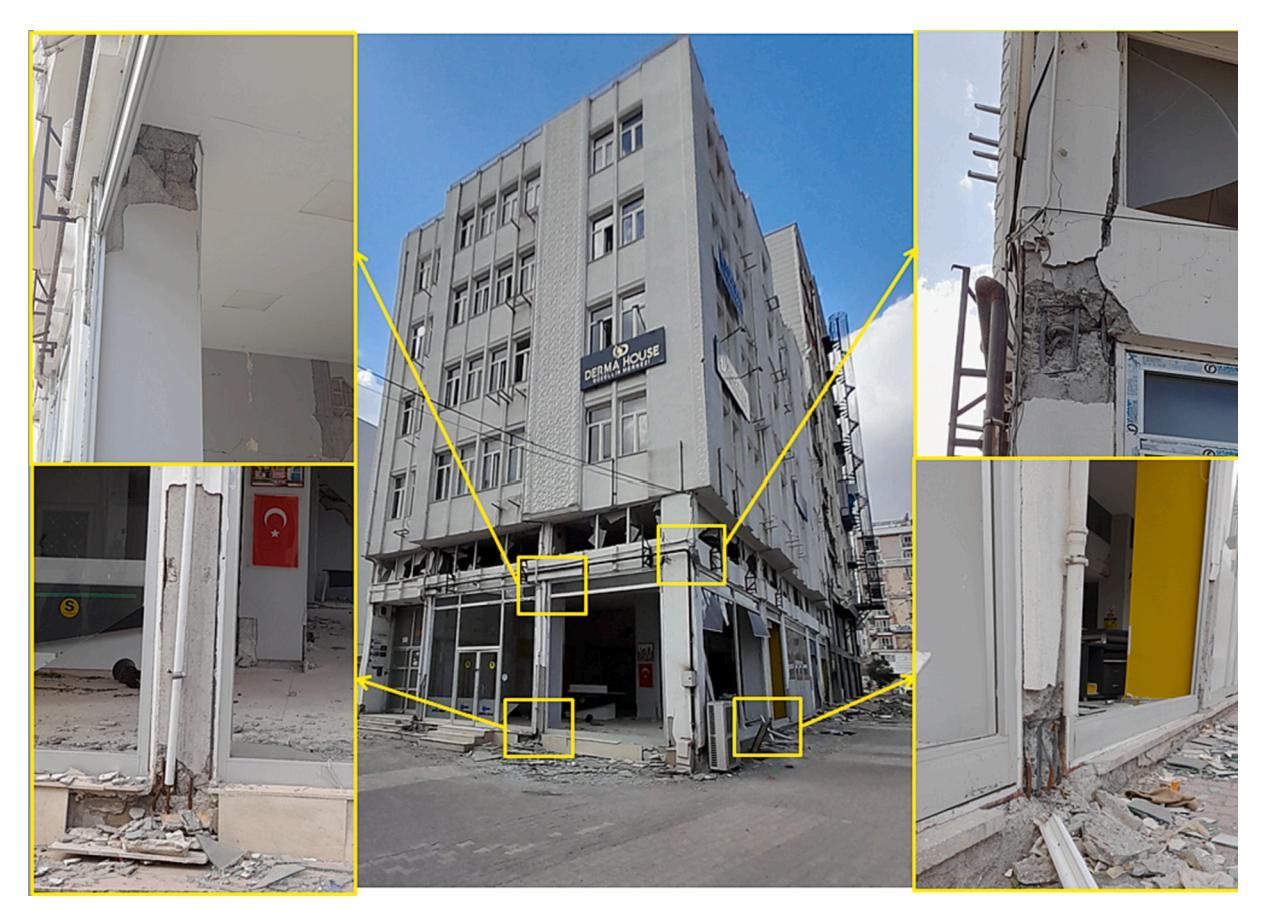
In the Fig. 18, the height of the first floor of building was increased and the infill walls were removed in the first floor. While significant damage was not observed on the upper floors of a 5-storey building, plastic hinges were formed in the ground floor columns.

Fig. 18. A damaged building because of soft and weak story.

- To ensure a more ductile and stronger structural behavior and to prevent the total collapse of reinforced concrete buildings, it is essential for columns to be stronger than beams. This consideration becomes even more critical in buildings that are vulnerable due to soft or weak stories.

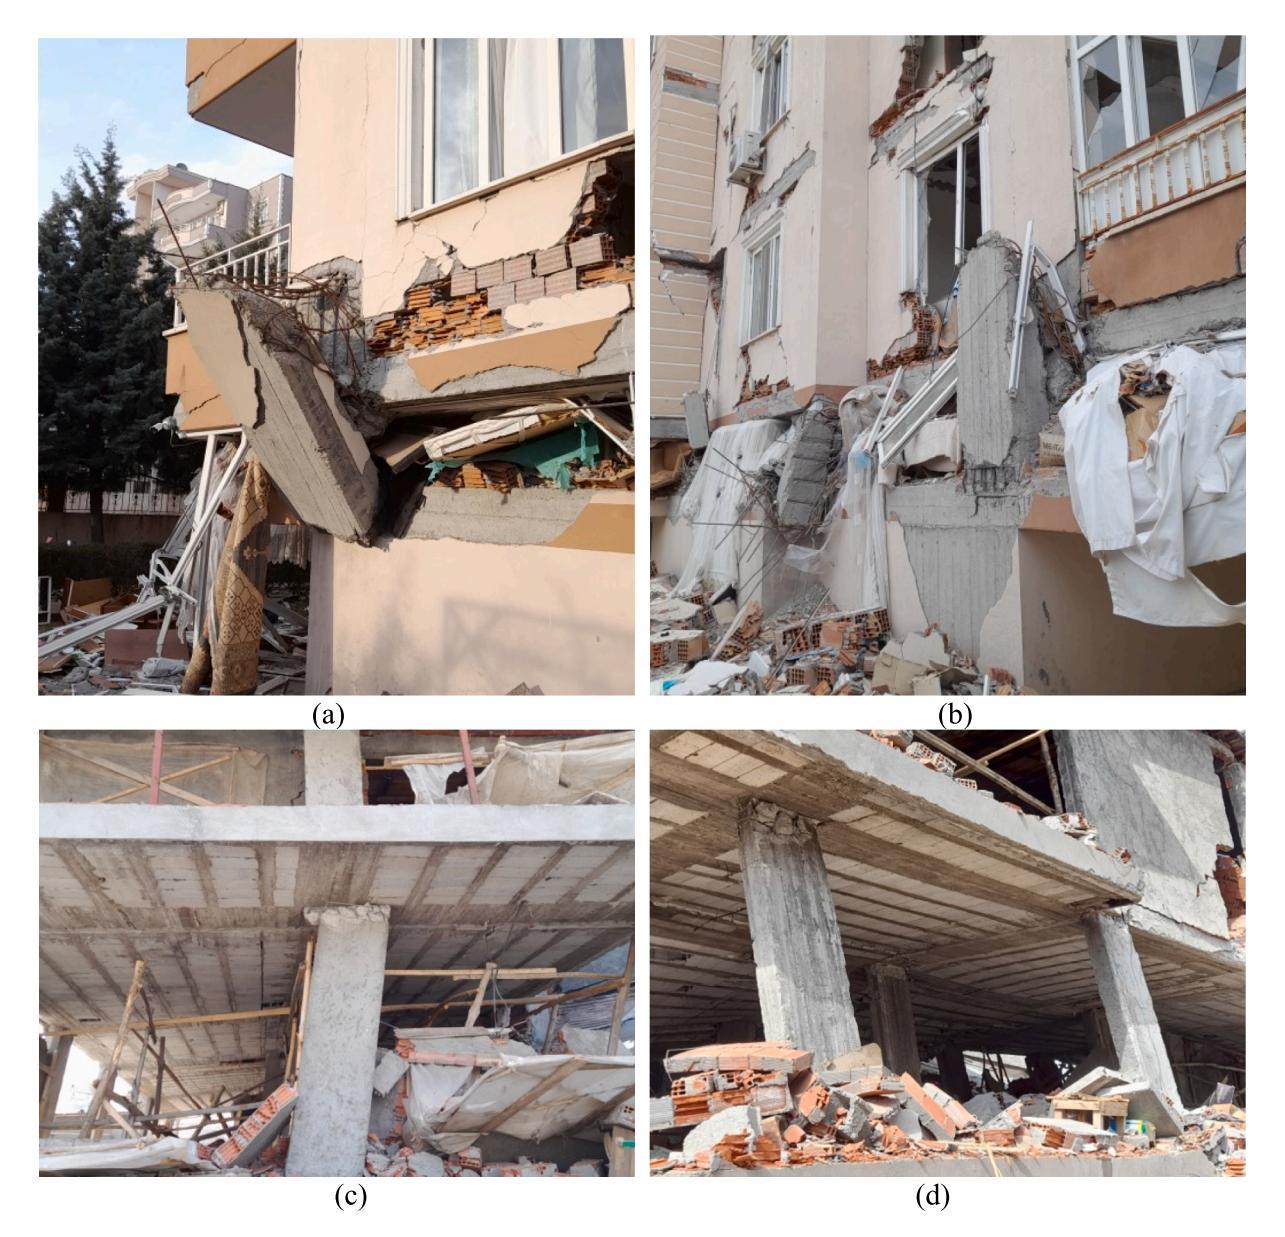
In reinforced concrete buildings, columns are designed stronger than beams. Thus, it is aimed that beams are damaged before columns to prevent building from brittle failure or totally collapse. Also to ensure ductile behavior columns are designed stronger than beams. TBEC-2018 is requires that sum of ultimate moment resistances of columns should be at least 20 % more than the sum of ultimate moment resistances of beams. However, in the field investigations, it has been observed that in many buildings, the columns were damaged before the beams and even collapse of the building floors (Fig. 19).

Fig. 19. Strong beam- weak column damages.

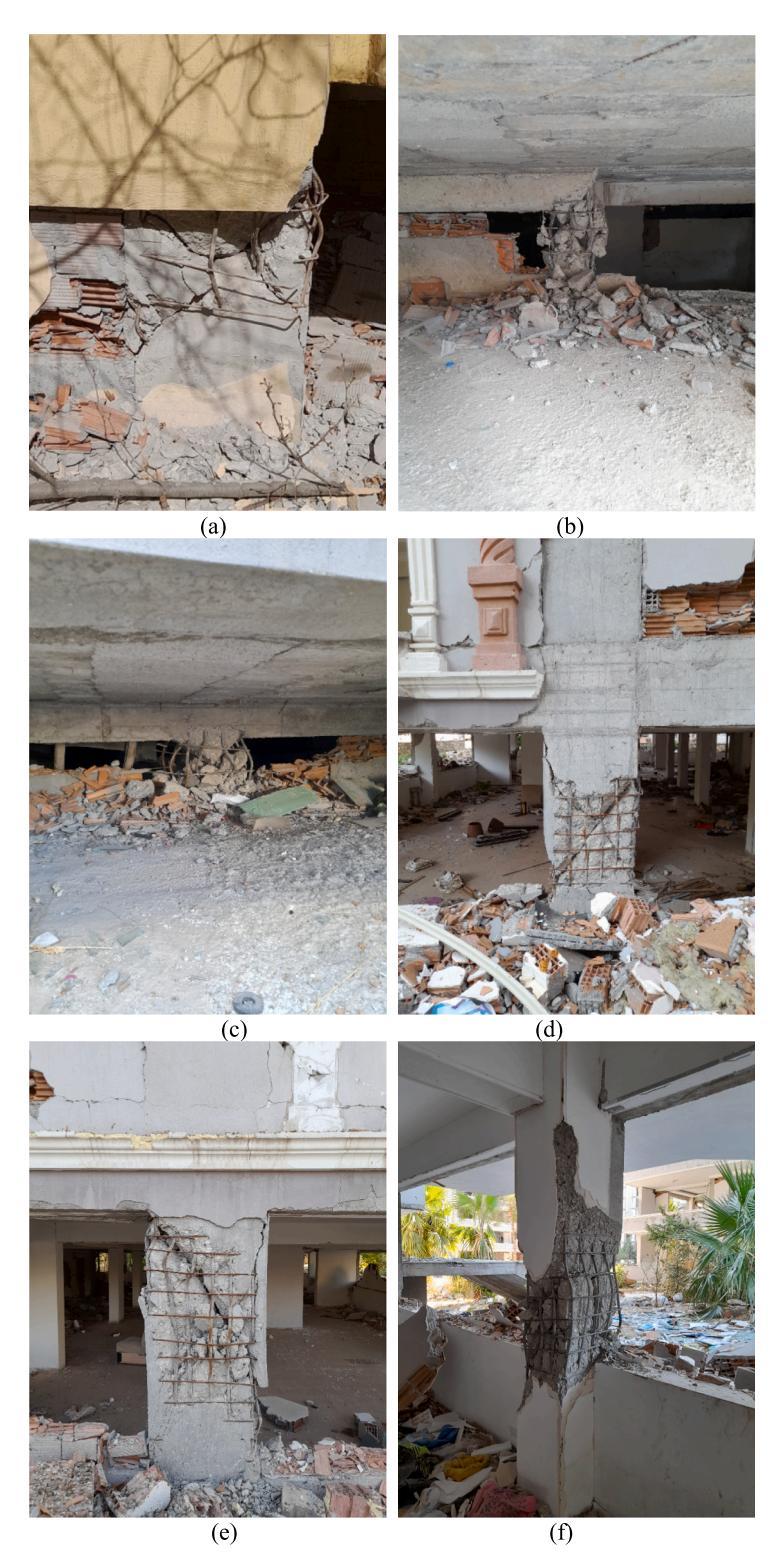
During an earthquake, it is expected that columns will displace freely along the story height. However, reasons such as building an infill wall adjacent to a column to a certain height or supporting the stair landings to the column restrict the displacement of the column and reduce the effective height of the column. Column with decreasing effective height behaves more rigid and additional shear forces come to this column during earthquake. In field observations damages based on short column effect was often observed (Fig. 20).

Fig. 20. Damaged columns because of short column effect.

- In the design of reinforced concrete buildings, it is crucial to prevent brittle damages. To achieve this, it is important to avoid the short column effect. To this end, a gap can be left between infill walls and structural elements. Additionally, in the basement, windows should be positioned away from the column sides.

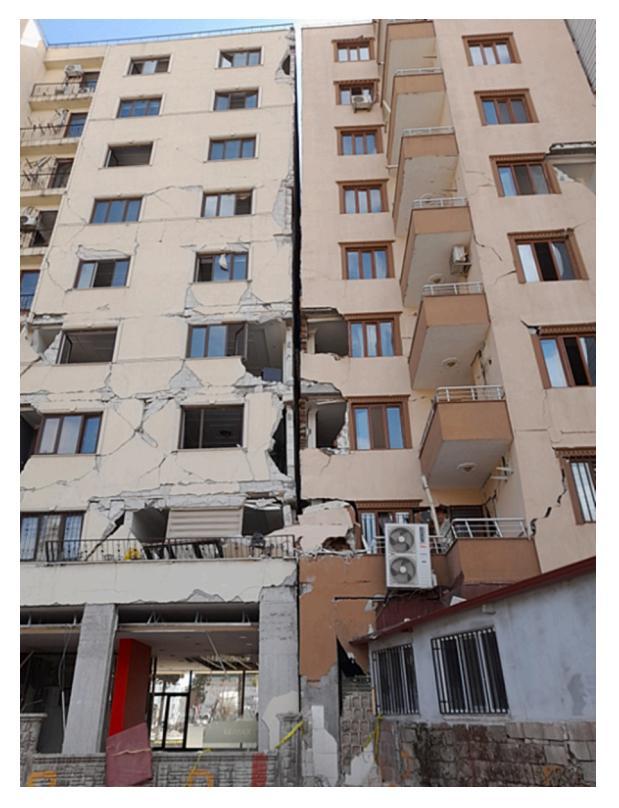
In field investigations, adjacent buildings with same floor height were widely observed (Fig. 21). Also damaged buildings because of different floor level were widely observed (Fig. 22). Design of buildings with span longer than 40 m should have expansion joints. However, in field observations, it was seen that many building expansion joints have not enough gap distance (Fig. 23). In many case, collapsed buildings severely damaged next to the building by impact effect (Fig. 24).

Fig. 21. Adjacent buildings with same floor level.

- In the design of reinforced concrete buildings, it is assumed that the building can freely displace during an earthquake. Therefore, an adequate gap should be left between buildings. However, in the case of adjacent buildings, they can collide and cause damage to each other. This situation is particularly hazardous for buildings with different floor levels. To prevent such damages, a sufficient gap should be maintained between buildings.

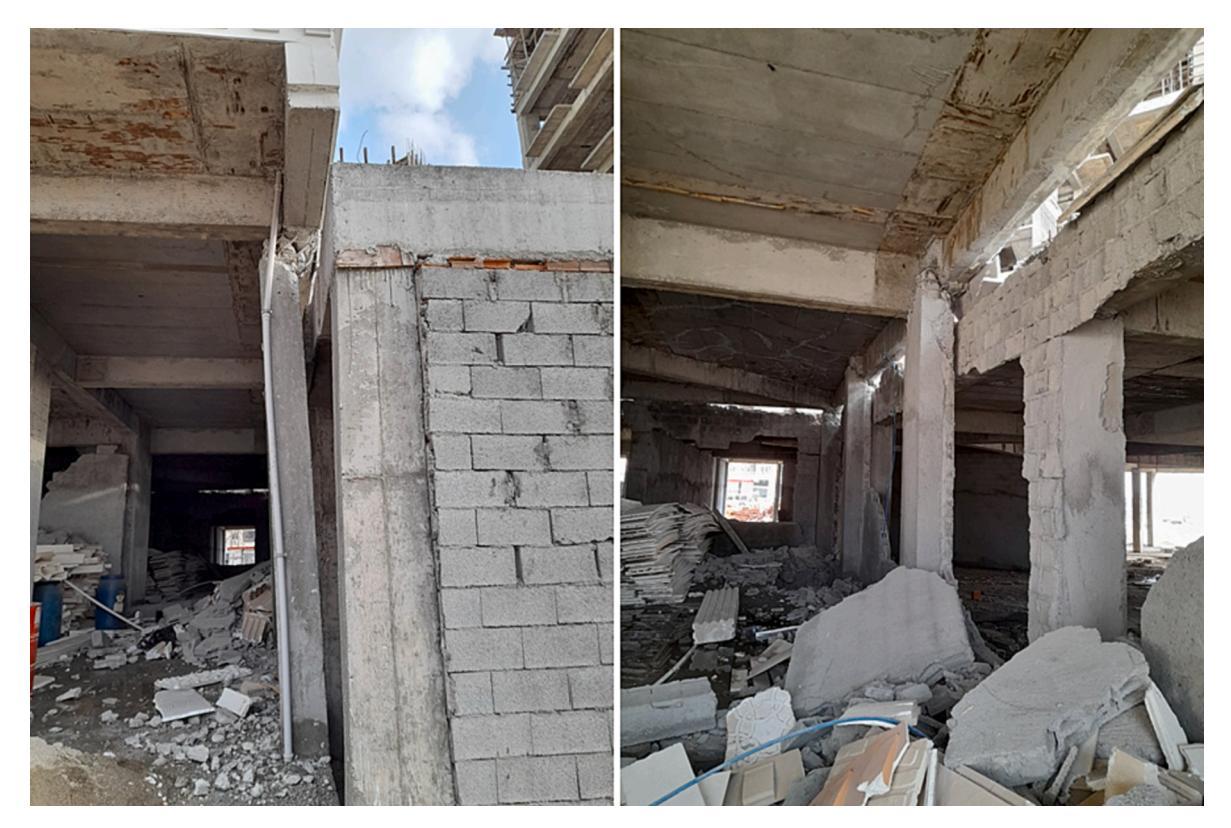
Fig. 22. Adjacent buildings with different floor level.

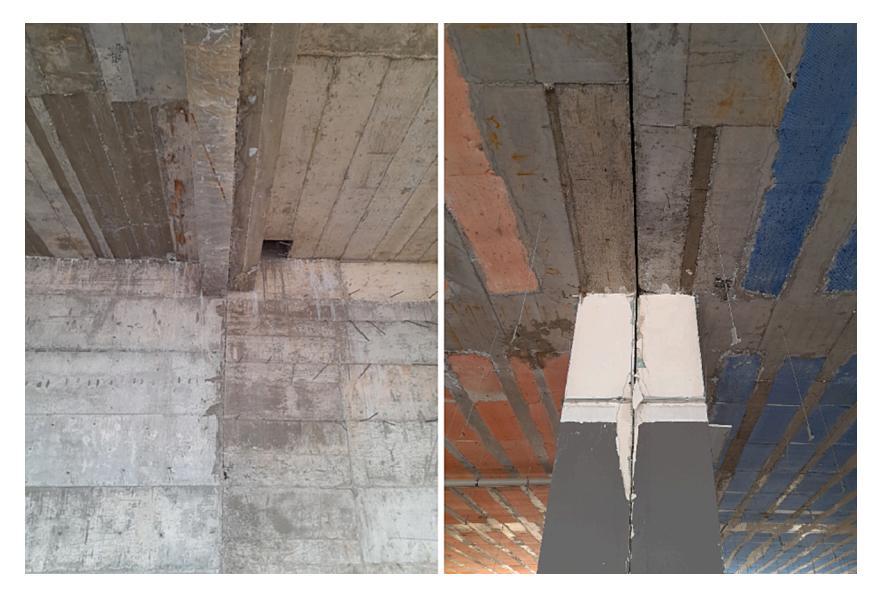
Fig. 23. Expansion joints with insufficient gap distance.

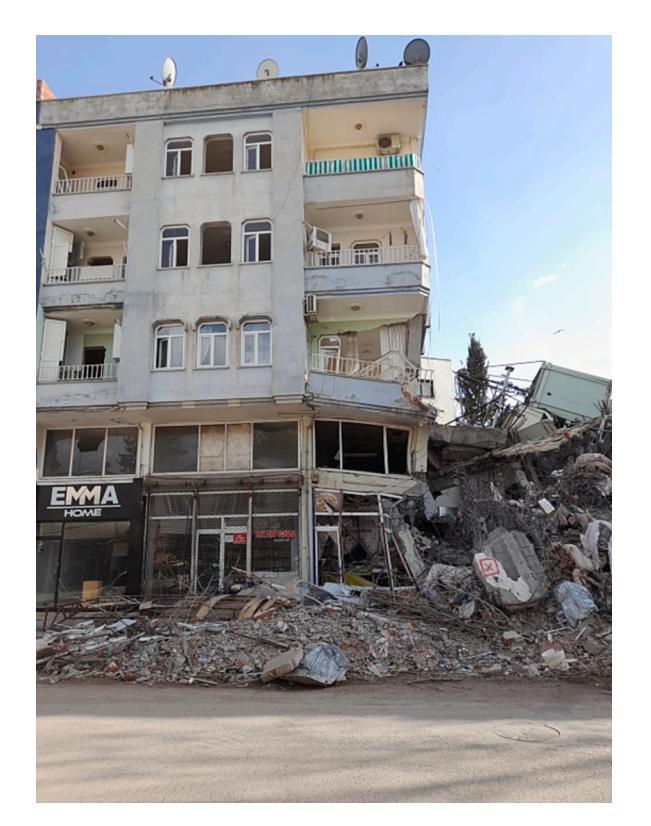
Fig 24. A damaged building because of impact effect of collapsed building.

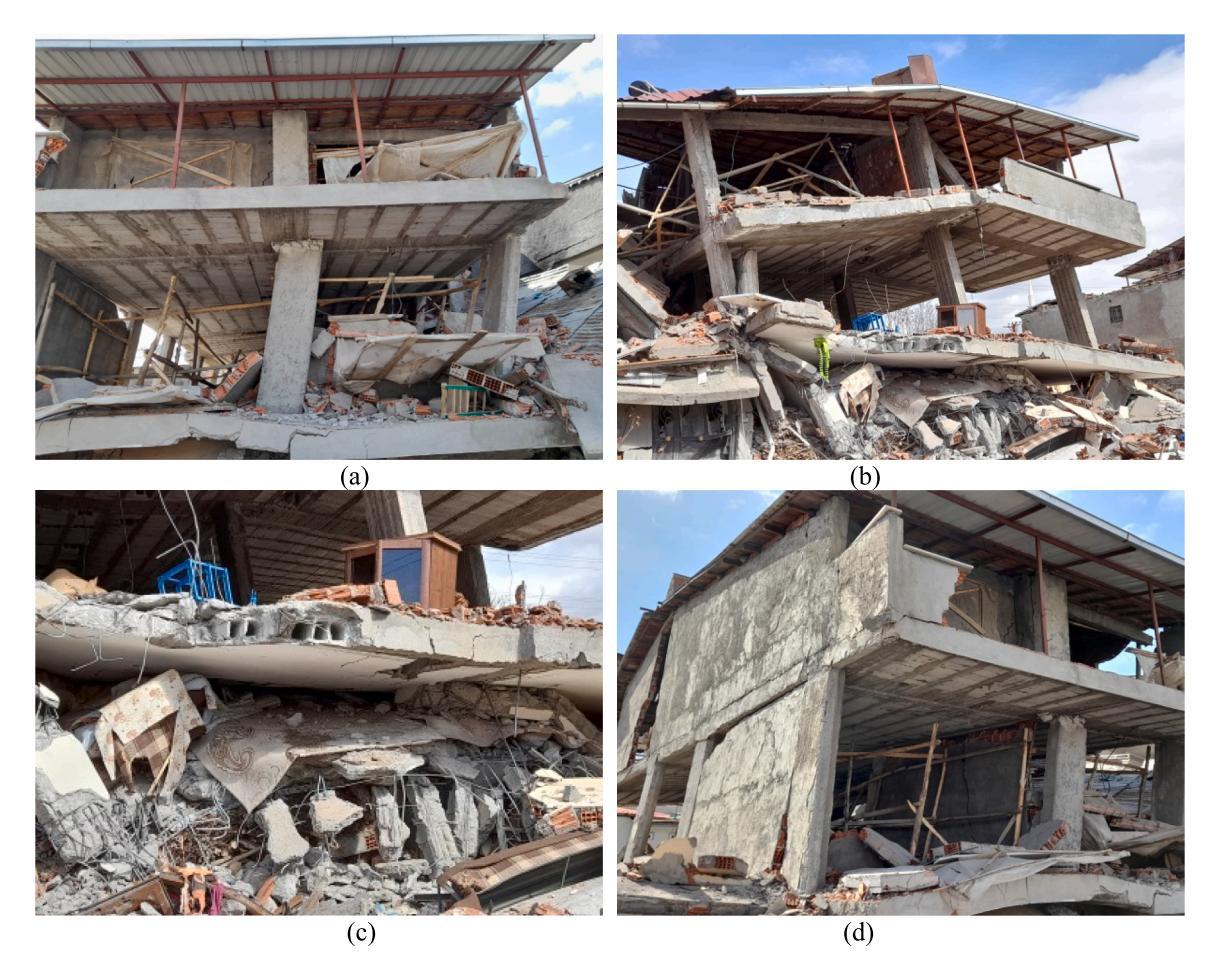
One way joist slab system is widely used in Türkiye, thanks to its advantages such as obtaining a plain ceiling surface, effective use of floor height, fast construction time and low formwork cost (Fig. 25). In this floor system, the floors consist of a thin slab layer of 7–10 cm thick, with joist placed parallel to each other at a height of about 32–40 cm. In this floor system, beam heights are taken the same as joist. In order to provide sufficient rigidity in these low height beams (shallow beams), the beam widths are increased and even exceed the column width. Although this situation causes problems in the transmission of the loads of the beam reinforcement passing outside the column, this situation is not taken into account in the Türkiye Earthquake Codes regulations. In addition, due to the use of shallow beams, building lateral displacements increase and building stiffness decreases compared to buildings with conventional beams. Since beams with low rigidity cannot keep the column rotations at a sufficient level, severe damage may occur in the columns

Fig. 26. A damaged building with one way joist slab.

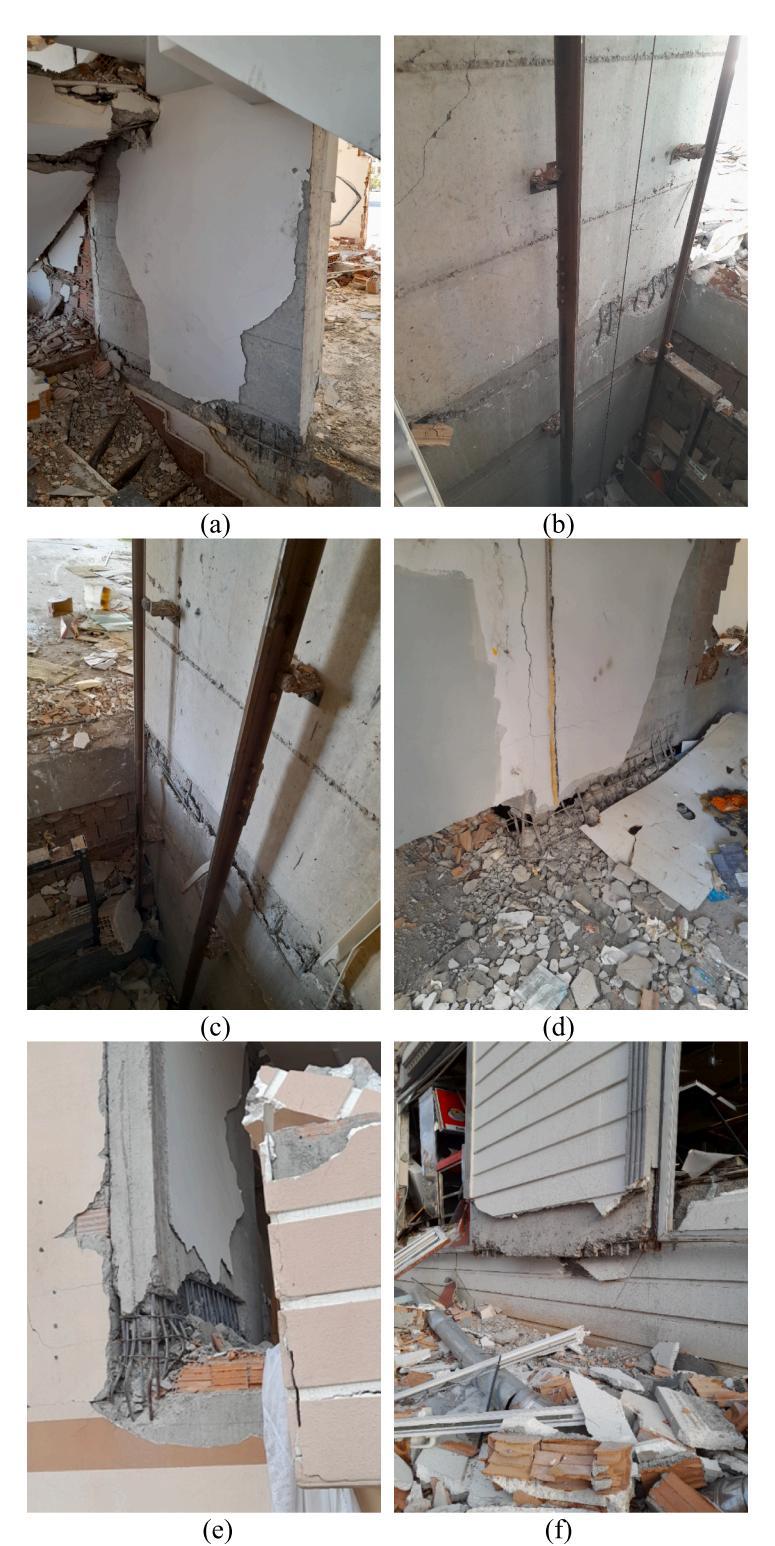
In field investigations shear wall damages commonly observed (Figs. 29-33). One of the main problem of damaged shear walls are low shear capacity due to insufficient transverse reinforcement and poor material quality.

Fig. 29. Damaged rectangular shape shear walls.

- Shear walls carry the majority of lateral loads during earthquakes and are essential for resisting displacements. In most cases, the performance of these elements determines the overall building performance. Therefore, greater attention should be paid to these elements in aspects such as workmanship, concrete quality, reinforcement details, and the design of wall end zones.

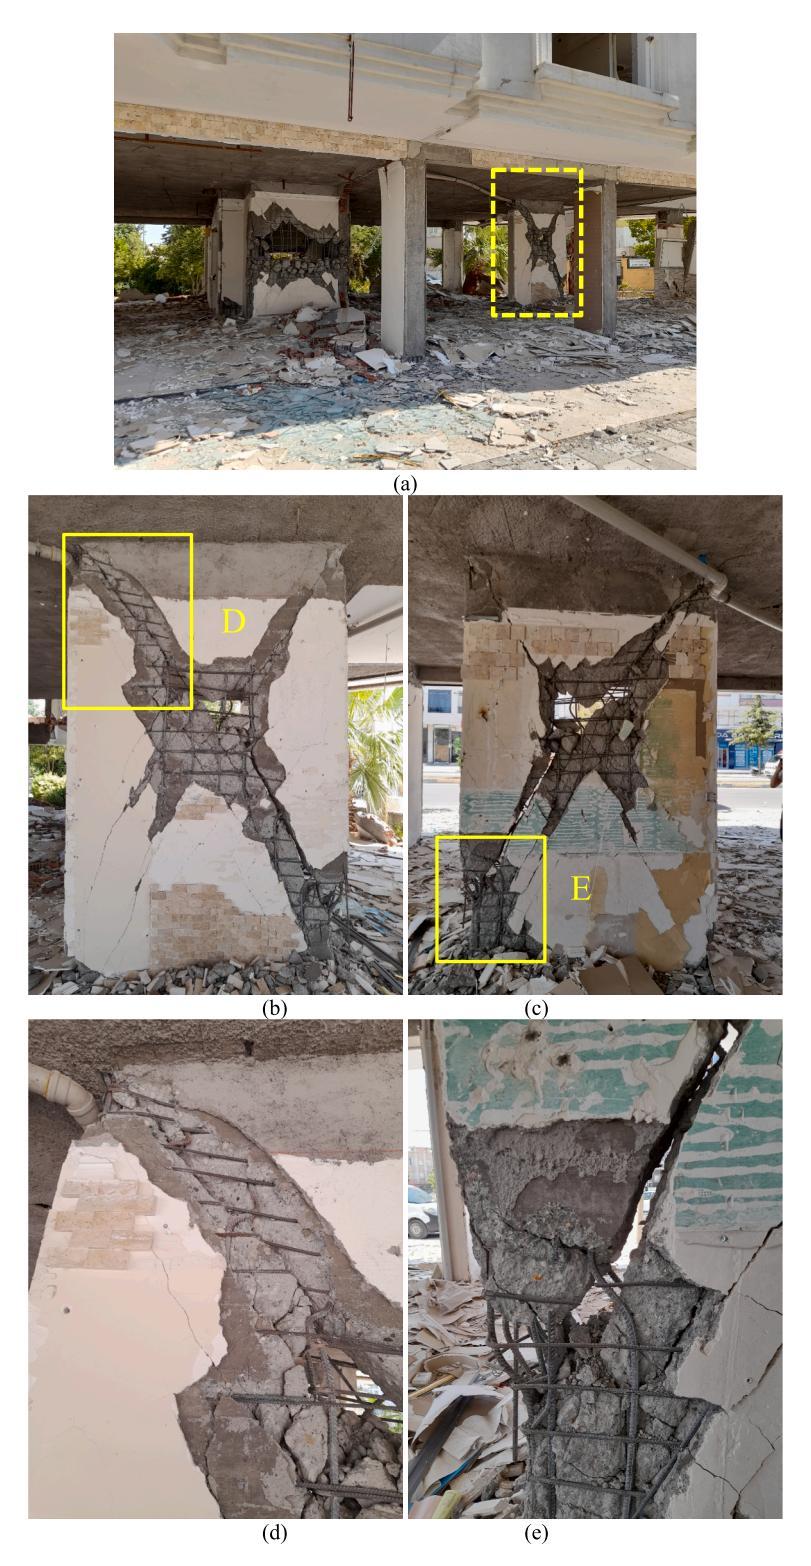
Fig. 30. A Damaged I shape shear wall due to insufficient shear capacity with dimension of 25x200 cm.

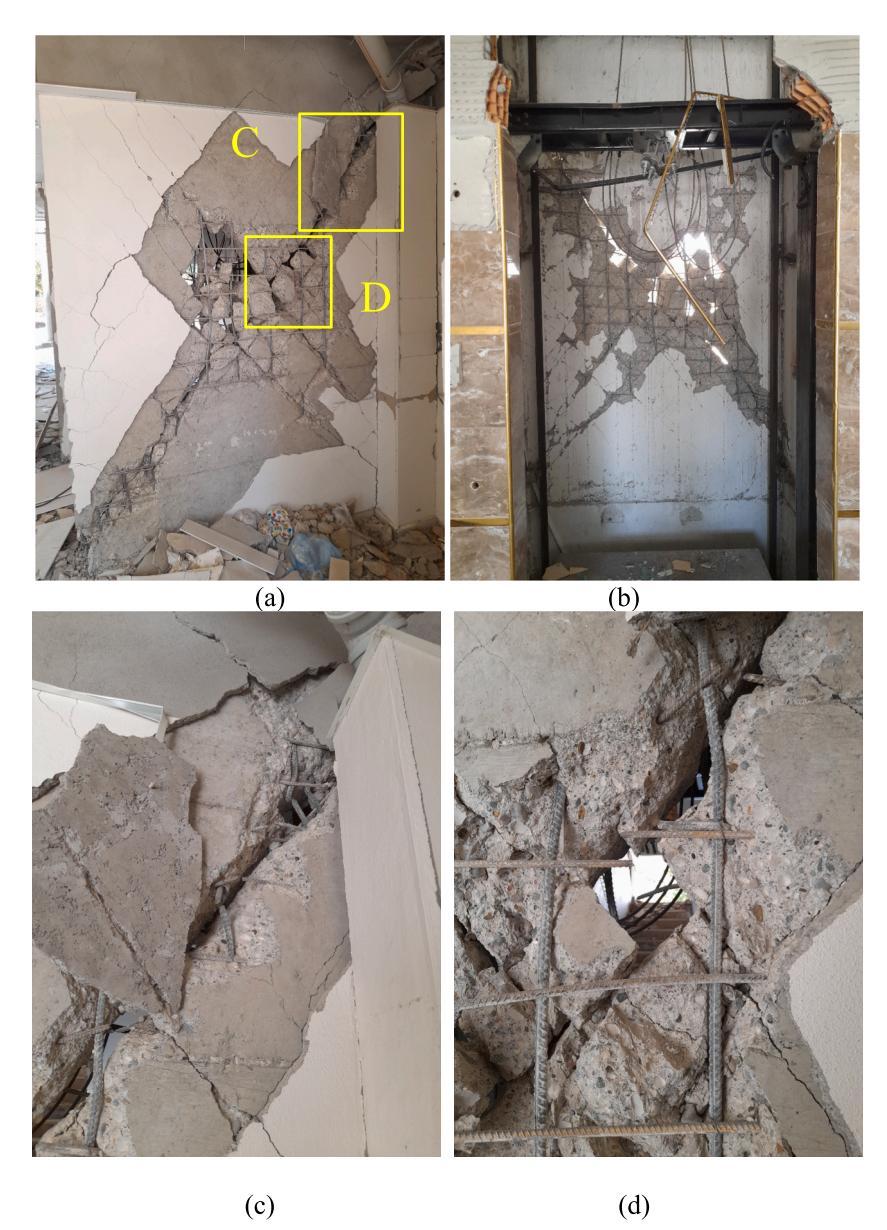
Fig. 31. A Damaged U shape shear wall due to insufficient shear capacity and rupture of reinforcement bars.

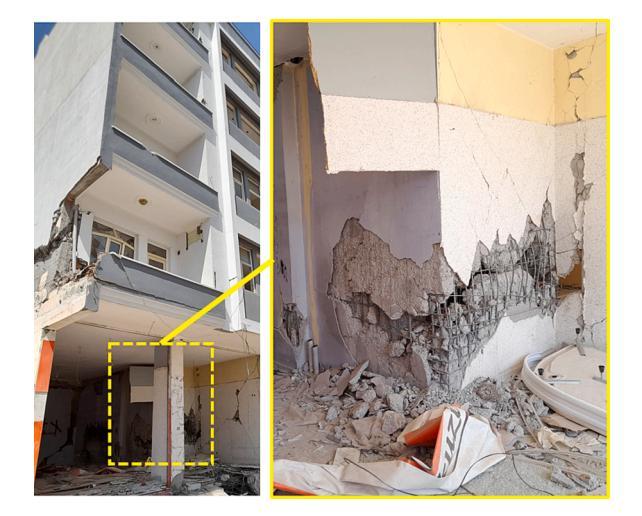
Fig. 32. A Damaged U shape shear wall.

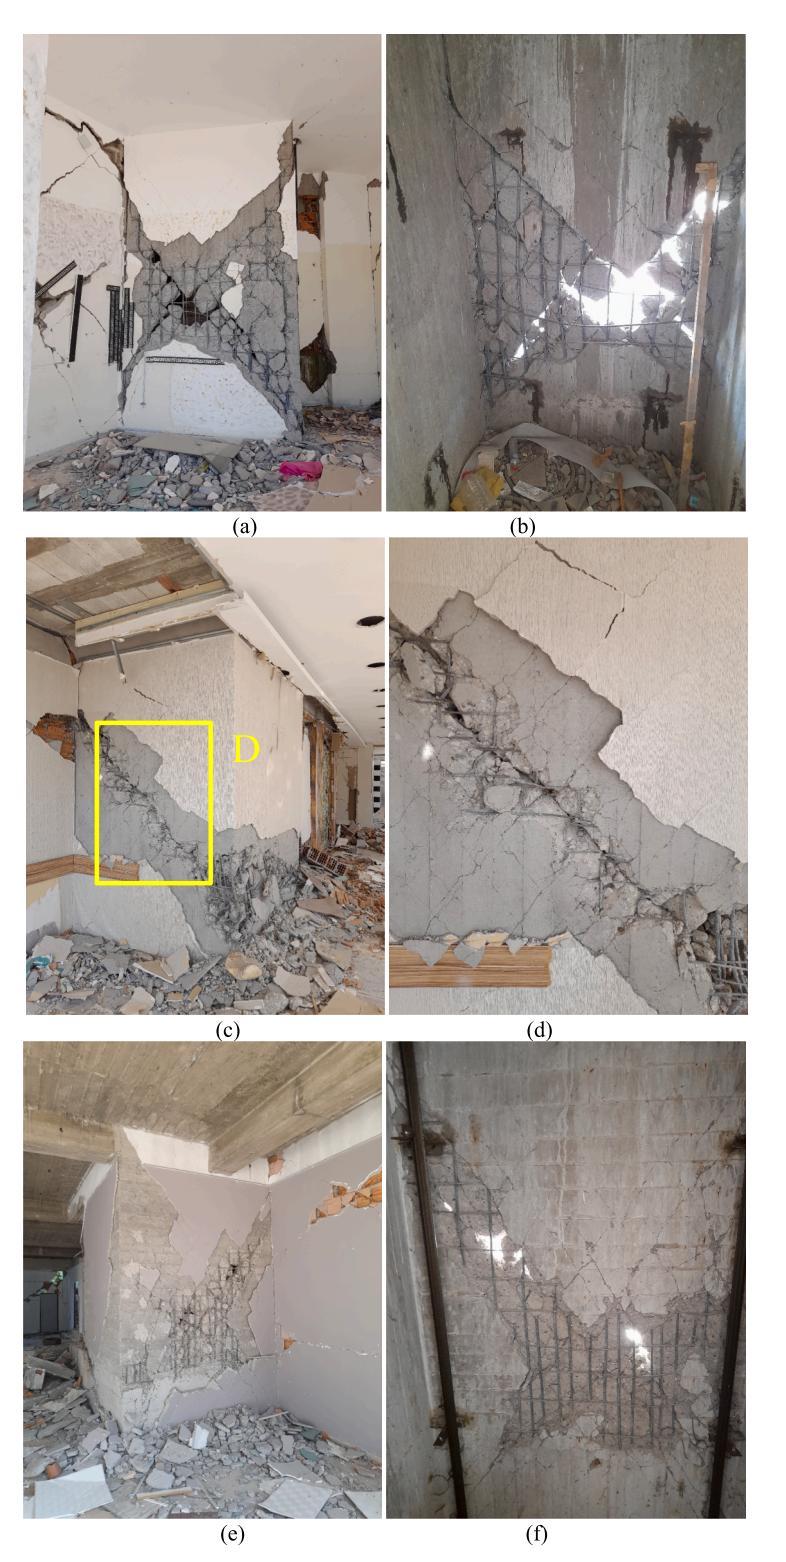
Fig. 33. Damaged U shape shear walls due to insufficient shear capacity.

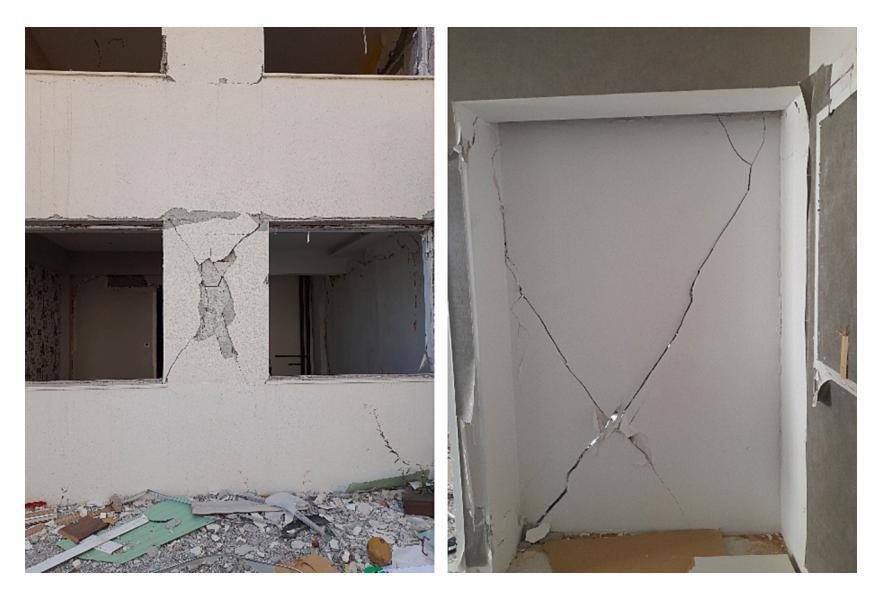
Although the stiffness of infill walls is lower than reinforced concrete elements, they carry horizontal force during an earthquake. When infill walls work together with a reinforced concrete frame, damage similar to a diagonal X shape occurs in the infill wall (Fig. 34). Due to the lack of adequate connection of the infill walls with the frame, out-of-plane collapse may occur in the infill walls due to the perpendicular effect of the earthquake to the wall plane. It has been observed that infill wall damage is concentrated in the lower floors where relative story drifts are high (Fig. 35).

Fig. 34. In-plane damaged infill walls.

- To prevent brittle infill wall damages, it is advisable to use flexible joints between infill walls and structural elements. This technique also helps avoid the short column effect, as well as the soft and weak story effects. However, precautions are required to prevent the infill wall from collapsing out of plane.

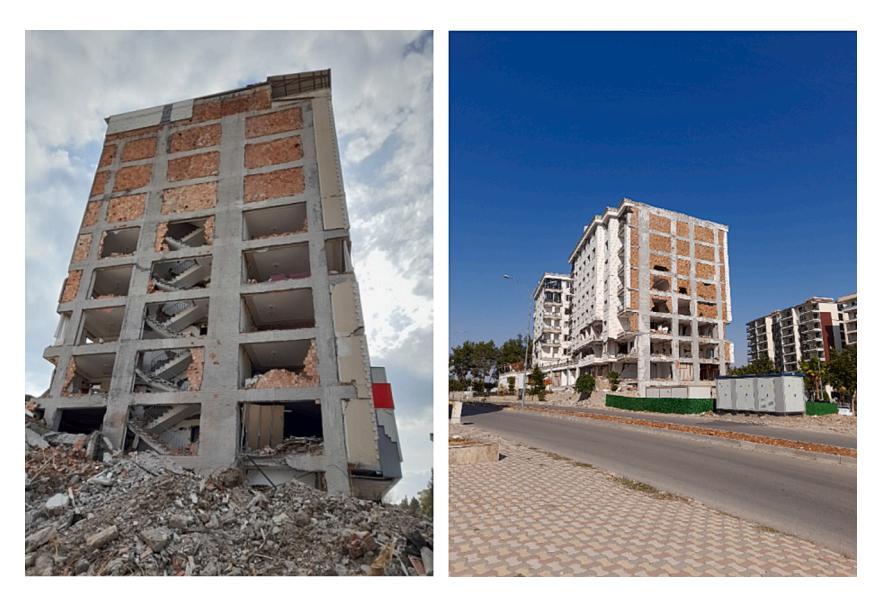
Fig. 35. Out-of-plane damaged infill walls.

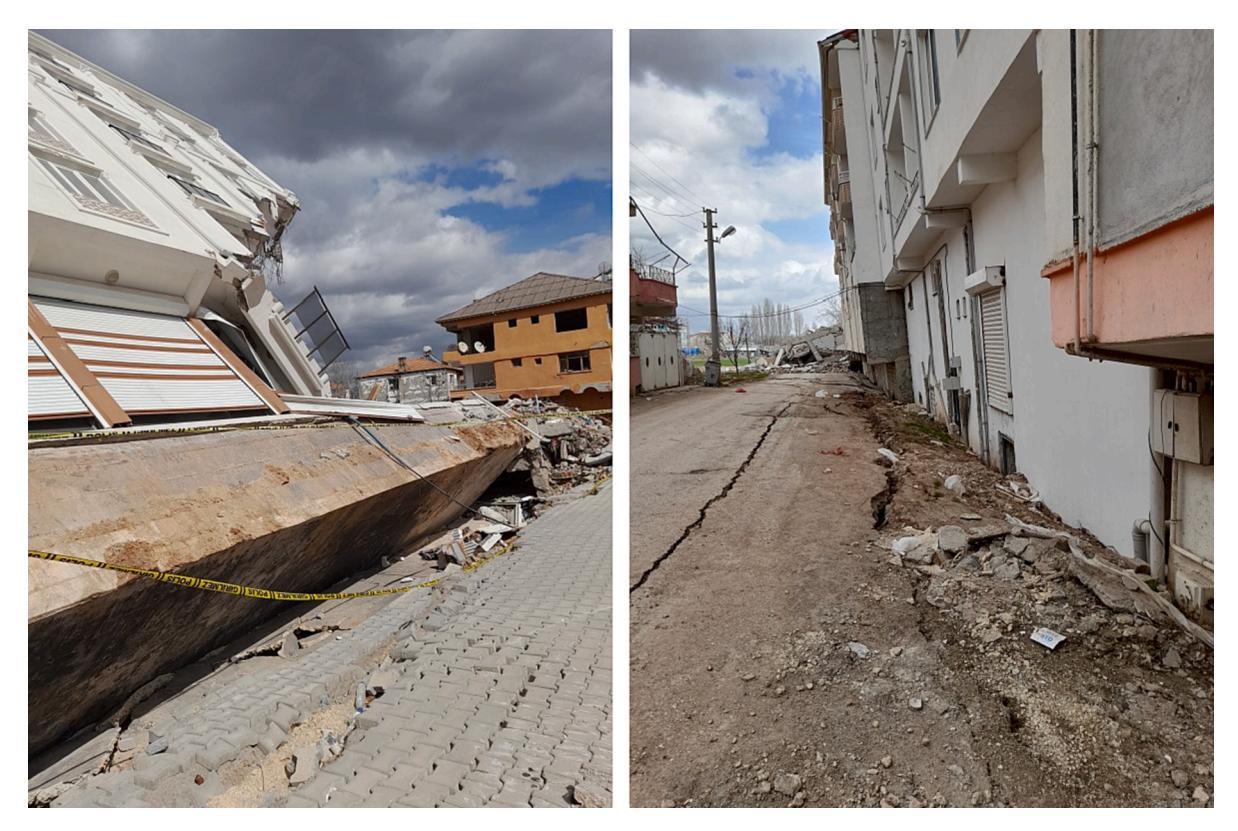
The soil examination must be carried out before a building design phase. However, soil examination is sometimes neglected or disregarded. TBEC-2018 defines 6 soil class as ZA, ZB, ZC, ZD, ZE and ZF (ZA is the best soil class and ZF is the worst soil class). In ZF soil class, site-specific soil behavior analysis should be performed. Also precaution should be taken in weak soils that have a significant risk in terms of soil liquefaction. In these weak soils, deep foundations (such as pile foundations) or soil improvements (such as jet grouting) should be used for earthquake resistant building design. In field observations it is seen that many buildings damaged because of soil liquefaction that is soil layers below the groundwater level temporarily lose their strength because of the earthquakes (Fig. 36).

Fig. 36. Damaged buildings because of soil liquefaction.

- In the design of a structure, it is crucial to understand the properties of the soil. Particularly in weak soils that pose a significant risk of soil liquefaction, precautionary measures should be taken. In weak soils, deep foundations or soil improvements should be used for earthquake resistant building design.
