# **Engineering Failure Analysis**

## Structural damage assessment of reinforced concrete buildings in Adıyaman after Kahramanmaraş (Türkiye) Earthquakes on 6 February 2023

## Ozan İnce

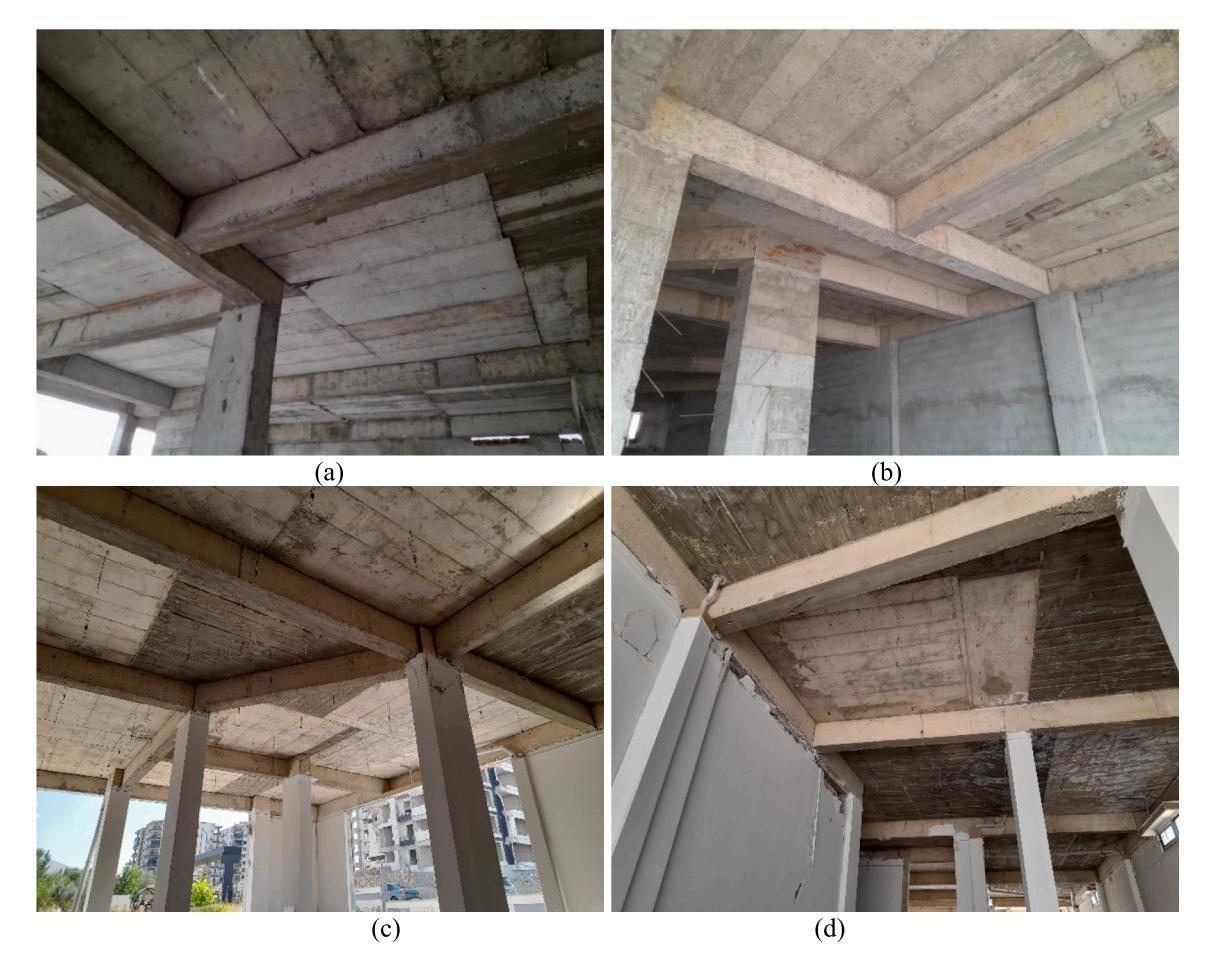
In TBEC-2018, there is not an obligation about discontinuity of frames. During an earthquakes, it is assumed that structural load bearing elements work together. To cooperate vertical structural element effectively (columns and shear walls), these element should be connected with beams to each other. However, in field observations buildings with discontinuous frames are commonly observed (Figs. 38-39).

Fig. 38. Under construction multi-story RC buildings with discontinuous frames.

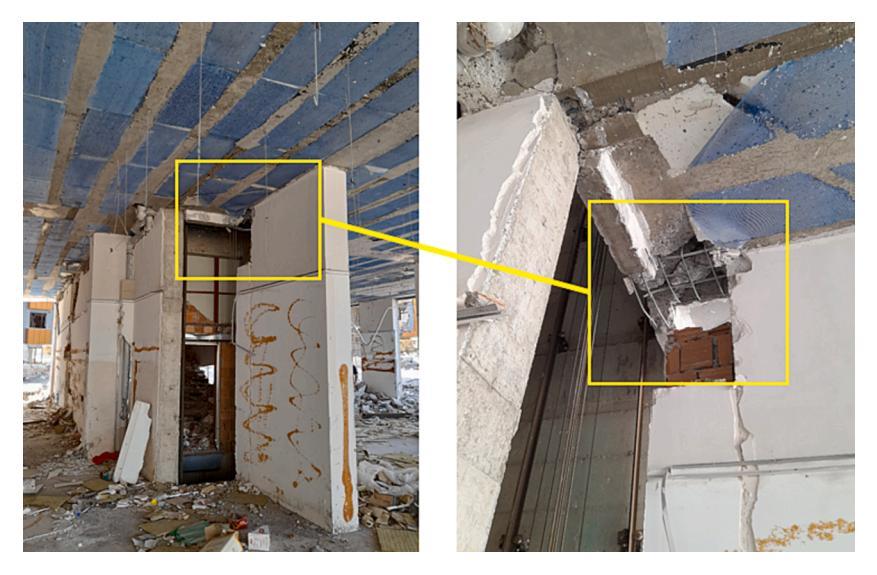
Fig. 39. A Damaged beam due to discontinuous frames.

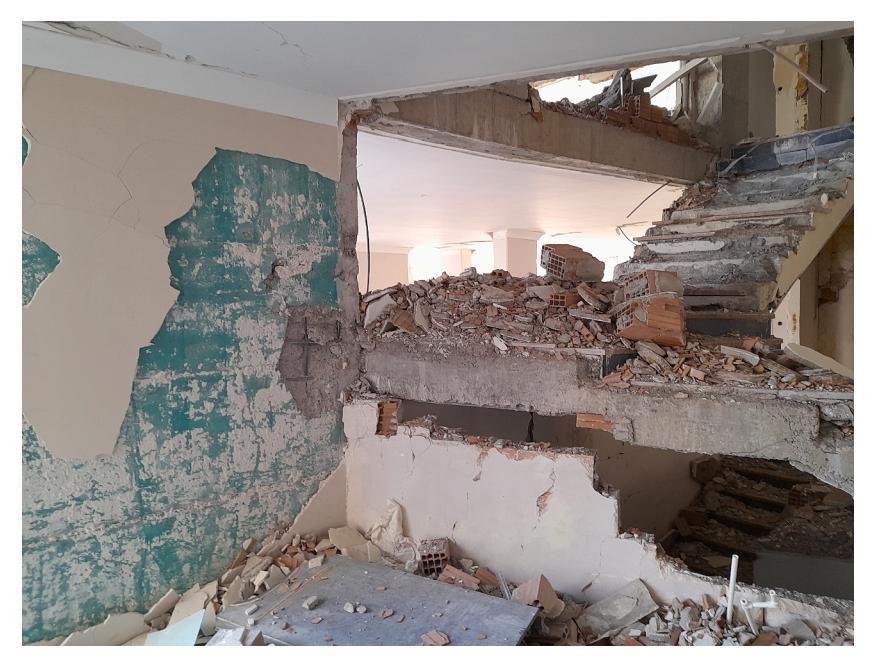
Reinforced concrete stairs are widely used in buildings from one floor to another. Stair landings should be supported by vertical bearing element to transfer their loads properly. Insufficient support condition could cause damages to stair or vertical element. In Fig. 40, it can be seen that a damaged shear wall because of stair. Also stair reinforcement details should be designed as in Fig. 41 to effective working of reinforcement. Incorrect reinforced details cause separation between concrete and reinforcement. In field investigations, stair damages widely observed by incorrect reinforcement detail (Figs. 42-43).

Fig. 40. A damaged shear wall due to stair.

- More attention should be paid to stair support conditions and stair reinforcement details. Stairs should be supported by vertical bearing element to transfer their loads. Stair reinforcement details should be designed to effective working of reinforcement.

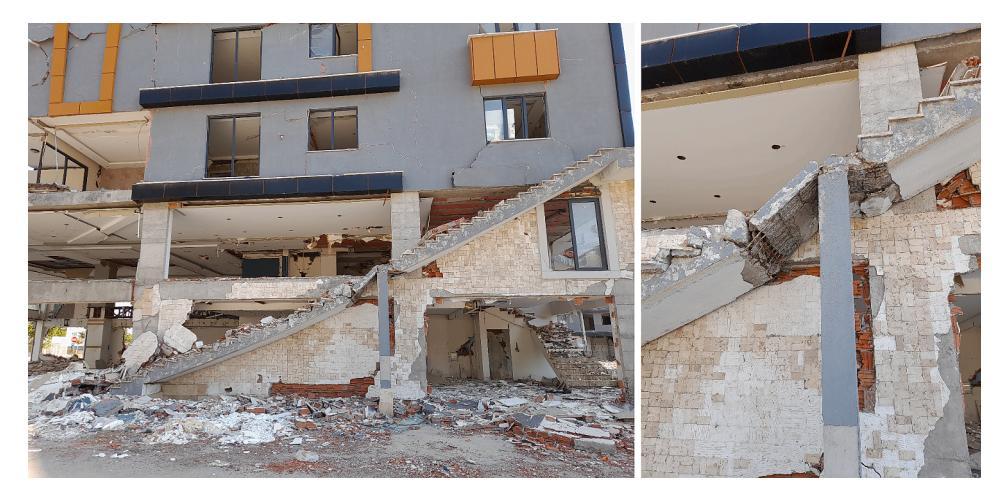
Fig. 42. A damaged reinforced concrete stair.

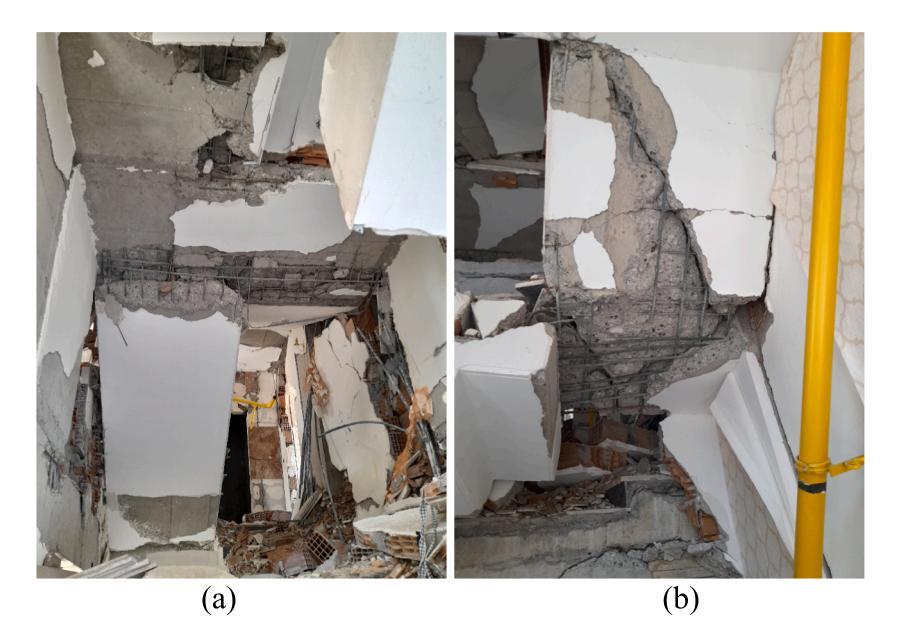
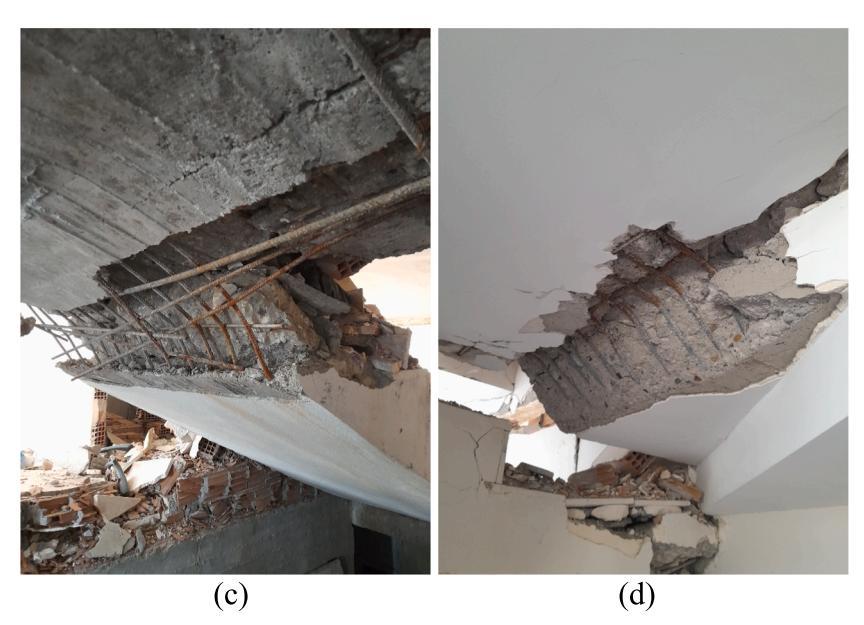
Fig. 43. Damaged stairs because of incorrect reinforcement details.
