TRANSFORMER FAILURE DUE TO CIRCUIT BREAKER INDUCED SWITCHING TRANSIENTS APPLICABLE TO THE CEMENT INDUSTRY

ABSTRACT

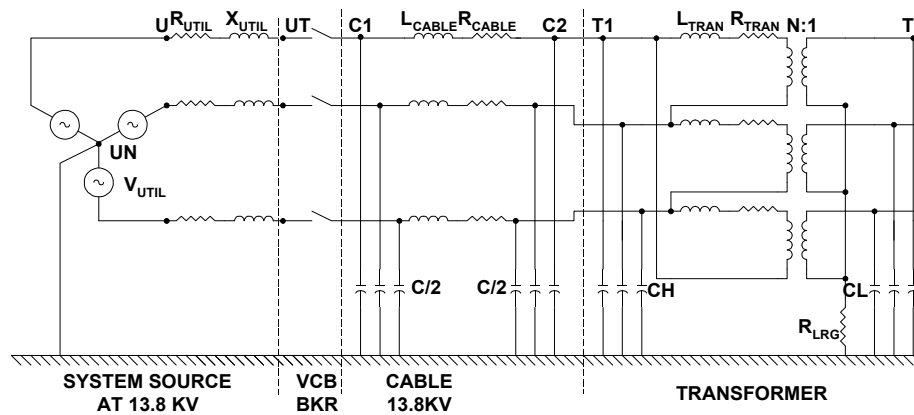
Figure 5. Important Circuit Elements for EMTP Modelling

When a statistical approach is taken for switching transients, complex modeling requires a frequency dependent transformer model and an arc model of the circuit breaker. For purposes of screening applications for potentially damaging switching transients, a simpler approach is suggested with the important circuit elements modeled in EMTP consisting of the source, breaker, cable and transformer as shown in Figure 5. The cable is represented by a Pi model consisting of the series impedance and half of the cable charging at each end. In some cases, multiple Pi models are used to represent the cable. The vacuum or SF6 breaker is represented by a switch with different models for opening (current chop), re-strike (excessive magnitude of TRV), re-ignition (excessive frequency of TRV) and closing (pre-strike). The three phase transformer model consists of the leakage impedance, magnetizing branch, winding capacitances from high-to-ground and low-to-ground. For oil filled transformers, the oil acts like a dielectric so the high-to-low capacitance is modeled. In cases requiring more detail, the transformer saturation and hysteresis effects are modeled.

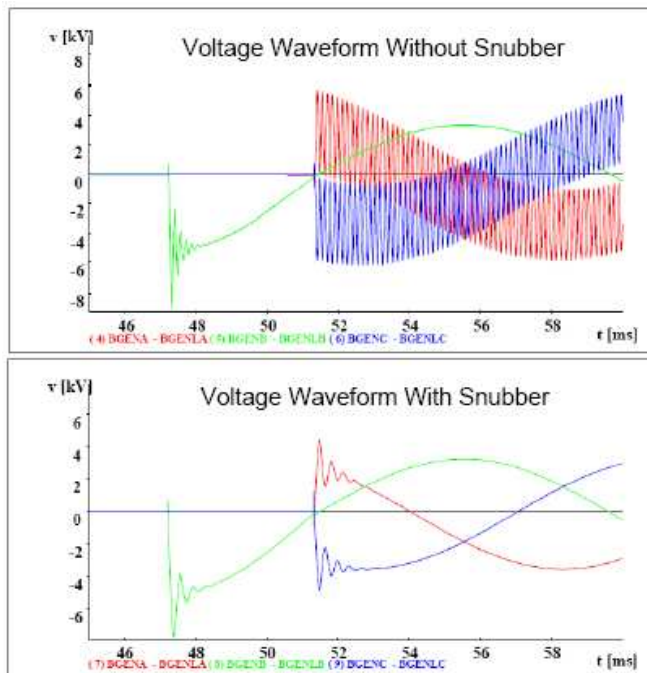
Figure 8. TRV Leading to Reignition During Energization of Drive Transformer With and Without Snubber

snubber installed. Re-ignition occurs because the TRV peak, time to crest and rate-of-rise of recovery voltage exceed IEEE ANSI C37.06 limits. The snubber reduces the TRV below the IEEE/ANSI limits for general purpose vacuum breakers [3] and for generator breakers [4]. Table 3 summarizes the re-ignition cases and the current chop cases. In all cases, the snubber is effective in reducing the transient voltage.

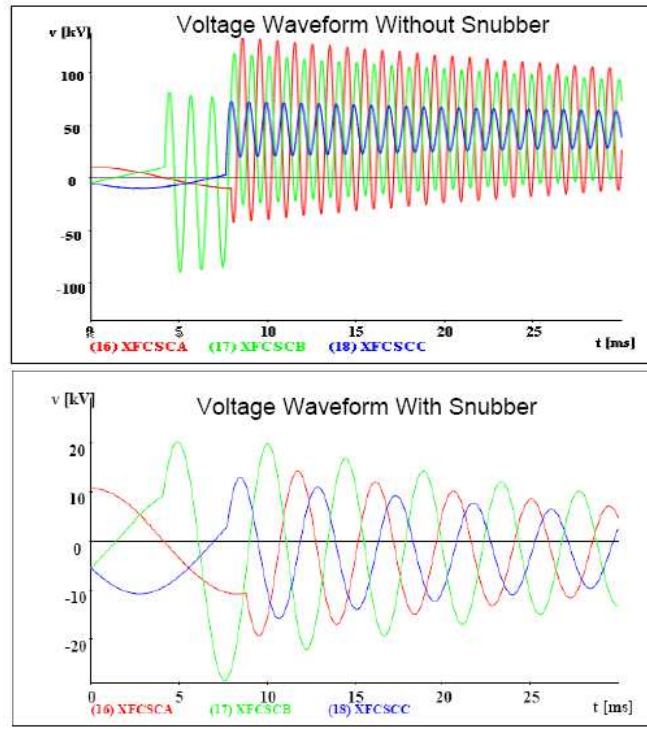
Figure 10. TOV initiated by Current Chop During De-Energization of Cast Coil Transformer With and Without Snubber

A snubber is required to reduce the peak below 95 kV BIL. The results of adding a snubber are shown in Figure 10. Note the significant reduction in the DC offset. The resistor in the snubber provides the reduction in DC offset as well as damping. The peak is reduced to 28.6 kV and oscillation of 215 Hz, both within acceptable limits. Finally, field measurements were taken after snubber installation to ensure they performed as designed. The field test setup for the snubber performance measurements is discussed in Section IV. The field measurements showed the snubber limited the TOV within acceptable limits.

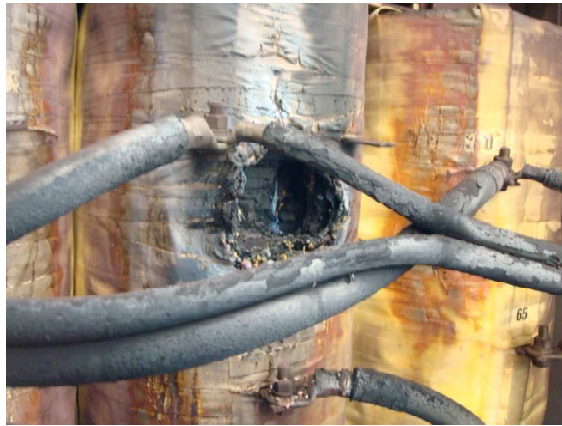
Figure 11. 4.16 kV Reduced Voltage Auto Transformer Starter Failure Due to Breaker Switching Transients

Normally we do not think of vacuum contactors (vs. breakers) as being a device that is subject to switching transient issues. However, in a few cases, they can be. The majority of the previous failures described in this paper had to do with magnitude or dv/dt . With cast coil or layer wound transformers, it is possible to excite an internal voltage resonance internal to the winding – typically between 3 kHz and 12 kHz. Such was the case for the following example involving vacuum contactor switching of a 4160V reduced voltage auto transformer (RVAT). This 4160V/5000HP motor was equipped with surge capacitors on the motor terminals and the RVAT failed layer-to-layer during a starting sequence in the middle of the winding (highest internal resonant voltage point) as shown in Figure 11. Since it is extremely difficult to model all the internal inductance and capacitances of these transformers, a sweep frequency resonance analysis (SFRA) measurement approach is a good alternative.

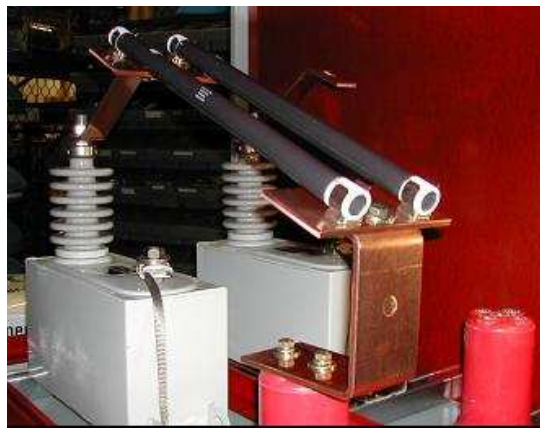
Figure 17. 15 kV Snubber Mounted Above the Transformer

Figure 17, shows one phase of a custom snubber circuit. The custom design was required because there was not enough room in the transformer for the snubber components. The enclosure had to be mounted above the transformer. The cable connections from the transformer were field installed and land on the copper bus. 15 kV non-shielded jumper cable was used to make the connection. Each phase passed through an insulation bushing to the transformer below. Bus work was required to provide a solid support for the fragile resistors. Normally only one resistor would be provided, but for this application, to achieve the delivery schedule, parallel resistors were designed to obtain the correct ohmic value (the correct single resistor value had long delivery).

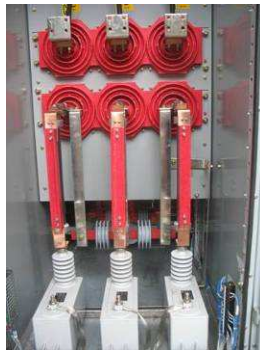
Figure 21. Snubber for Metal Enclosed 13.8 kV Vacuum Breaker

- 3) 13.8 kV Low Resistance Grounded System. Snubbers were provided for new metal enclosed vacuum switchgear and a new transformer rated 7500 KVA with primary voltage of 13.8 kV as shown in Figure 21. Single-phase surge capacitors rated 13.8 kV were used because it is not possible to buy three-phase surge capacitors rated for 13.8kV line-to-ground. Single resistors of the right ohmic value were available. Adequate clearance did not require the use of glastic.

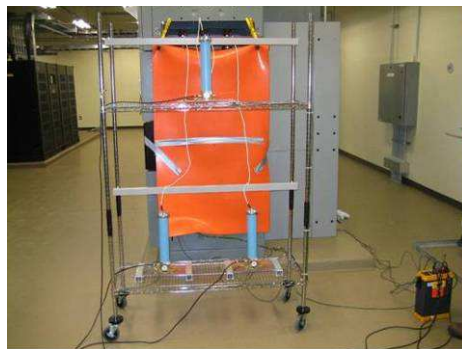
Figure 22. Snubber Performance Measurement Setup for 15 kV Transformer Using High Bandwidth Voltage Dividers

The test measurement setup generally consists of voltage dividers and a transient recording device. The voltage dividers should be made of capacitive and resistive components with a bandwidth of 10 MHz. The scope or power quality meter should be capable of transient voltage waveshape sampling, 8000 Vpeak full scale, 200 nsec sample resolution (5 MHz sampling).

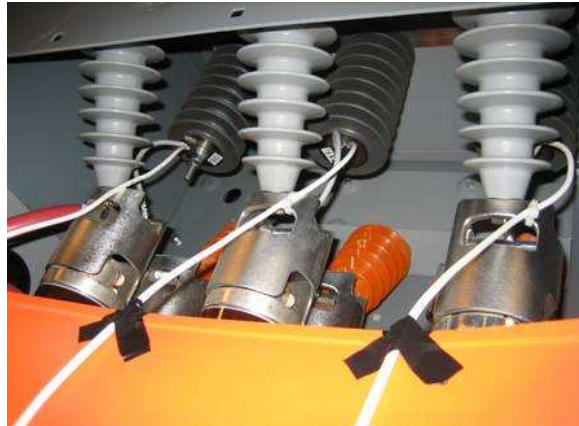
Figure 23. Voltage Divider Connections at 18 kV Surge Arrester on Transformer Primary Bushing

An outage and lockout/tagout are needed to install the voltage dividers, make connections to each of the three phases at transformer primary bushing and make secondary connections to the transient recorder. Figure 22 shows the test measurement setup for a typical cast-coil transformer. Voltage divider connections to the transformer primary were made as shown in Figure 23. Additionally, for tests requiring load at a transformer, a portable load bank may be connected to the transformer secondary. A resistive load bank configurable to different load levels (300 kW or 100 kW) prevents destructive testing.
