Destructive testing and computer modeling of a scale prestressed concrete I-girder bridge

ABSTRACT

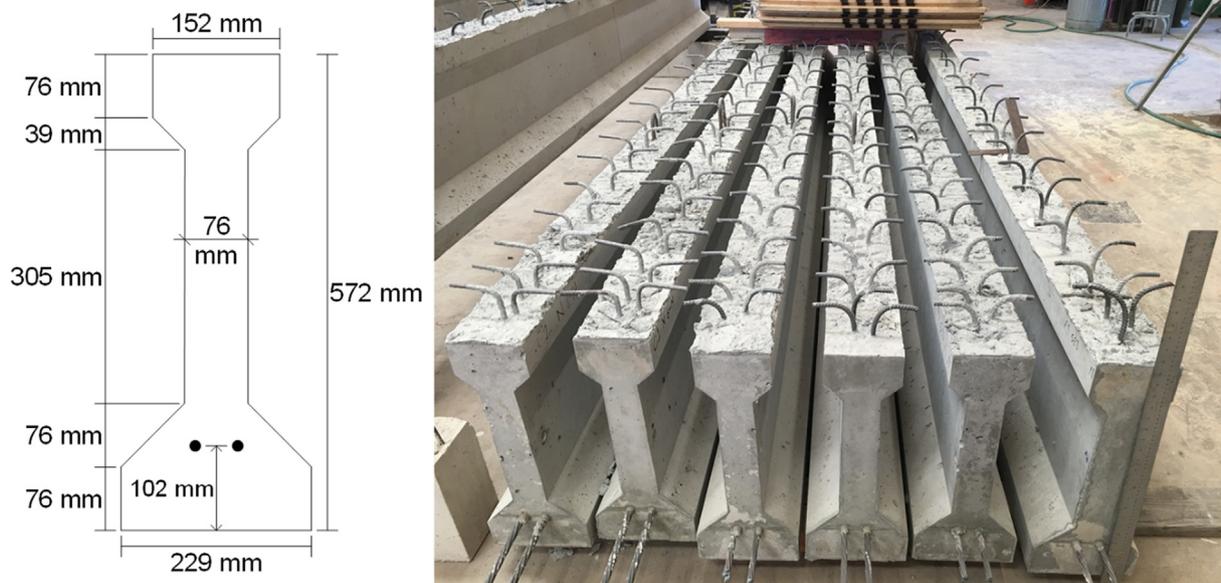
Fig. 1. Scale girder dimensions (left) and completed sections (right).

The main prestressed reinforcement in the scale girders was designed to be roughly similar to the full-scale girders from the decommissioned bridge by ensuring an in-service compressive stress from the prestress to be within 1% of that in the decommissioned girder. The decommissioned bridge and scale bridge both had the same girder cross sections across the bridge width. The shear steel was designed by using an equivalent percent contribution of the concrete and steel to the overall shear capacity. The scale I-girders were 572 mm in depth and contained two straight grade 1860–13.2 mm prestressing strands tensioned to a jacking stress of 1282 MPa. The strands were located at a distance of 102 mm from the bottom of the girder (Fig. 1). Shear reinforcement consisted of grade 420 - No. 10 Z-bars. These Z-bars also provided interface reinforcement, ensuring composite action with the bridge deck, as in the decommissioned sections. The prestressed girders were 5.49 m long and were placed at a spacing of 1.17 m (based on half the spacing provided in the full-scale bridge). The girder concrete achieved an average compressive strength at release of 30 MPa, and an average final (28-day) compressive strength of 44 MPa. These strengths are roughly similar to the strengths from the decommissioned girders, no efforts were made to scale material properties.

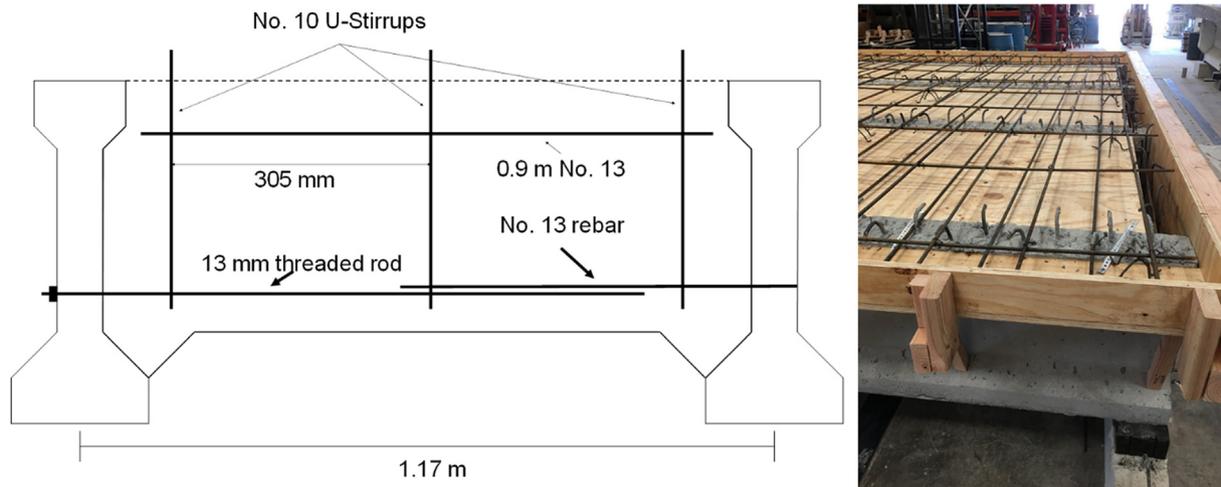
Fig. 2. Diaphragm steel (left) and deck steel (right).

Engineering Laboratory at the University of Oklahoma. Elastomeric bearing pads were used for all supports, consistent with bridge construction in Oklahoma. The bearing pads were placed flush with the ends of the girders creating a 5.33 m span measured center to center of the pads or a 5.18 m measured face to face of the pads (the pads were approximately 160 mm wide). The bridge girders were laid out, then formwork for the deck and diaphragms was built onto the girders, such that the prestressed girders supported the full dead weight of the deck and diaphragms. The deck was 10.8 cm thick and 4.0 m wide, creating a 0.3 m overhang on each side. Diaphragms were 10.2 cm wide, began at the slab soffit and terminated 15.2 cm from the bottom of the girders. These dimensions are all half those shown on the original plans for the full scale bridge. Diaphragms were cast monolithically with the deck and a No. 13 rebar connected the interior girders with the diaphragm, while a 13 mm threaded rod embedded in the concrete attached to the exterior girders with a nut and washer. Reinforcement in the deck and diaphragms was based on the full-scale bridge, generally using about half the area of steel in the full scale bridge. Fig. 2 shows the steel used in the deck and diaphragms.

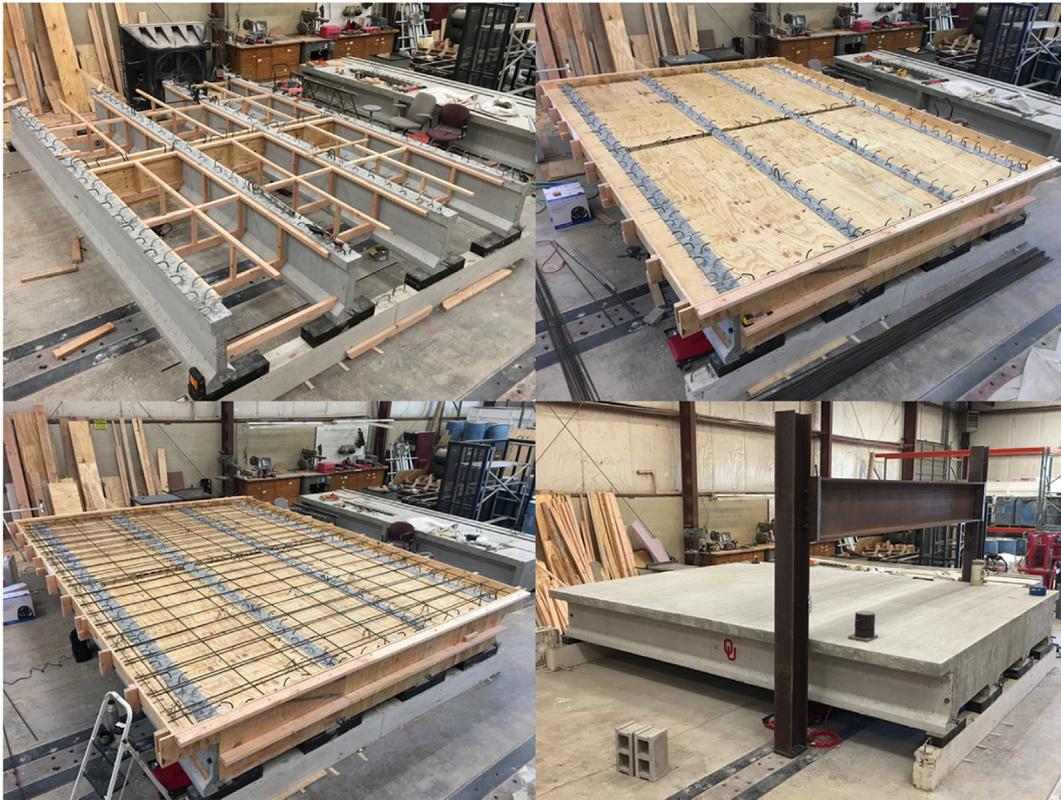
Fig. 3. Bridge construction progress. Top left shows girders laid out and beginning of formwork construction. Top right shows completed formwork including diaphragms. Bottom left shows deck steel. Bottom right shows completed bridge with load frame.

Photos from bridge construction are shown in Fig. 3. Two companion girders with a section of deck equal to the top flange width of girders were also built. This size of deck section was selected to match one of the decommissioned girders. The strength of one of these companion girders is compared to the theoretical strength of one of the scale bridge's girders later in the paper. It is worth noting here that the difference in flexural strength between the individual companion girder as cast and the strength of a girder with the tributary width of slab is only 7 percent. These girders were designed in the same fashion as the girders used in the scale bridge and one was tested with a load applied at the same location as the scale bridge, providing a comparison between the behaviors of an individual girder and the composite bridge. The deck concrete reached an average 28-day strength of 29 MPa.

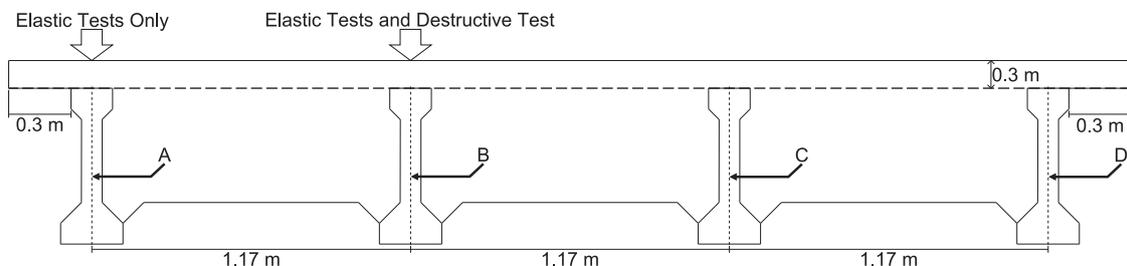
Fig. 4. Girder naming convention and location of loads.

The destructive test of the scale bridge was performed with the load over the interior girder B as shown in Fig. 4. Prior to any testing, cracking was observed at the interface between the end diaphragms and the girders. This cracking is likely due to shrinkage of the diaphragm concrete, as it was present during elastic testing, and is shown in Fig. 10. Cracking like this has been observed at bridge diaphragms in several other studies [1,13,30]. These cracks appeared to widen at early load increments, indicating some bending of the end of the bridge perhaps due to greater deflections at the support under the loaded

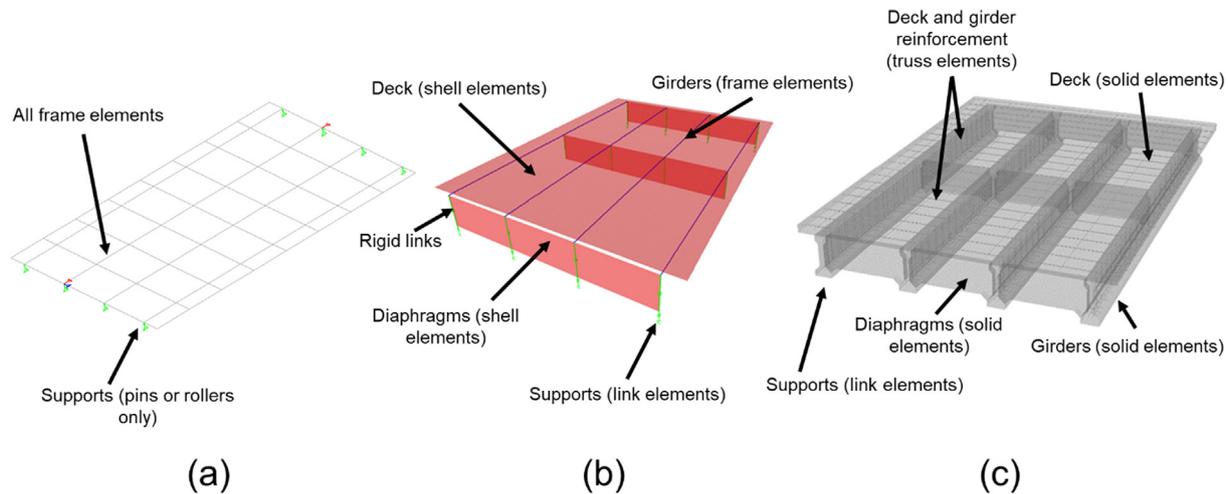
Fig. 5. Isometric view of computer models in study. (a) 2-D grillage, (b) 2-D model, (3) 3-D model.

Stiffness of the elastomeric bearing supports was derived based on deflections at the supports measured during testing and was included in the grillage model parameters. In order to compare the response of the scale bridge model with the test data, point loads of 89 kN and 178 kN were placed on girders A and B at the quarter-span point, respectively. These loads correspond to the maximum load on girder A during elastic testing (89 kN) and the linear portion of the destructive test when load was placed on girder B (178 kN). To determine shear DFs from the grillage model, reactions at each support were divided by the sum of the total reaction at that end of the bridge. This procedure has been used in similar research [21]. Shear DFs were determined from the scale bridge test in a similar way but by dividing the support deflection under each girder by the sum of the support deflections at that end of the bridge. This method seemed to provide reasonable estimates of load distribution since all supports had the same stiffness and supports are expected to behave linearly in this load range. The grillage layout is shown in Fig. 5(a).

The loading used in the test was modeled as a point load in the 2-D model, and as a displacement boundary condition in the 3-D model. The self-weight of all bridge components was included in both models. For simplicity, bearing pads used in the test were excluded and replaced by linear link elements, representing roller and pin supports at each end of the bridge. Prestressing was only included in the 3-D model. It was modeled by using the embedment technique [28], where strands are modeled as truss elements and embedded in concrete employing “embedded region” constraints. The jacking stress (1282 MPa) was applied as a predefined stress field, transferred at girder ends. The 2-D FEM is shown in Fig. 5(b), and the 3-D FEM is shown in Fig. 5(c).

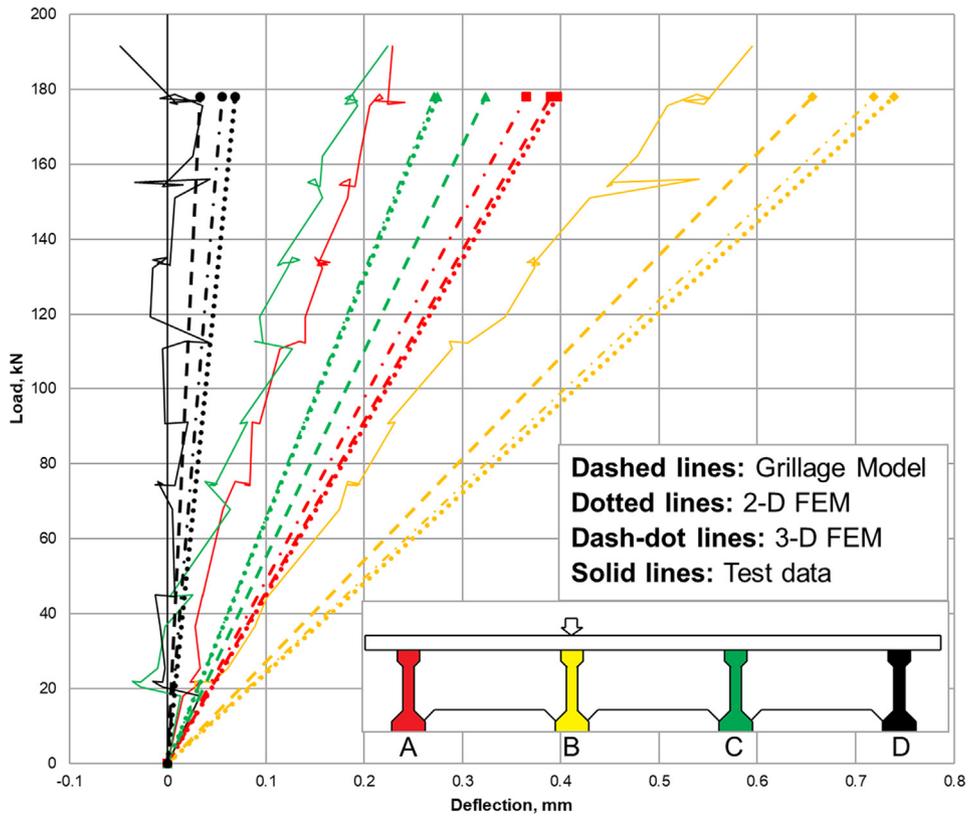
Fig. 6. Comparison of load versus deflection relationships for computer models and scale bridge loaded at girder B.

Fig. 6 shows the agreement between the model and the scale bridge response when load was applied at girder B (interior case). Fig. 7 shows the agreement between the models and the scale bridge response when load was applied at girder A (exterior case). Referring to Fig. 6 for the interior case, the agreement between deflections from the three computer models is good, however there are differences between the models and the bridge test. On average, when load was placed over girder B, the models differed from the test by 68 percent, or 0.120 mm. For the exterior case however (Fig. 7), the agreement between all models and the test is excellent. Deflections measured in the test differed on average from the models by only 19%, or 0.004 mm. If pinned connections were used at each support, as opposed to pin-roller connections, model results agreed better with test results where the interior girder was loaded but agreed poorly with test results where the exterior girder was loaded. Therefore, it is theorized that the discrepancy between model and test results was due to the support conditions being idealized as pin and rollers in modeling, whereas in testing elastomeric bearing pads provide intermediate restraint against rotation. Despite differences between deflections predicted by the models, DFs were considered more important to match for design or load rating purposes.

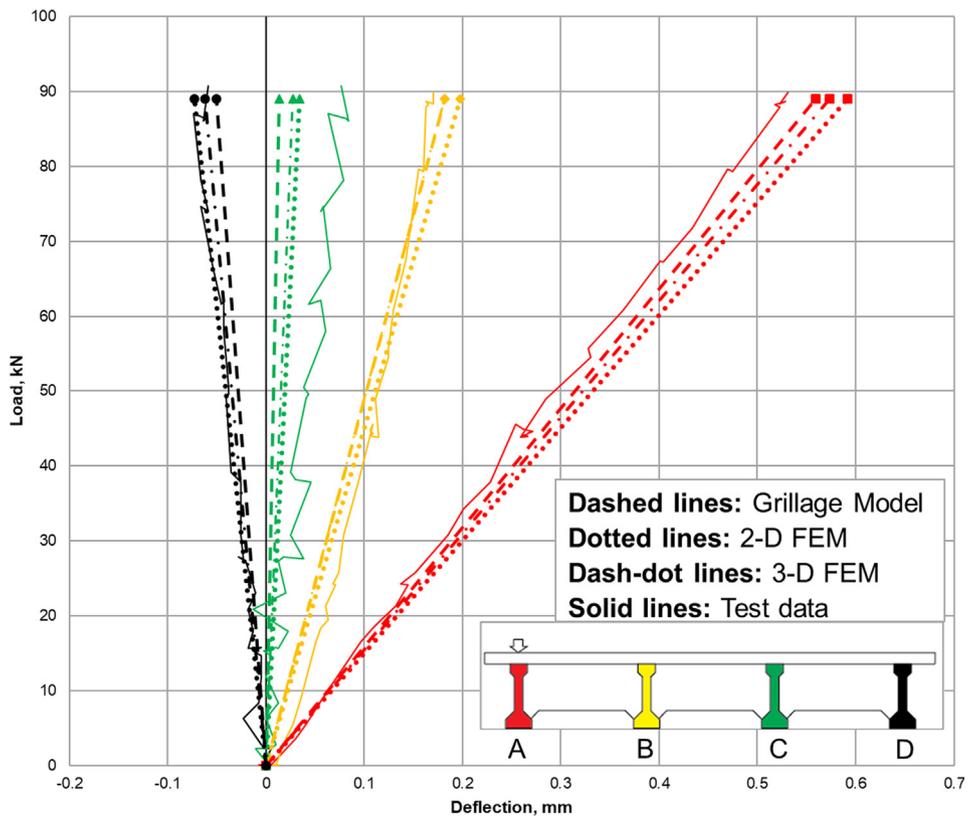
Fig. 7. Comparison of load versus deflection relationships for computer models and scale bridge loaded at girder A.

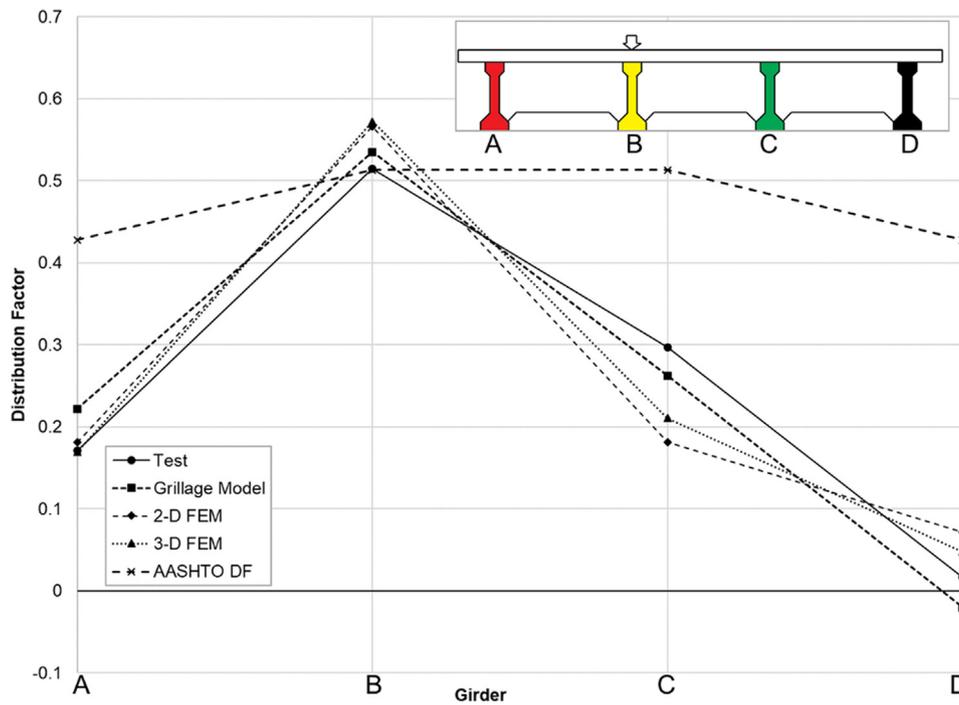
Fig. 8. Comparison of DFs from models and bridge test for interior girder (B) loaded.

Figs. 8 and 9 also show the AASHTO DFs from Section 4.6.2.2.1 of the 8th edition of the AASHTO LRFD Bridge Design Specifications [17]. These DFs were included for comparison to the results of the models, but their applicability is limited for the case of this scale bridge. The scale bridge does not meet the range of applicability for the AASHTO DF equations due to the thickness of the deck and the total length of the bridge. Another issue with comparing the AASHTO DFs directly to the DFs found in this paper is that the AASHTO DFs are based on a truck loading, while the DFs in this paper are based on point loads placed directly over the girders. This difference is particularly noticeable for girder A. In Fig. 8 girder A takes less of the total shear than predicted by AASHTO because the load is based on a point load directly acting on

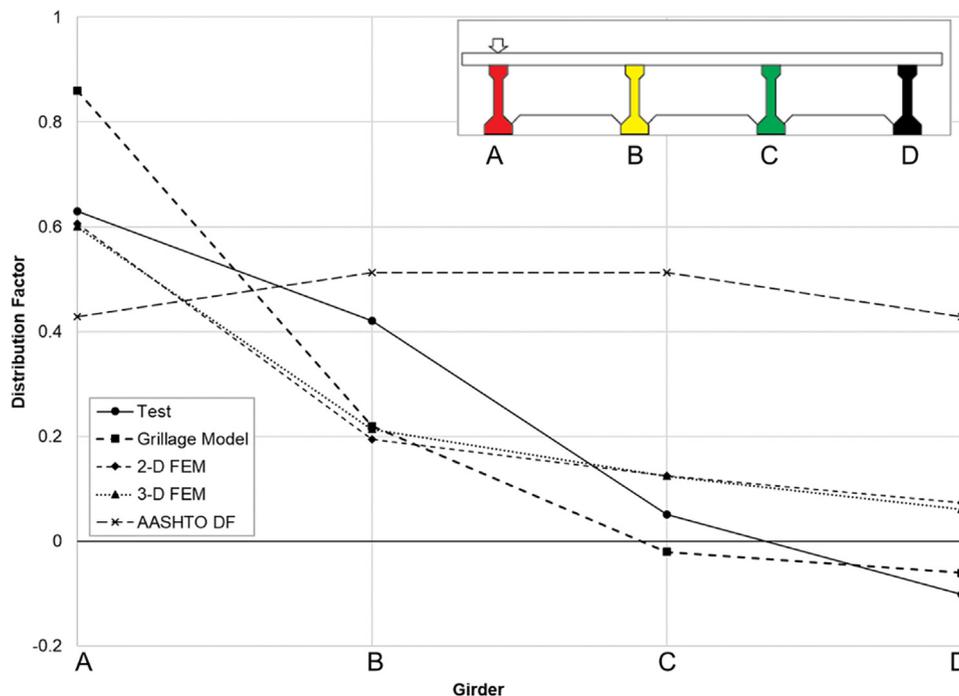
Fig. 9. Comparison of DFs from models and bridge test for exterior girder (A) loaded.

girder B as opposed to the wheels of a truck. The same goes for Fig. 9 where the point load is mostly carried directly to the support of girder A instead of wheel loads that might be shared more equally between the adjacent girders.

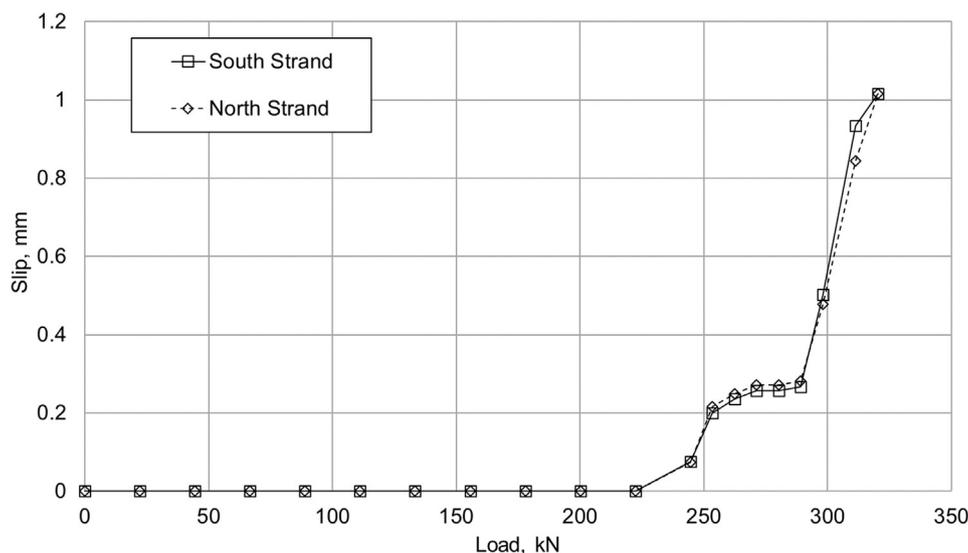
Fig. 11. Strand slip in girder B up to removal of gauges.

The first visually observed girder cracking due to the applied load occurred at 245 kN. This web shear cracking occurred in the web of girder B. The slope of the load-deflection curve for this girder decreased at a load of around 178 kN, so cracking likely initiated before it was observed by the research team. At 253 kN of load, this shear cracking extended into the bottom flange of girder B interrupting the transfer length of the two 13.2 mm diameter prestressing strands in the bottom flange of the girder. At 280 kN, the first flexural crack was observed directly below the load point. Strand slip was measured in both of the strands in girder B at this time, likely related to reduced bond from the shear cracks. The measured slip for girder B is shown in Fig. 11. The dial gauges used to measure strand slip were removed at around 311 kN of load because they had reached the limit of their stroke. At 298 kN of load, another web shear crack appeared approximately 0.61 m (11%) into the span from the initial shear crack. Horizontal bond-shear cracking began to occur at a load of 334 kN and a diagonal crack on the underside of the slab appeared. This crack in the slab initiated at the load point and terminated near the corner of the slab nearest girder A. Some of the cracking in Girder B and the slab visible at 334 kN of load is

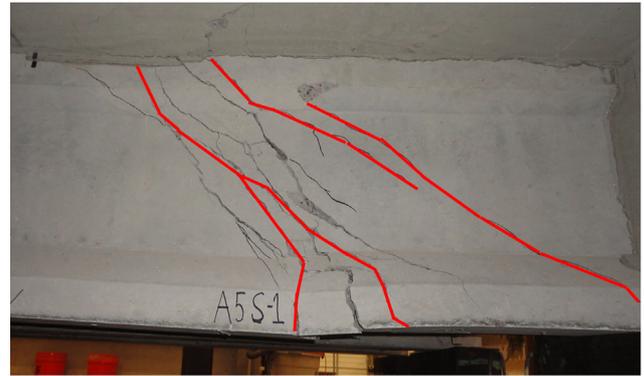
Fig. 12. Girder B final cracking (cracking at 334 kN of load outlined in red). (For interpretation of the references to colour in this figure legend, the reader is referred to the web version of this article.)

shown in Fig. 12.

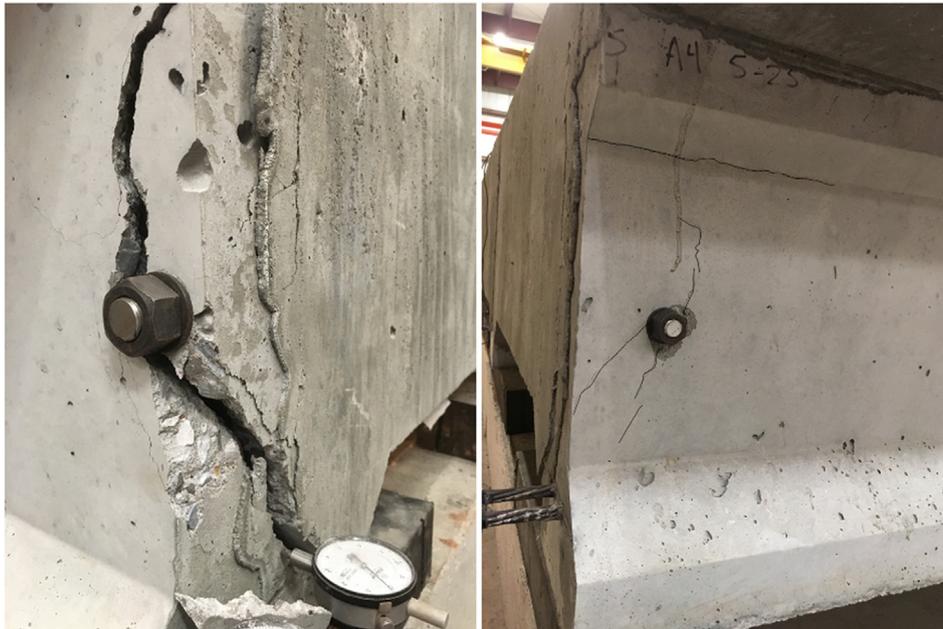
Fig. 13. Cracking at diaphragm to girder connections on girder A. Left image shows end closest to load, right image shows end farther from load.

At a load of 347 kN, cracking in girder A occurred at the bolted connection to the diaphragm, potentially due to limited cover between the bolt and the end of the beam. More adequate cover to the connection should have been provided, but the bolt hole spacer shifted during concrete placement. The horizontal crack at the web to flange interface on the girder indicates potential torsion in the end girder caused by the diaphragm connection. Similar cracking was also observed at the opposite end of girder A. Cracking at the diaphragm/girder interface in both ends of girders A is shown in Fig. 13. The cracking at this exterior girder appears to be related to large deformations in the deck. As girder B failed and the bridge deck deformed as a plate, girder A (exterior) rotated away from the bridge due to its connection to the deck, and the end diaphragm also rotated away from the bridge, causing the bolted connection at the girder to fail.

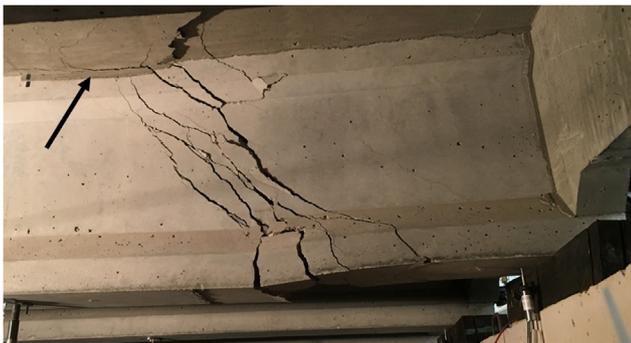
Fig. 14. Cracking in girder B at failure. Arrow indicates load location and punching shear.

Load was applied up to a maximum of 427 kN, at which point there was extensive cracking in the loaded girder, including a horizontal crack at the deck-girder interface. The load point also punched through the deck at the maximum load (see Fig. 14). Punching shear was the ultimate failure mechanism for the bridge. In Fig. 14 the black arrow indicates the location of the load point. Diagonal cracking in the slab can be seen in this figure as well as large shear cracks and shear deformation in the girder. Some separation of the deck and girder occurred due to the punching shear.

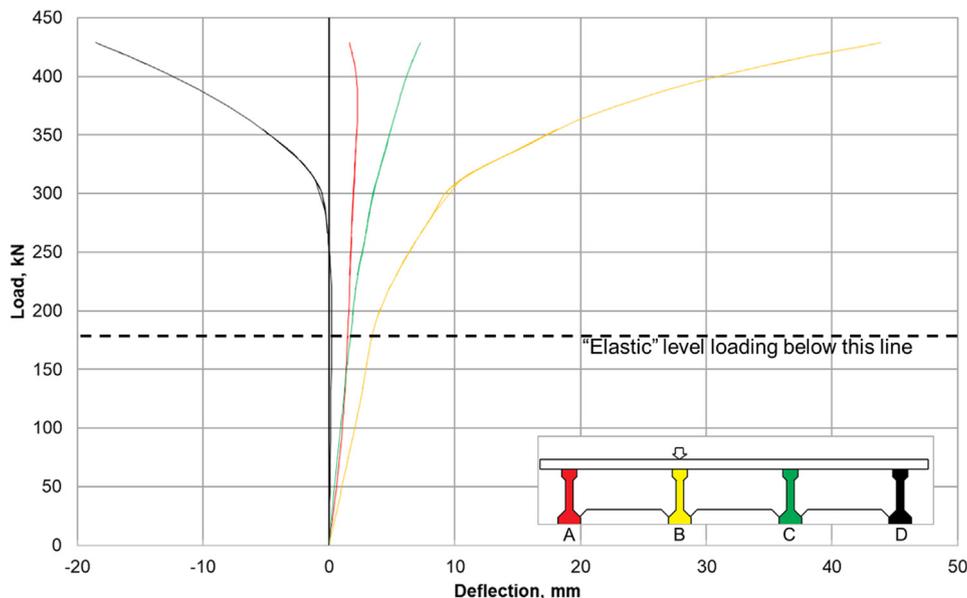
Fig. 15. Load vs. deflection for bridge test.

Fig. 15 shows the load versus deflection curves for the destructive

test. Girder D raised off of its supports by the end of the test, as indicated by the negative deflection in Fig. 15. The change in slope of the girder B response at around 191 kN of load corresponds to initial cracking; as the cracks worsened, the deflection of the girder increased at an increasing rate. Additionally, after the loaded girder cracked, the slopes of the other girders begin to change, particularly for girder C. This is due to the additional demand on the adjacent girders when the stiffness of girder B decreased. The response of girder A (exterior) remained roughly linear for the duration of the test. The slab likely transferred more of the demand to girder C than girder A due to the larger torsional stiffness of girder C.

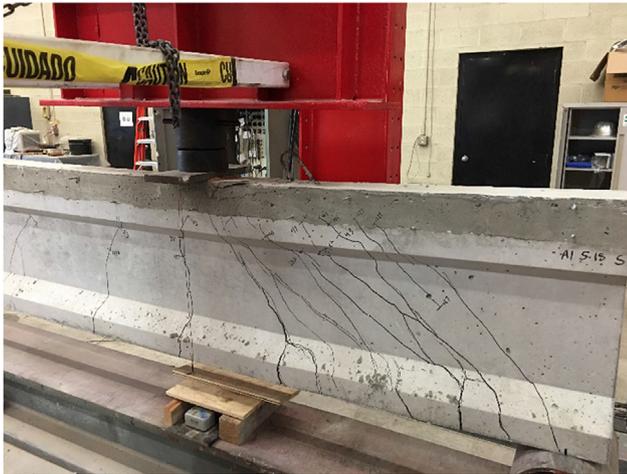
Fig. 16. Final cracking for individual scale girder test.

A picture of the individual girder failure is shown in Fig. 16. Note that the shear cracking at the end of this girder is similar to the cracking pattern observed for the loaded girder (girder B) in the bridge test. The nominal flexural capacity of the individual girder calculated using strain compatibility was 200 kN-m compared to a calculated moment capacity of 215 kN-m for the bridge using the tributary width of the deck (7 percent difference). The capacity should theoretically have been governed by flexure in both cases, however shear cracking caused strand slip and reduced the shear capacity, leading to bond-shear failures in both cases. The shear span-to-depth ratio of this test was only 2.4, and bond-shear failures are often observed for this type of loading [31].

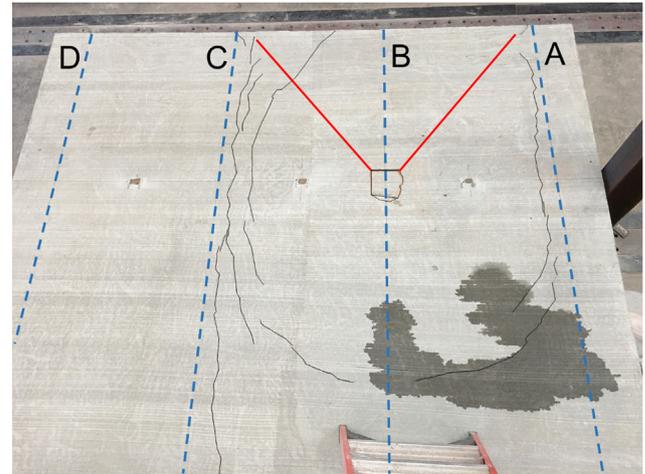
Fig. 17. Deck cracking from bridge test. Cracking visible in the deck top is highlighted in black. Dashed lines indicate locations of girders. Red lines denote locations of cracking on underside of bridge deck. (For interpretation of the references to colour in this figure legend, the reader is referred to the web version of this article.)

Final cracking in the bridge deck is shown in Fig. 17. A typical highway bridge deck for simply supported bridges can be designed as a one-way slab continuous over the girders. However, there are several reasons to believe the failure of the deck during this test is indicative of a two-way slab rather than a one-way slab. The deck cracking pattern suggests the failure of a two-way slab supported on its edges by the girders A and C and the middle and end diaphragms. The circular cracking visible around the load point, with negative moment cracking at the girders adjacent to the loaded girder and at the diaphragms is

similar to a two-way slab with a point load in the middle. There was less negative moment cracking observed at the top of the slab at the face of the end diaphragm compared to the middle diaphragm. This diaphragm rotated away from the ends of the girders, and thus had less stiffness to resist the negative moment in the deck. The diagonal cracking underneath the deck is also similar to the assumed behavior of two-way slabs for yield line analysis. The loss in load carrying capacity of a girder (in this case the loaded girder B) resulted in a transition from one-way slab behavior to two-way slab behavior.
