Special Issue

Non-Destructive Testing and Assessment of Reinforced Concrete and Masonry Structures

In-situ and lab tests for mechanical characterization of stone masonry historical structures

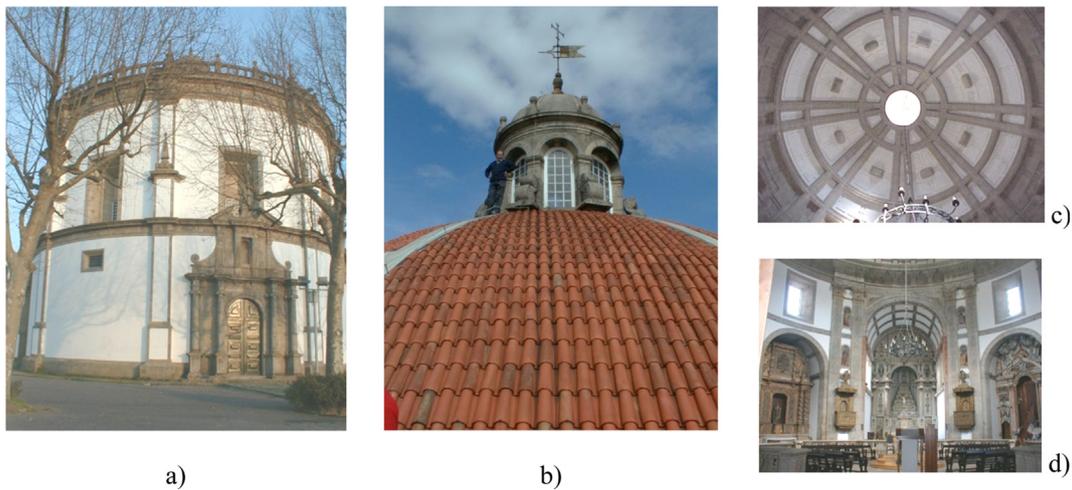
Fig. 1. The “Serra do Pilar” monastery church: a) Outside, b) the roof and the small upper dome, c) the dome structure and d) inside.

The first is the “Serra do Pilar” monastery church, founded back in 1537, located in Vila Nova de Gaia, adjacent to the south bank of Douro river and facing the historical center of Porto, Portugal. The initially existing church was later replaced by a new, larger and cylindrical one, finished in 1678. Made of local granite stone, probably inspired in the Rome Pantheon as shown in Fig. 1, it was an innovative option contrasting with the dominant Portuguese architecture by that time. The church is 29.6 m high with external radius around 15 m (Fig. 1-a)), covered by a 0.60 m thick hemispherical dome with 23.0 m internal diameter, above which 4.0 m high columns (separated by windows) support another small dome (Fig. 1-b)) completing the roof structure (Fig. 1-c)). The church structure has eight buttresses (16.8 m high) between small chapels (Fig. 1-d)) defined by arches which provide support to windows. In the main chapel zone there is a larger arch (13.4 m high) adjacent to a 14 m high vault covering the main altar which develops along a rectangular shape zone.

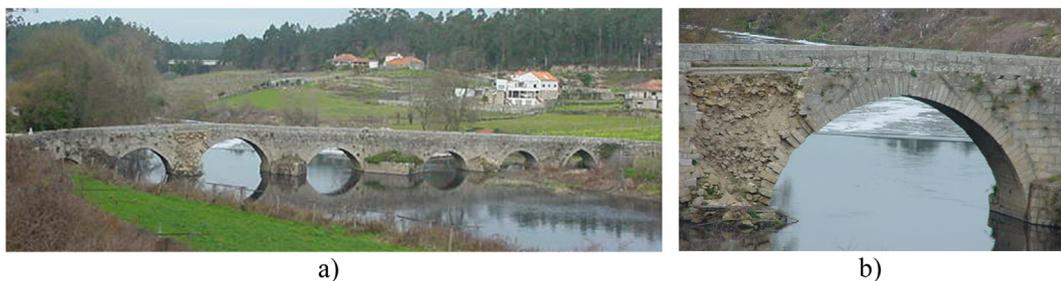
Fig. 2. D. Zameiro bridge: a) general view, b) partially collapsed pier.

features. Fig. 2-a shows an overall view of D. Zameiro bridge that suffered partial collapse of a pier (Fig. 2-b) from which infill material samples were taken for lab characterization.

Samples of infill material of the Zameiro bridge (Fig. 2) were used to make oedometric tests as a first, more simple and not very expensive way of characterizing the deformability of such a loose and poor material collected in disturbed conditions. According to current geotechnical lab practices, the sample was laterally confined, with free drain at the top and bottom, and subjected to incremental axial load [10]. The values of oedometric modulus during the test ranged between 6.3 MPa and 23.7 MPa. In order to meet laterally unconfined conditions of bridge infill material, the elastic modulus (E) can be related to the oedometric modulus (E_{edom}) and the Poisson ratio (ν) through the expression (2).

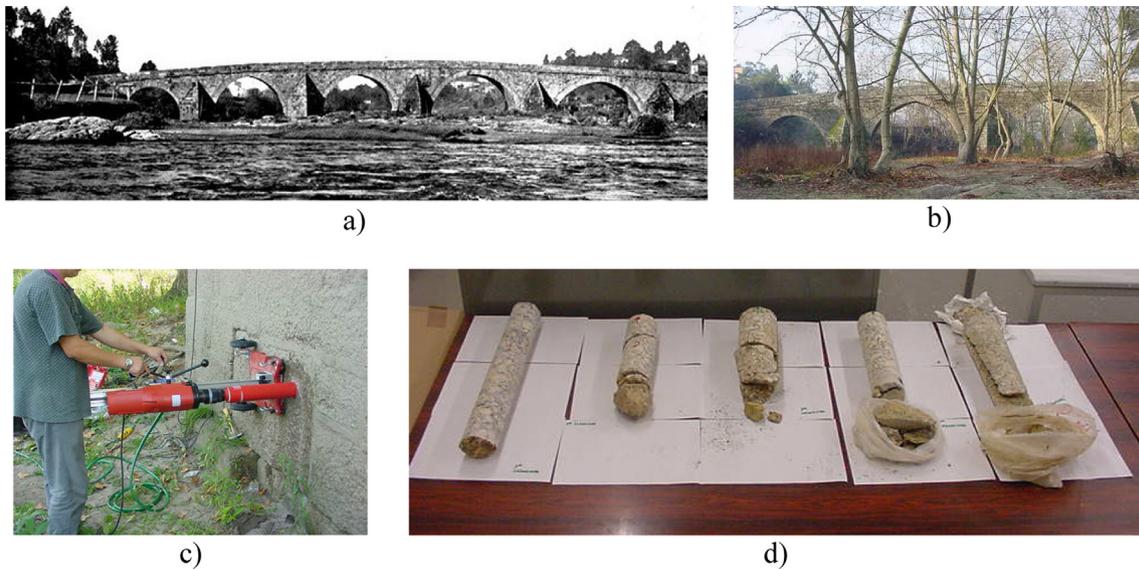
Fig. 3. Lagoncinha bridge: a) general old view, b) partial upstream view, c) core sampling and d) obtained samples.

Fig. 3 shows a general old view (a) and a partial recent picture (b) of the Lagoncinha bridge that in late 1990’s was found with several damages in some arches due to traffic and foundation settlement. From this bridge only stone material samples (Fig. 3-c and -d) were extracted for lab characterization; due to the poor conditions of the samples, joint tests could not be made. More details about this bridge and a corresponding comprehensive study (including detailed numerical simulations) can be found in Costa [7].

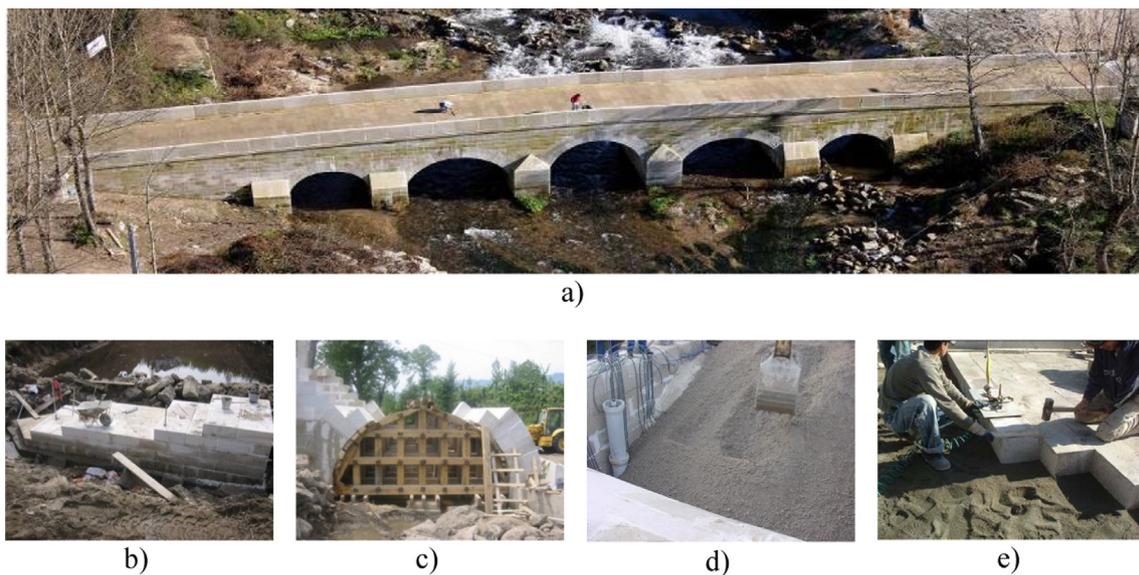
Fig. 4. New Vila-Fria bridge. a) General aerial view (courtesy of Prof. Francisco Piqueiro, FEUP) and constructive phases: b) piers, c) arches, d) infill and e) pavement.

The fourth and last case, generally illustrated in Fig. 4-a), is the “new” Vila Fria bridge, built between 2003 and 2005, to replace an old passage over the Vizela river about 60 km from Porto.

Taking advantage of full availability of the well graded granular material applied in the backfill of the Vila Fria bridge (Fig. 4), a broad characterization was made concerning its physical and mechanical properties, including parametric experimental studies to investigate the influence of different contents of binder (cement) foreseen to be present in the real construction. For this case, triaxial tests were carried out on samples of: i) pure granular material and ii) granular material with binder (7% of cement), as extensively described in [10]. Some of the corresponding results, in terms of deviatoric stresses ($\sigma_1 - \sigma_3$) vs. axial strain (ϵ_a) plots, are shown in Fig. 17 for three different consolidation stress levels (denoted as A, B and C, in increasing order), both for infill material samples without binder (samples type 1, Fig. 17-a) and with 7% cement (samples type 3, Fig. 17-b), where σ_3 is identified as the consolidation stress and σ_1 is the axial stress. The corresponding evolutions of volume variation (ΔV) recorded during the tests are plotted in Fig. 17-c) and -d), respectively.

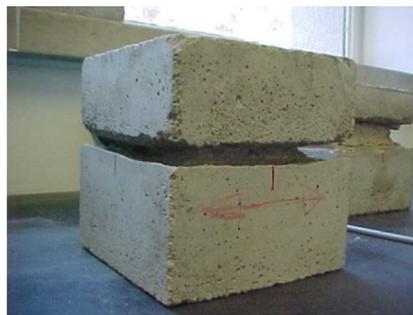
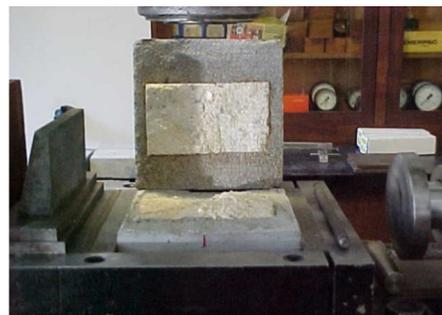
Fig. 5. Sample of mortar joint: a) ready for testing; b) after test.

Both shear and normal tests were made in the same shear-box machine existing at LNEC, with internal dimensions of $200 \times 200 \text{ mm}^2$. Therefore, the joints were encapsulated by a concrete envelope with adequate shape to fit inside the shear-box as shown in Fig. 5, with the surface to be sheared placed horizontally and along the shearing plane. In total, 11 mortar joints and 8 dry joints were tested.

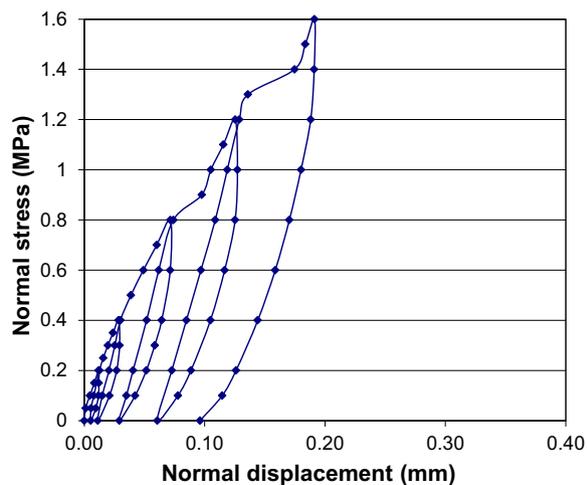
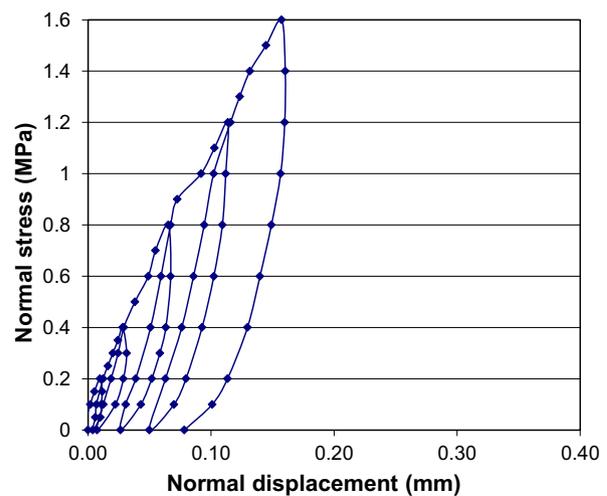
Fig. 6. Examples of normal stress vs normal displacement plots: a) mortar and b) dry joints.

Examples of normal compression test plots of mortar and dry joints are shown in Fig. 6. The former (Fig. 6-a) exhibits larger deformability for first loading than for reloading and also shows some sudden increases of normal displacement due to mortar crushing that was audible during the test. The dry joint plot (Fig. 6-b) shows similar trend in terms of deformability, but not the sudden increases of displacement.

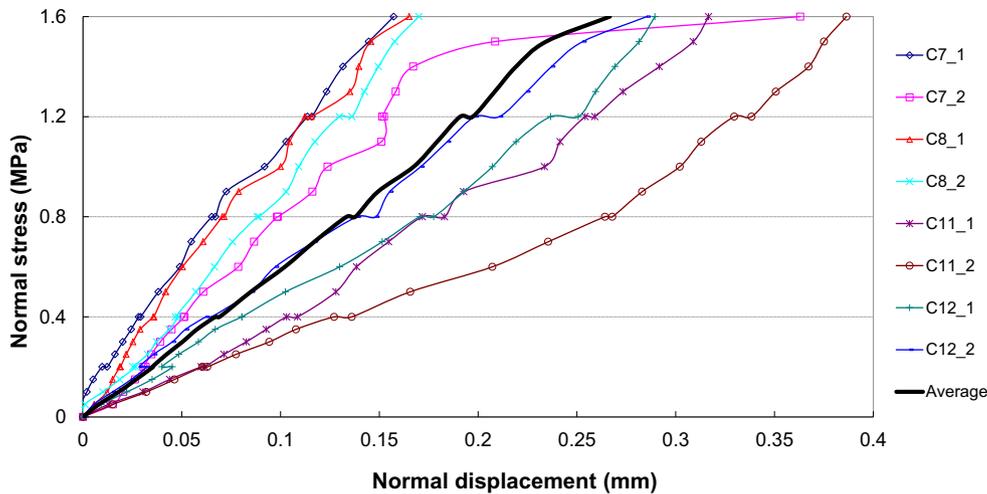
Fig. 7. Normal stress tests' plots and average curve, of first loading branches of dry joints.

The first loading branches (of the same joint type) were separated Almeida [1] from the unloading/reloading branches and plotted together for all tests as shown in Fig. 7 for the dry joints; these curves correspond to the envelope curves from the cyclic tests. For each stress level, the displacements were averaged, leading to the thick black line for which a linear approximation led to the value 6.24 MPa/mm for normal loading stiffness $k_{n,l}$.

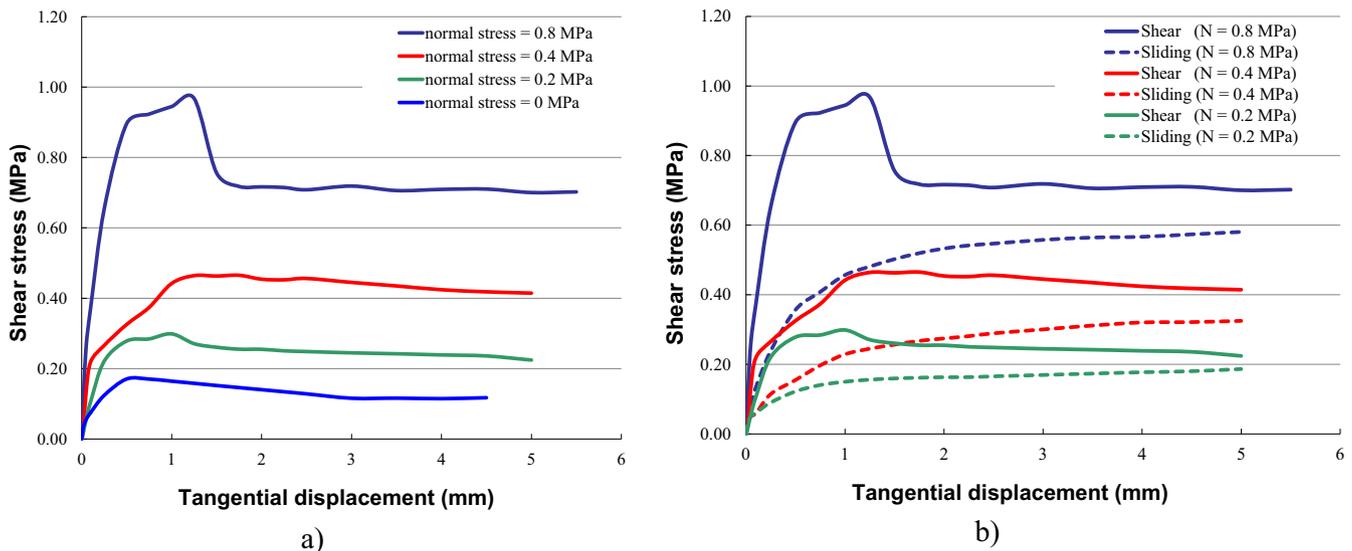
Fig. 8. Average shear stress - displacement curves of mortar joints: a) first shear tests and b) sliding tests compared with first shear tests.

Similarly, shear tests were made for a set of increasing normal stress levels, both for dry and mortar joints. Since for the latter, joint halves were not separated, the shear test started by initial shearing of the sample leading to the mortar rupture and sample splitting into two halves. Four normal stress levels were applied (0, 0.2, 0.4 and 0.8 MPa) for these initial shearing tests of different joints and the results were plotted in shear stress vs. tangential displacement plots (Fig. 8) characterizing the first-shear response.

By averaging the shear tests' results as above explained, the four curves shown in Fig. 8-a) were obtained for mortar joints corresponding to the four normal stress levels. After split and replaced

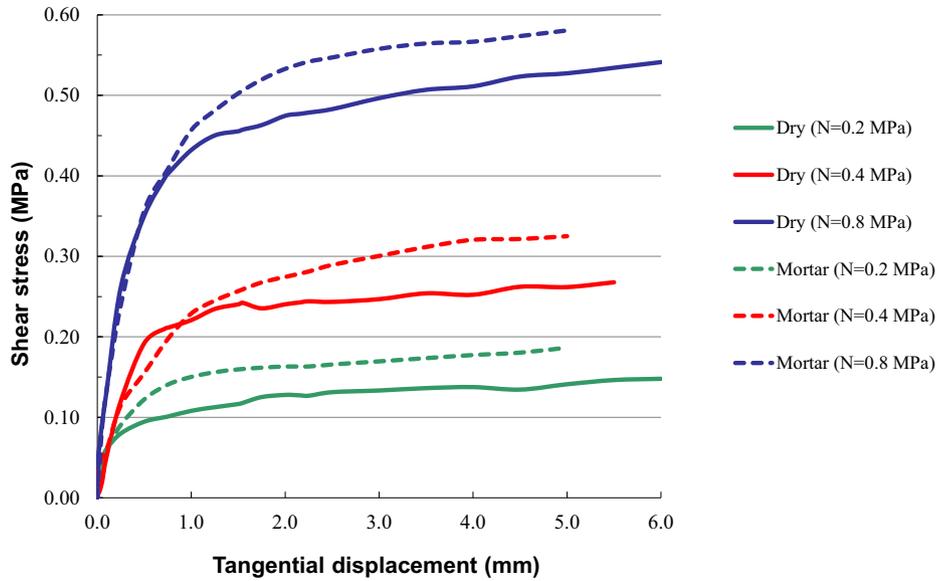
Fig. 9. Comparison of average shear stress - shear displacement curves from sliding tests of mortar joints (dashed lines) and dry joints (solid lines).

A similar study was made for dry joints and comparison with average shear curves of mortar joints can be observed in the plots shown in Fig. 9, where solid lines refer to dry joint curves and dashed ones to the mortar joints sliding shear response. Despite showing similar initial stiffness, the mortar joints reach larger shear strength, probably resulting from better connection provided by the mortar material.

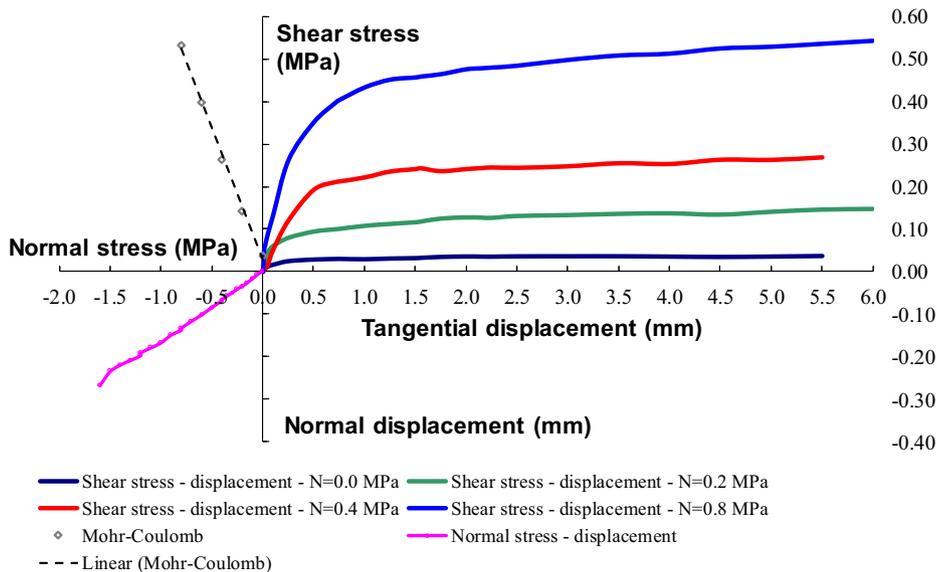
Fig. 10. Global average plots for dry joints: shear stress-displacement curves; normal stress-displacement response and adjusted Mohr-Coulomb line.

For a comprehensive presentation and interpretation of results, average curves obtained from normal compression and sliding tests were plotted in a combined diagram shown in Fig. 10 (for the dry joints case) which, simultaneously, evidences the shear response curves for different pre-compression levels, the normal compressive response (namely the normal stiffness in terms of first loading, $k_{n,l} = 6.24 \text{ MPa/mm}$) and the Mohr-Coulomb line ($\phi = 35.6^\circ$) adjusted to the pair of values of maximum shear strength and associated compression level.

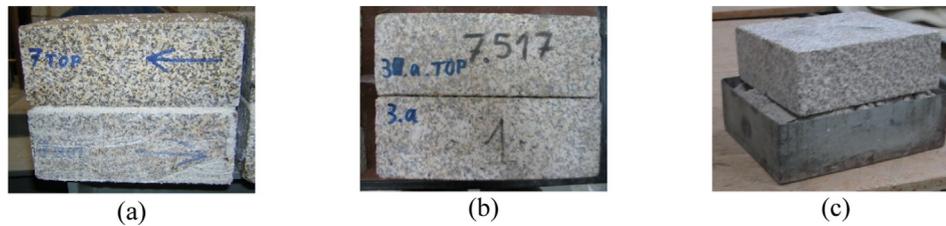
Fig. 11. Vila Fria bridge samples of: (a) stone-to-stone mortar joints, (b) stone-to-stone dry joints (c) and stone-to-infill joints.

For testing masonry joints, two granite-stone parallelepiped samples with $200 \times 200 \times 75 \text{ mm}^3$ dimensions were used; the contact between the two stones was set in the larger area faces. For mortar joints, stones were connected by a layer of hydraulic mortar equal to that used in the bridge construction and with similar thickness (about 7 mm), as shown in Fig. 11-a. The joints between the stone and infill material were characterized by testing samples of pure granular material used in the backfill and a stone block with dimensions equal to the blocks used in the above mentioned joint tests (see Fig. 11-c).

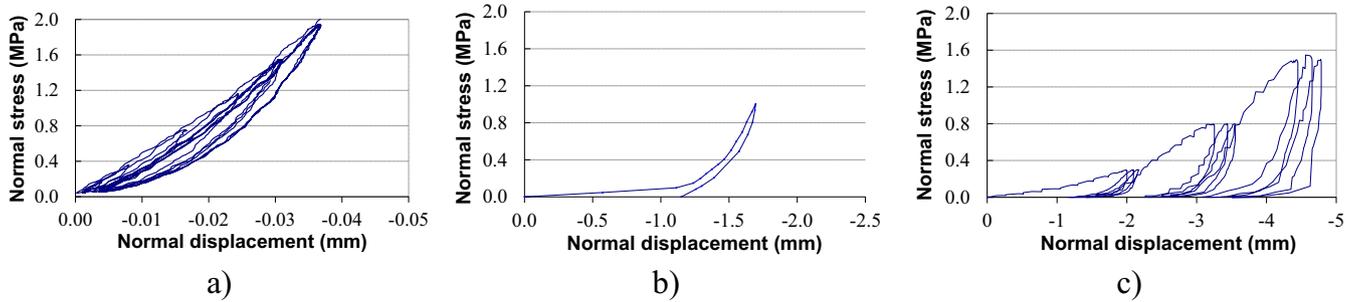
Fig. 12. Normal stress vs. vertical displacement of: (a) the stone-to-stone mortar joints, (b) stone-to-stone dry joints and (c) stone-to-infill joints.

The characterization of the joint behavior in the normal direction was based on the results of cyclic compression tests, which provided records of the evolution of compressive strength, σ , with the normal displacement, d , as shown in Fig. 12 for one example of each joint type.

For mortar stone-to-stone joints (6 tests performed) and stone-to-infill joints (just 1 sample tested) it was possible to evaluate the degradation of normal stiffness and compressive strength of joints due to successive cycles of loading-unloading-reloading. Mortar joints (Fig. 12-a) show loading branches characterized by roughly constant stiffness, k_{ni} , with an average value around 62 MPa/mm, about ten times that of the Serra do Pilar church. The unloading-reloading cycles showed positive curvature and, in general, strength recovery. Stone-to-stone dry joints (2 tests performed) and stone-to-infill joints (Fig. 12-b and -c) exhibit positive curvature in the first compression loading phases, with initial large deformability, characteristic of adjustments between joint surfaces, followed by considerable normal stiffness increase. For dry stone joints, such stiffness reached values about 1.2 to 2.8 MPa/mm, after the initial adjustment phase. Stone-to-infill joints show three loading branches with approximately constant stiffness of 0.1, 0.2 and 0.5 MPa/mm, about ten times lower than those of the Serra do Pilar dry or mortar joints. The unloading-reloading cycles also exhibit positive curvature, characterized by two branches of roughly constant stiffness with the transition between the two branches for both unloading and reloading phases occurring for similar stress levels. As usual, residual displacements are observed after unloading.

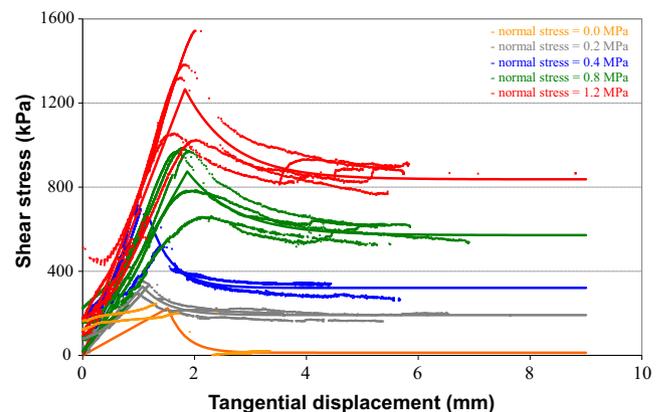
Fig. 13. Shear stress vs. tangential displacement of stone-to-stone mortar joints.

The shear behavior of joints is expressed in terms of shear stress vs. horizontal displacement diagrams (τ , γ), under different levels of constant normal stress. Fig. 13 shows the (τ , γ) curves obtained for all mortar joints and all normal stress levels, after correcting the horizontal displacement as described in Costa [10]. In the same figure, thicker line curves are also included, which correspond to average curves adjusted to the set of curves obtained for each level of normal stress. These curves are typically characterized by a linear phase followed by softening and a residual phase. Although not shown herein, dry and stone-to-infill joints exhibit a linear branch followed by hardening and plateau phases; details can be found in Costa [10].

In these tests, generally it was found that the initial stiffness, the peak shear and the residual shear stress are higher, for larger levels of installed normal stress. For mortar joints the obtained stiffness values ranged between 0.12 and 0.76 MPa/mm; for dry

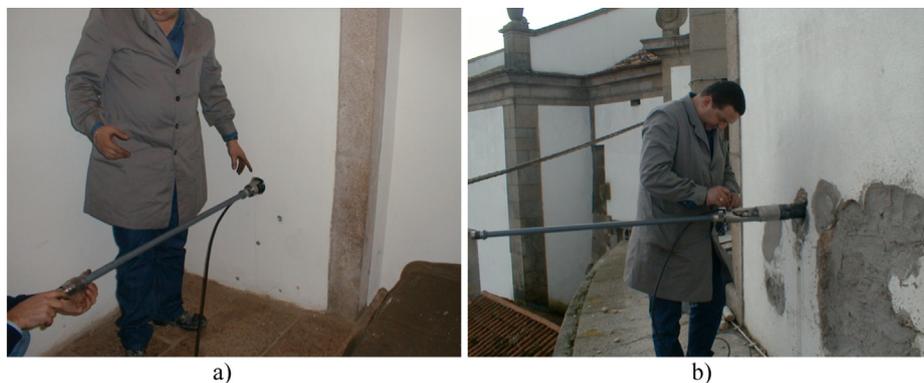
Fig. 14. Dilatometer tests' locations: a) 1st, near the ground; b) 2nd, about 11 m high.

As mentioned before, borehole dilatometer (BHD) tests were made in the Serra do Pilar church, as fully described in LNEC [14] and Almeida [1]. These tests provided mechanical deformability data relative to original walls' infill material of a 350 years old construction, at two different height level locations: the 1st test at 0.50 m and the 2nd test roughly at 11 m above the ground level

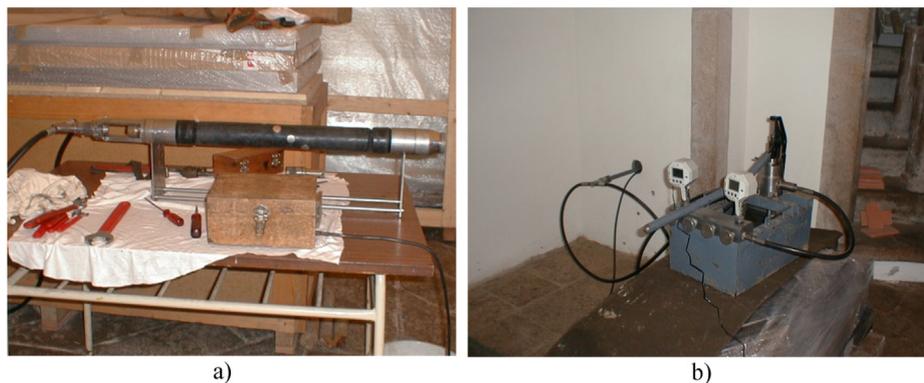
Fig. 15. BHD tests: a) dilatometer probe; b) hydraulic pressure pump and control unit.

The dilatometer was developed at LNECLNEC (2000 for current use in rock mechanics testing. As illustrated in Fig. 15-a, it consists of a probe made of a stiff steel body with a rubber membrane in the central zone (0.60 m long) that allows applying hydrostatic pressure to 76 mm diameter boreholes' wall by means of water injection inside the rubber membrane. It is provided with four LVDT type transducers (with $1\ \mu\text{m}$ resolution), aligned in four directions separated by 45° , to obtain diametral displacements due to applied pressure that is measured by a digital pressure gauge (50 bar range and 0.1% full scale resolution) as shown Fig. 15-b.

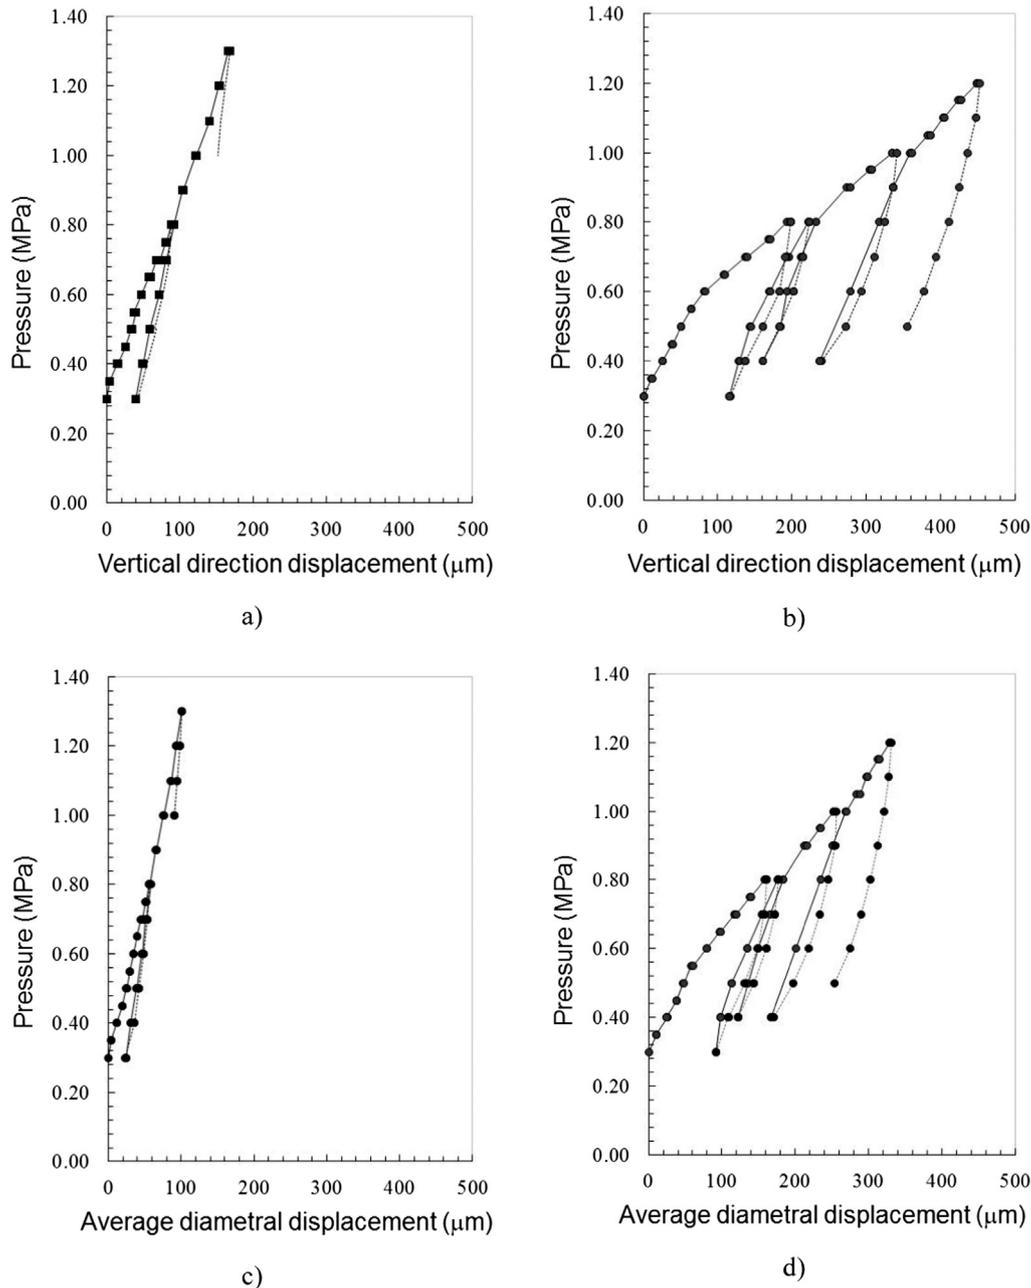
Fig. 16. Pressure vs. diametral displacement plots of BHD tests: a) 1st test and b) 2nd test for vertical direction response; c) 1st test and d) 2nd test for average response in the four directions.

Test recordings allowed plotting applied pressure vs. diametral displacement in vertical and horizontal directions, as well as in 45° and 135° directions relative to the vertical. Loading-unloading-reloading cycles of pressure were applied up to about 1.3 MPa (see Fig. 16). As expected in this kind of soil type materials, the first loading up to a "virgin" stress state exhibits lower stiffness than subsequent reloading stages to the same stress level; this is evidenced in Fig. 16-a and -b, respectively, for the 1st and 2nd tests where the corresponding pressure vs. diametral displacement plots are shown for the vertical direction.

was computed and the corresponding average response plot was obtained, as shown in Fig. 16-c and -d, respectively, for the 1st and 2nd tests. It is clear that, for the 1st test (lower level, near ground) a stiffer infill material was found than for the 2nd test (in the upper level), which is quite reasonable to accept as a plausible situation. This fact also justifies the reason why more cycles were made in the 2nd level; actually, the 1st test near the ground level was stopped earlier than expected (only one complete load-unload-reload cycle was achieved) due to failure of the rubber membrane, probably caused by its contact with a harsher conglomerate of sharp and stiff pieces of stone, mortar and voids.

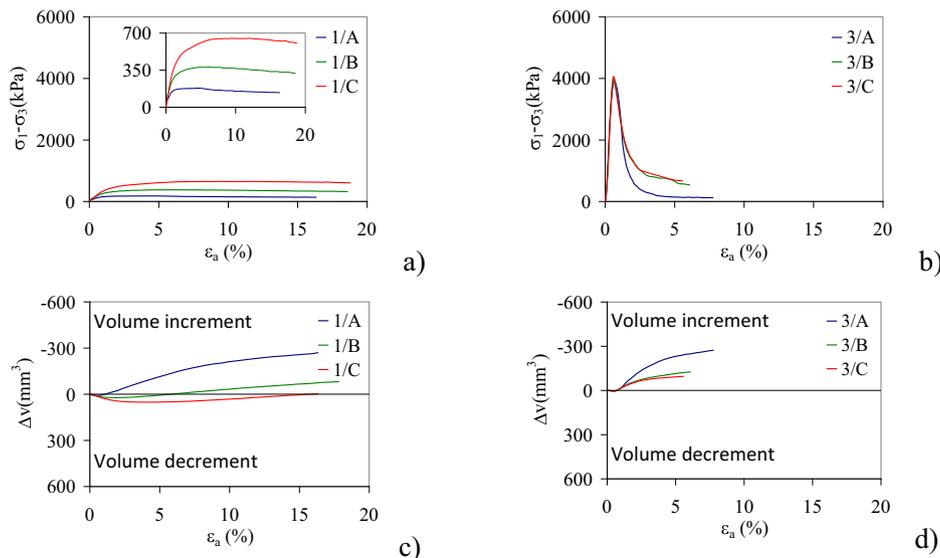
Fig. 17. Triaxial test results for infill material of Vila Fra bridge. Deviatoric stress ($\sigma_1 - \sigma_3$) vs. axial strain (ϵ_a) plots for samples, a) without binder, b) with 7% of cement and corresponding volume variation vs. axial strain plots, c) and d), respectively.

The pure granular material (Fig. 17-a) shows an initial phase of linear elastic behaviour, followed by hardening and a constant branch for the highest consolidation level (C); for lower consolidation stress levels smooth softening phases are observed, showing a slight strength peak due to dilatancy phenomena (Fig. 17-c). Quite different response is obtained for granular material with 7% of cement, showing almost linear response up to clear peak strength (see Fig. 17-b), followed by pronounced softening until a residual branch. Peak strength is not very influenced by the consolidation stress level and sample volume never decreases (by contrast with pure granular samples) due to the sample consistency granted by the cement addition.

For both cases, Mohr-Coulomb failure envelopes were possible to be drawn leading to friction angle about 42° and cohesion of 13 kPa for pure granular material, wherein cohesion is a consequence of imbrication between particles; for samples of granular material with cement, friction angle and cohesion were obtained as 33° and 1055 kPa, respectively, the latter clearly influenced by the cement bond effect.
