Deterioration assessment model for splash zone of marine concrete structures

B.H.J. Pushpakumara^{a,*},¹, M.S.G.M. Fernando^b

^a Department of Civil Engineering, Faculty of Engineering, General Sir John Kotelawala Defence University, Ratmalana 10390, Sri Lanka

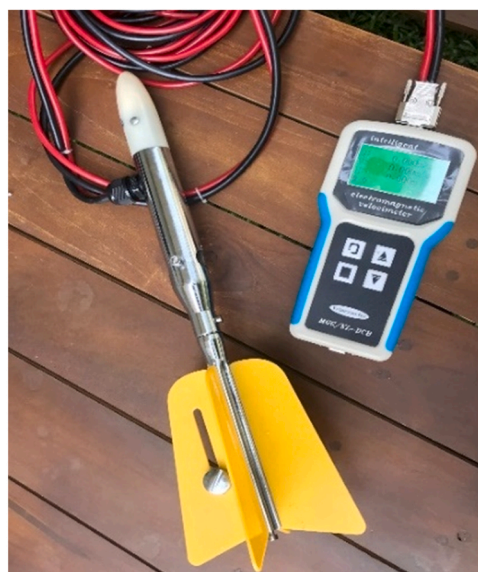
Fig. 2. Velocimeter.

The portable Electromagnetic Velocity Meter (Fig. 2) was used to take the velocity measurements of the water bodies according to EN14154 and ISO4064. This equipment consists of two parts: electromagnetic velocity sensor and the display unit. Here, the velocity sensor was put into the water body and the readings were recorded.

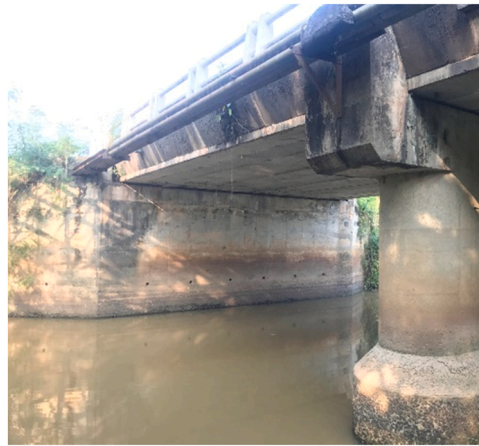
Fig. 4. Veyangoda (B208) Bridge.

The structure has mainly deteriorated due to abrasion erosion caused by high flood flow during the rainy season. The chloride concentration of water is very low which is 0.177 g/l. During flood seasons the water level raises up to 1500 mm. Furthermore, there are no visible cracks and vegetation cover. According to the NDT results the bridge is in good condition.

The values obtained for Visual Inspection (VI), Crack Detail (CD), Water Quality (WQ), NDT and Casual Factors (CF) are 1.288, 1, 1.308, 1.248 and 2.915, respectively. Using these values, the SCI was obtained as 1.547. Then, calculate the deterioration (i.e. 63.6 %) as a percentage. According to the calculation, the level of deterioration of the splash zone of the structure is 36.4 %. This structure has received a lower percentage because in this structure there is no visible cracks, therefore no corrosion occurred due to external factors and also is located far away from the coastline. It can be concluded that the percentage obtained is accurate with respect to visual inspection information and NDT results.

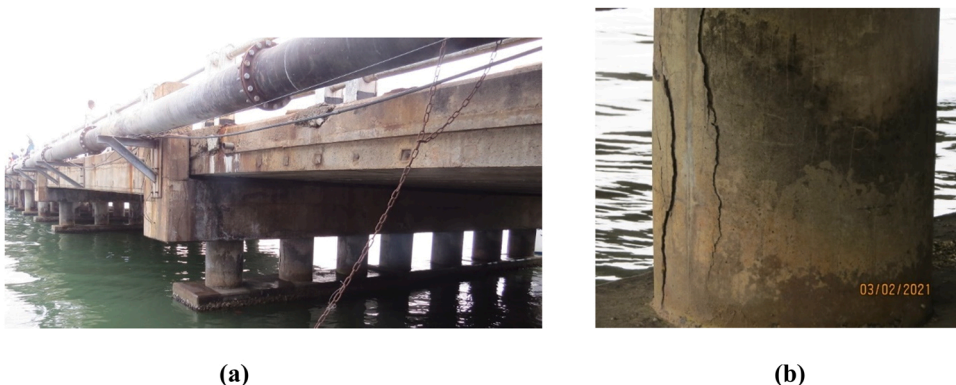
Mankuliya Bridge (Fig. 5) is located on Negombo lagoon (near to seashore), Sri Lanka and this has been exposed to extreme environmental conditions for over 100 years.

As the structure is located in the lagoon area the water contains a high level of chloride ions (9.13 g/l). Therefore, chloride ion induced corrosion can be seen. The flow velocity is very high. In this structure, severe structural distresses such as spalling of greater than 150 mm in length and width and cracks greater than 300 mm in length were observed. Moreover, the NDT results show poor structural integrity.

Fig. 5. Mankuliya Bridge (a) Spans and piers (b) visible cracks.

The values obtained for *VI*, *CD*, *WQ*, *NDT* and *CF* are 3.664, 4, 1.508, 4 and 3.693, respectively. The *SCI* was obtained as 2.94. Then, calculate the deterioration as a percentage (i.e. 69.2 %).
