Failure Analysis and Repair of a Catastrophically Damaged Gas Turbine Compressor Disk Using SEM Technique and CFD Analysis

Abstract During a major overhaul of an 85 MW gas turbine unit in Iran-Rey power plant, 39 cracks were detected with different lengths and locations on the compressor disk of stage 11. All of the cracks initiated from the dovetail regions. Preliminary visual inspections and further microfractography using the scanning electron microscope demonstrated that the fretting fatigue phenomenon was the main cause of failure. Four repair methods were suggested to restart the unit. The first one was to remove all of the cracks from the disk by machining, or the so-called blending. The second, third, and fourth ways were to remove the entire rotor blades of stage 11, to remove the entire rotor and stator blades of the stage 11 simultaneously, and to remove those rotor blades of stage 11 corresponding to the damaged dovetails, respectively. Although the first way of solution was initially carried out on the damaged disk, the first author offered that restarting the unit with the blended disk is not reliable enough because of the presence of a large number of repair points

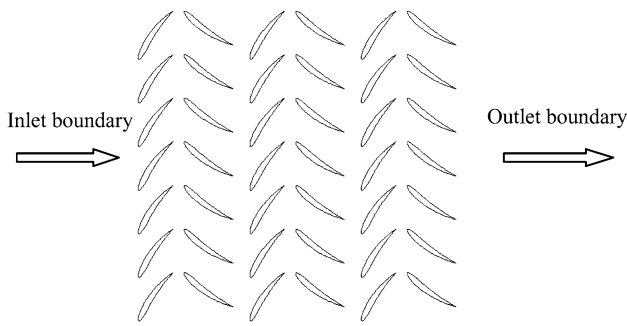
Fig. 9 Three stages of the cascade blades containing rotors and stators [23]

Three stages of a 2D cascade containing seven rotor blades and seven stator vanes were simulated as shown in Fig. 9. The cascade blades characteristics and the steady-state conditions of the fluid flow are presented in Tables 2 and 3, respectively [23]. The commercial software Fluent was utilized for the flow analysis.

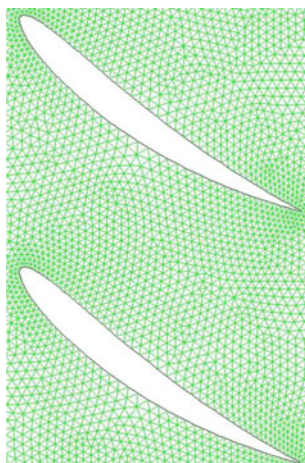
The two-dimensional, compressible NS equations were solved by FVM. Since no coriolis acceleration exists, the governing equations at relative coordinate system are equal to the absolute governing equations. Also, no energy transfer exists, and the total entropy is considered to be constant. Therefore, we used the absolute velocity by adding the rotational velocity to the relative velocity. Periodic boundary conditions at up and down domains as well as the velocity and pressure at inlet and outlet boundaries were used, respectively. The domain was divided into several separate blocks corresponding to the rotor and stator. The rotor blocks are rotational, and the stator blocks are fixed. Figures 9 and 10 show the physical domain, and the unstructured grids around the blades, respectively.

Fig. 10 Triangle unstructured grids around the blades

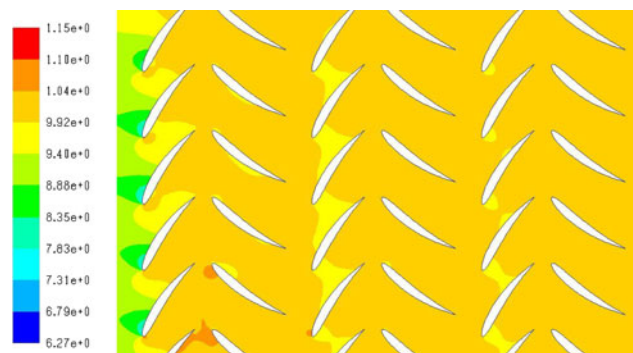
Fig. 11 Static pressure contours in complete cascade

(i.e., no blade removal) condition. As seen in Fig. 11, no flow separation occurs between the blades.

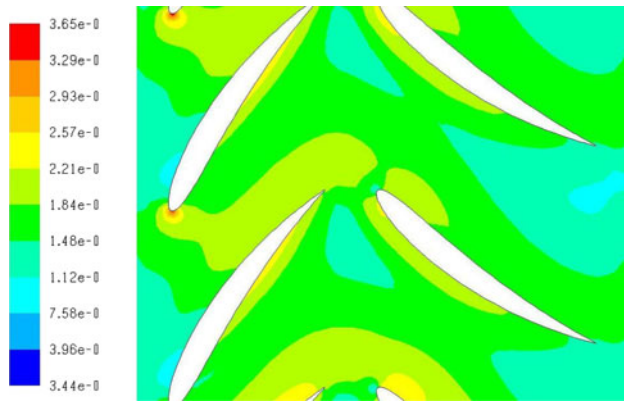
Note that the parameters presented in Table 3 have been elaborated in [23], and hence, they are not explained herein. Figures 11, 12, and 13 show respectively the static pressure contours, the Mach number distribution, and the stream lines for the three-stage compressor in its complete

Fig. 12 Mach number distribution at complete cascade

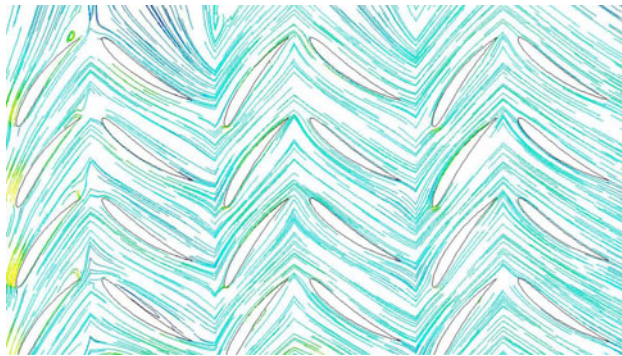
Fig. 13 Stream lines in complete cascade
