Engineering Structures

Repair assessment for distortion-induced fatigue cracks in a seismically retrofitted double-deck bridge complex

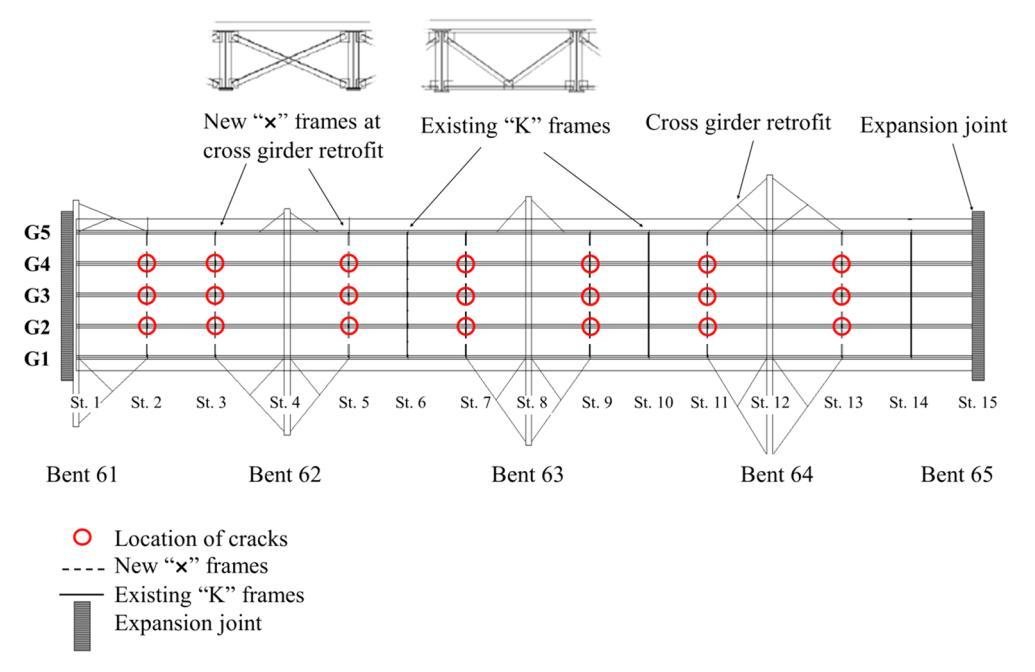
Within approximately one year following the completion of the seismic retrofit, the DOT inspectors identified several cracks in the webs of the longitudinal plate girders during a routine inspection. The cracks were a combination of horizontal cracks formed at the web to upper flange joint and horseshoe-shaped cracks originating from the stiffener-to-web intersection, as shown in Fig. 3. These cracks were pre-dominately located in the three interior girders at the location of the cross-girder retrofit and new cross-diaphragms, as shown in Fig. 2.

Fig. 2. Seismic retrofitted bridge plan-view.

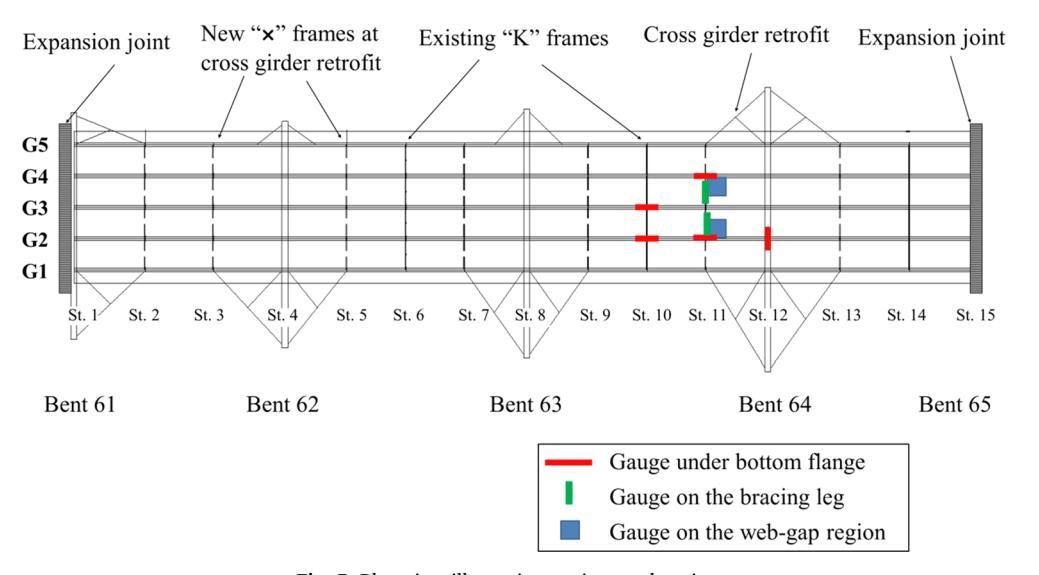
The north side of girder 2 (G2) and the south side of girder 4 (G4) at station 11 were selected to attach the strain gages in the web-gap region, as shown in Fig. 5. At each location, three strain gages were placed over 25.4-mm (1-in.), the top gage being positioned 19.1 mm (0.75 in.) from the bottom of the top girder flange, and 30.5 mm (1.2)

Fig. 5. Plan view illustrating strain gage locations.

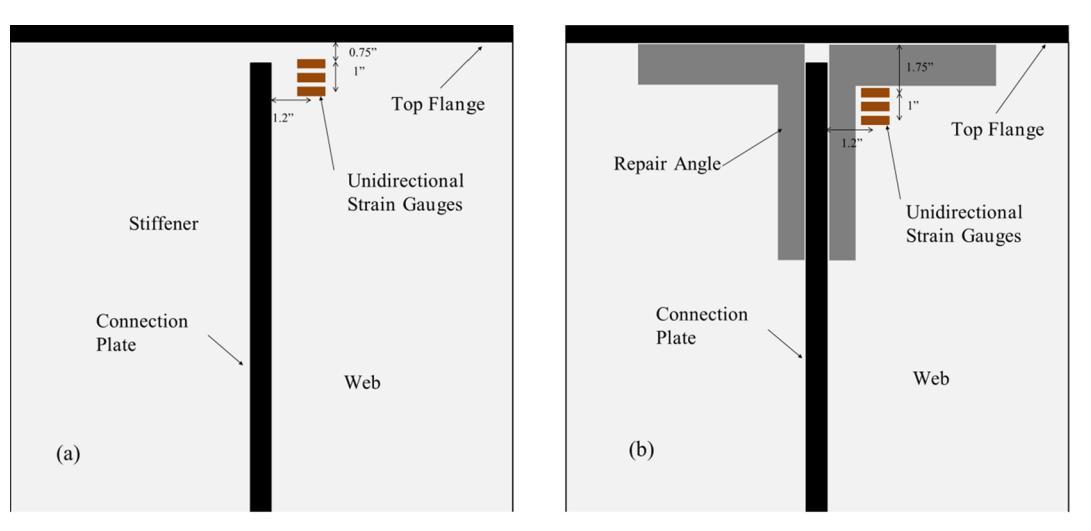
in.) from the connection plate surface. Fig. 6 shows the layout and detailed arrangement of these gages in the web-gap region for the first and second field tests. The vertical location of the gages shifted downward for 25.4 mm (1 in.) placing them 44.5 mm (1.75 in.) from the bottom of the top flange for the second trial. This relocation was necessary as the repair angle was in the original location of the gages in the first field test.

Fig. 6. Web-Gap strain gage arrangement for the (a) first field test, and (b) second field test.

The bottom gage in the three-gage set in the web-gap region of interior girders in the first field test was positioned at the same location as the gage positioned at the top of the three-gage set in the second field test, as shown in Fig. 6. Hence, these two individual gages were used to conduct a comparison between stresses at the same location before and after the repair. Also, the average of the three-gage readings in the web-gap was used as another comparison between the first and second field tests. The field test data indicates a significant reduction in stress for the gages attached in the web-gap region.

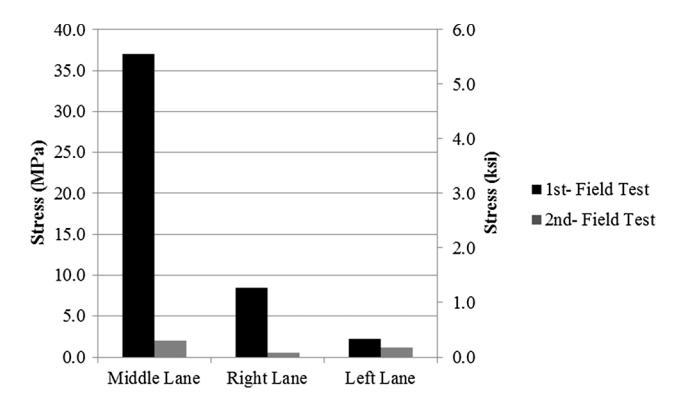
Fig. 12. Comparison between average stresses of three gages at the web-gap of G2 before and after repair.

the pilot bridge repair. The average stress in G2 is reduced by 92% following the repair with the middle lane loaded. This reduction is 91% and 21% when the truck is located in the right and left lane, respectively. Average stresses measured by the three gages at the G4 web-gap are reduced by 74% when the truck load is applied to the middle lane, 93% when truck load is applied to the right lane, and 81% when the truck load is applied to the left lane.

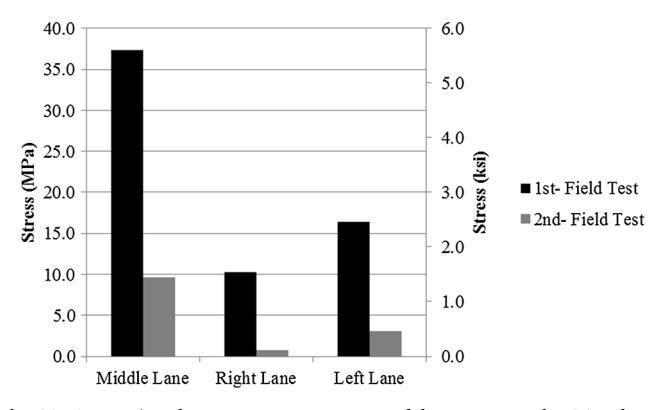
Fig. 13. Comparison between average stresses of three gages at the G4 web-gap before and after the repair.

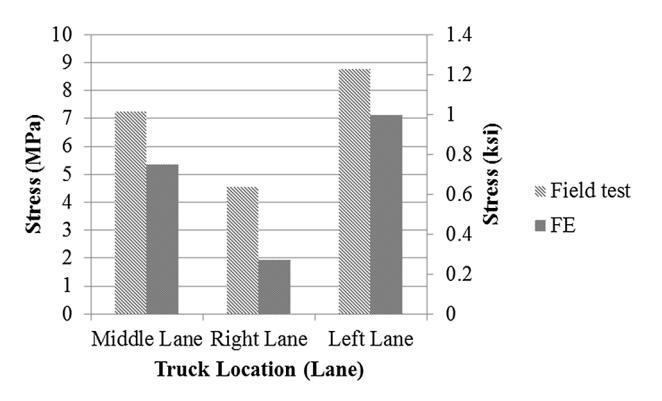
In order to verify the simulation of the bridge, results from the FE model were compared with the corresponding field test results of the bridge before the repair (first field test measurements). The results from the FE analysis are compared with results from field measurements for stresses at the bottom flange of G2 and G4, as shown in Fig. 16. As this figure shows, the FE and field test results were consistent in determining the location of maximum stress in the longitudinal girders for each load case. However, the bending stresses in the longitudinal girder obtained from the FE showed higher values than those measured in the field test. Fig. 17 compares the bending stresses at cross girder for all three load cases. The FE results and field test measurements identify the same trend in stresses (location of minimum and maximum stresses) even though there is a difference between stress values. The reason for these differences could be attributed to a number of factors. First, all the originally designed stiffeners inside the cross girder were modeled but it is plausible that some of them might not be fully functional as they are hidden inside the box girder. Second, all material properties were assumed perfect in the FE model while the material properties in the bridge that has been in service since 1964 could change due to aging and corrosion.

Fig. 17. Stress comparison between first field tests and FE for cross girder.

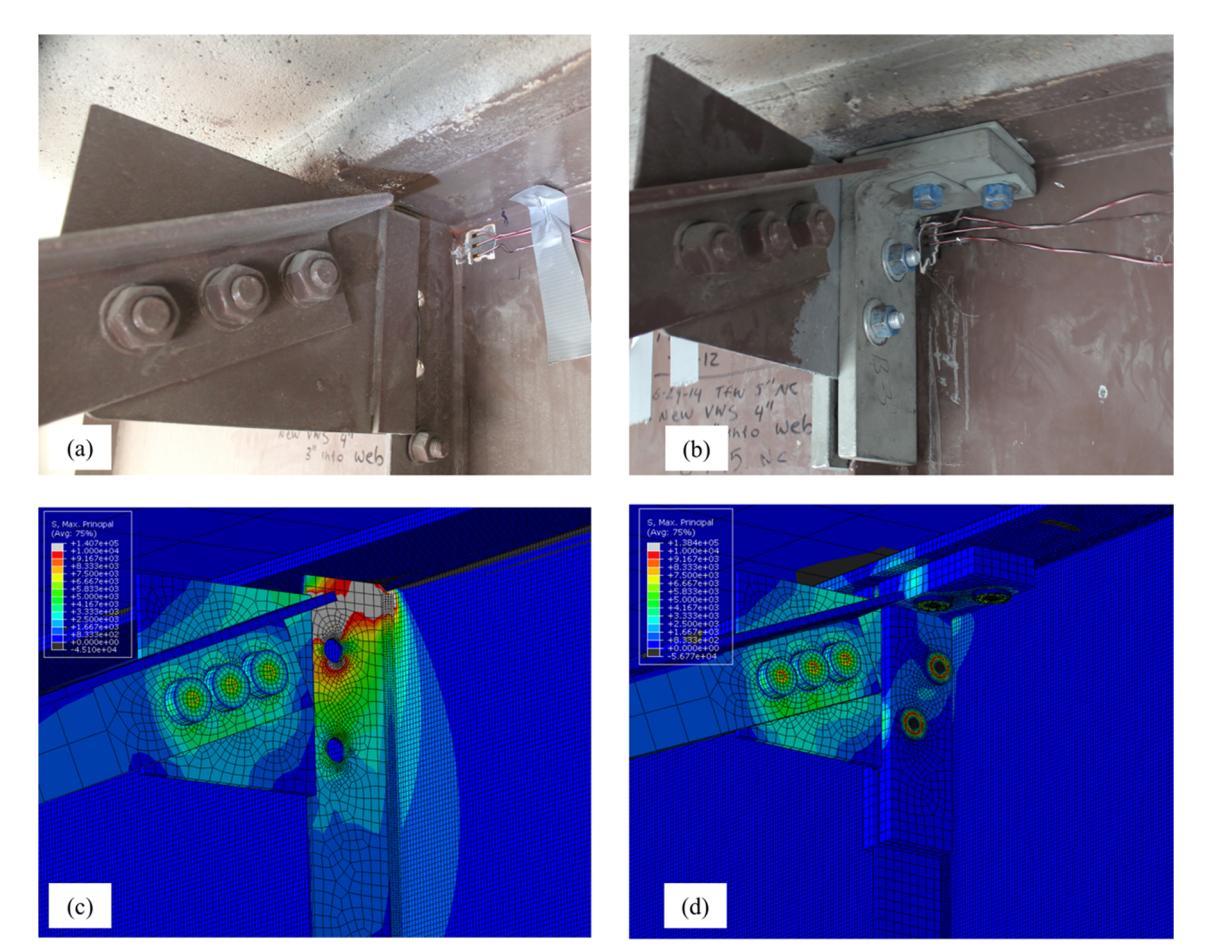
The bridge following the repair was simulated by modifying the verified FE model of the bridge prior to the repair. Fig. 18 shows the FE models with views of the instrumented web-gap region of G2 before and after the repair. For consistency purposes, a similar truck was used for loading both models.

Fig. 18. Web-Gap instrumentations for the (a) first field test, (b) second field test, stress distribution obtained from FE for the (c) model before repair, and (d) model after repair.
