First application of reinforced concrete in Spain and first European application in bridges: The rehabilitation of the Roman bridge of Alcántara

Juan Pedro Cortés-Pérez^{a,*}, Mario Núñez-Fernández^a, Alfonso Cortés-Pérez^b, Montaña Jiménez-Espada^a

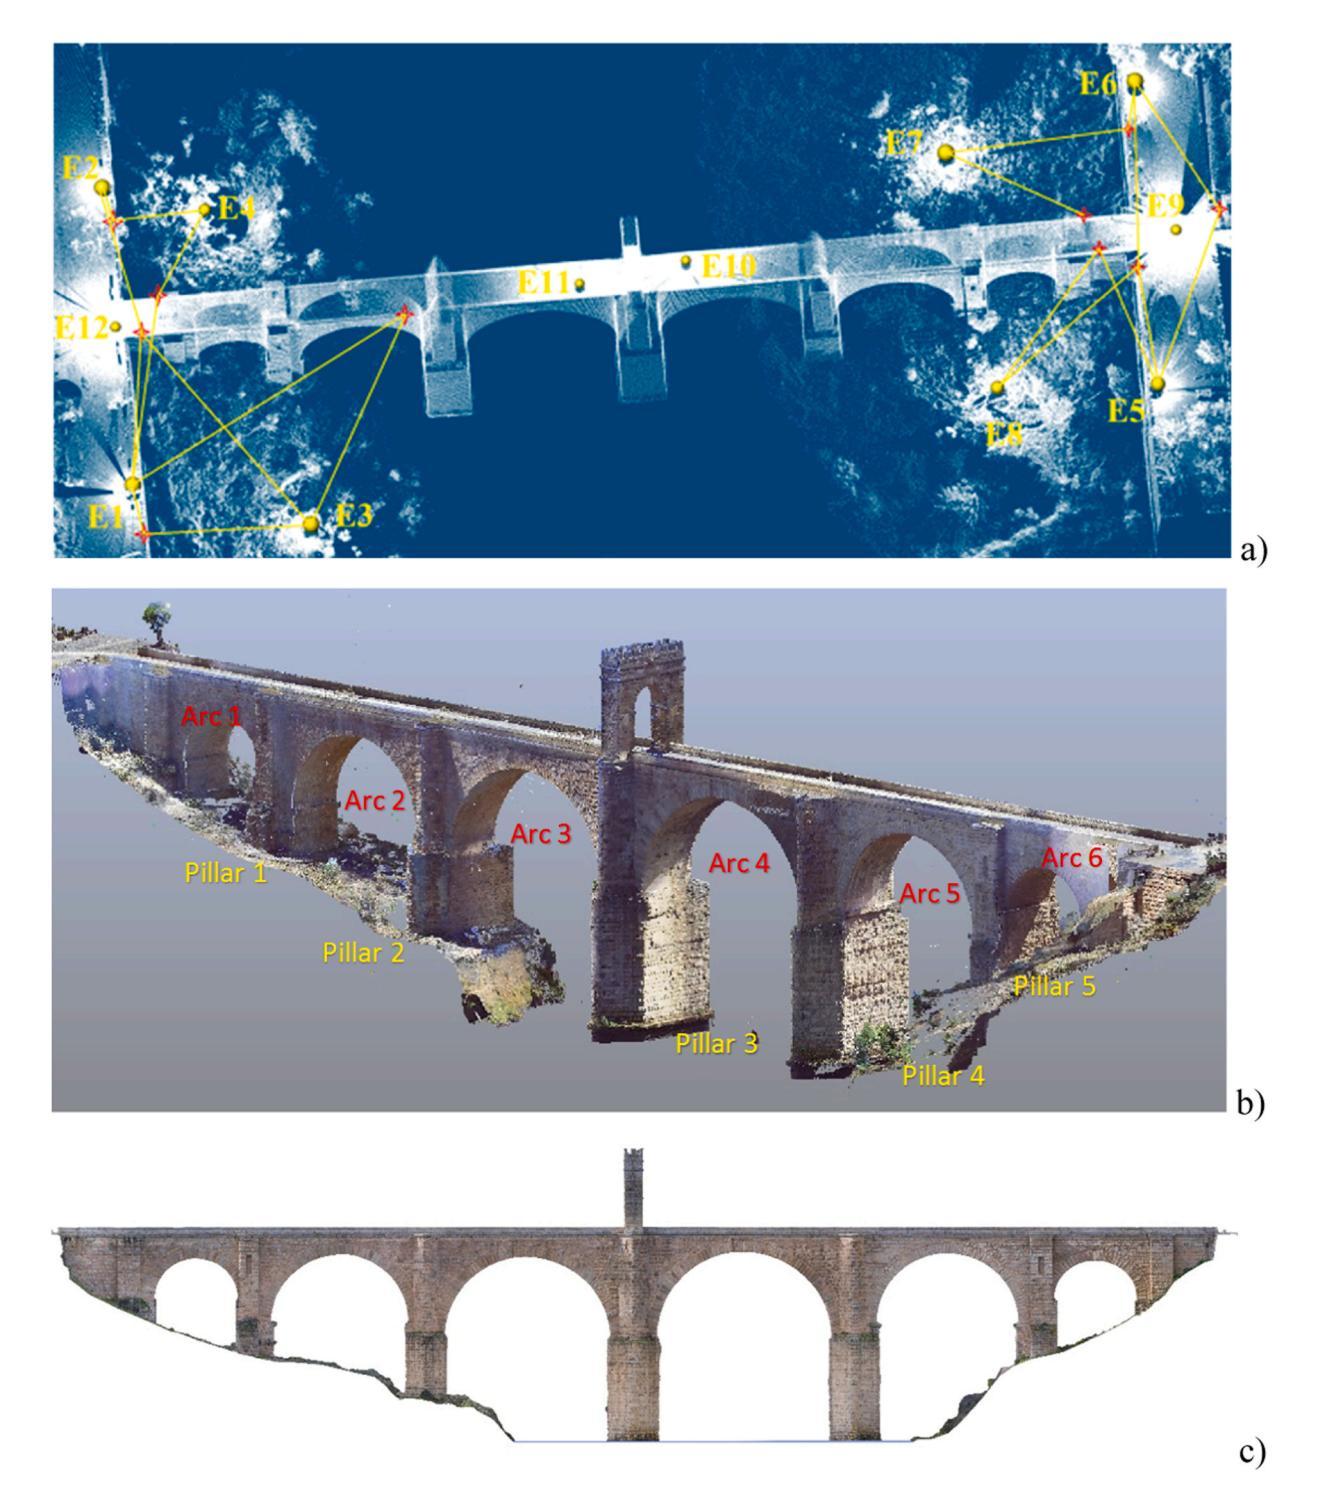
Fig. 1. Images of the surveys carried out a) 3D view of the point cloud made in the survey from the upstream right bank, with nomenclature of arches and piers (2015), b) 3D view of the point cloud and positions of the scanning points and c) orthophotography of the upstream elevation from the drone survey (2017).

Fig. 1 shows several images of the upstream elevation of the bridge obtained from the laser scanner survey and different photographs of intervention areas on the bridge. In the Fig. 1.a the positions of the laser scanner can be seen in the 2015 shot, which condition the definition of certain areas. In Fig. 1.b the 3D view of the 2015 survey with the nomenclature of arches and piers is shown. It shows areas with low definition, e.g. the soffit and spandrel of arch 4. In Fig. 1c, is the orthophotography of the upstream elevation of the bridge obtained from the 2017 drone survey, in which the accuracy is much higher than the previous ones.
