# **Engineering Failure Analysis**

## Structural damage assessment of reinforced concrete buildings in Adıyaman after Kahramanmaraş (Türkiye) Earthquakes on 6 February 2023

## Ozan İnce

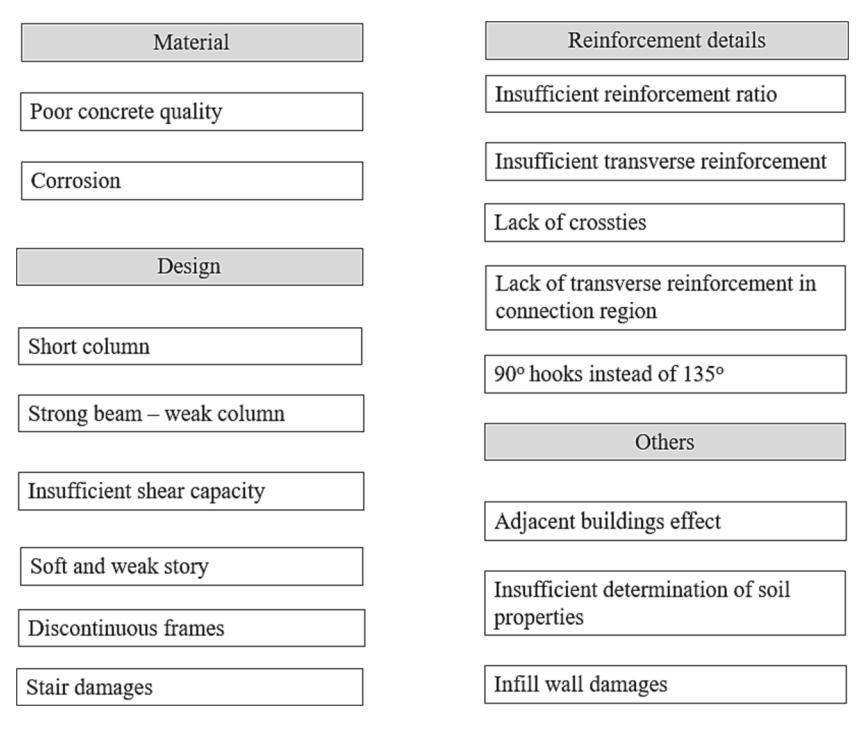
Fig. 9. Classification of damage reasons of RC buildings.

Deficiencies during the design phase can potentially harm reinforced concrete buildings. Many damages have been observed due to reasons such as the discontinuity of the frames, the inability to provide strong column-weak beam condition, soft and weak story effect, short column effect and low shear strength of the elements. In addition, serious damage was observed in many buildings due to the adjacent buildings, which was not taken into account during the design phase. Under this title, the reasons that adversely affect the earthquake performance of reinforced concrete buildings are examined in detail and figures of the field investigations are given (Fig. 9).

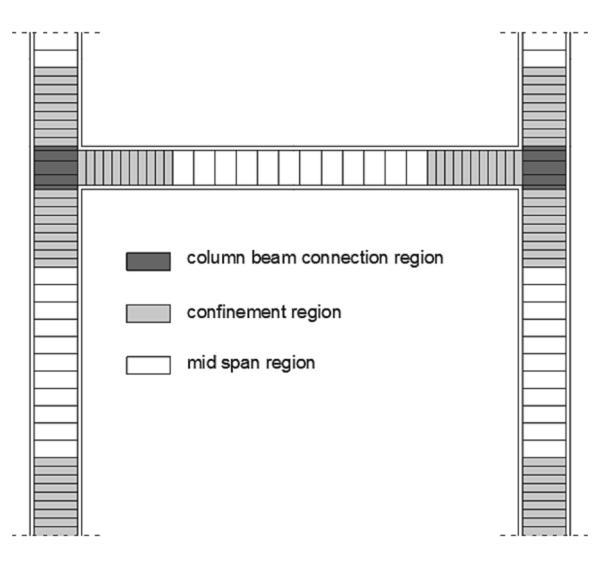
Fig. 12. Regions of transverse reinforcement for RC elements.

Türkiye Earthquake Codes (TEC-1975, TEC-1998, TEC-2007 and TEC-2018) defines there region for reinforced concrete elements. Column-beam connection region, confinement region and mid-span region is defined in these codes (Fig. 12). Türkiye Earthquake Codes requires that column transverse reinforcements should be continued within the column beam connection area. However, even in buildings constructed after 2010, lack of transverse reinforcement of column-beam connection was frequently observed (Fig. 13).

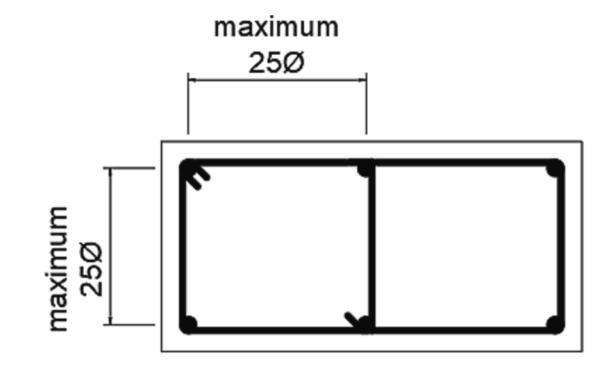
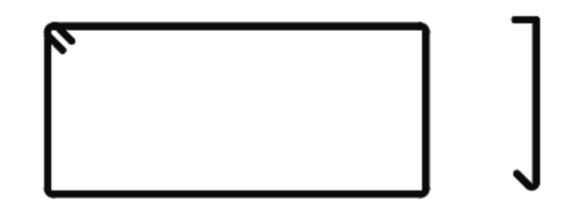
Fig. 15. Detail example of transverse reinforcement.

Türkiye Earthquake Codes requires that distance between transverse reinforcement arms should not exceed 25Ø (Ø: diameter of transverse reinforcement) (Fig. 15). However, in field observations, transverse reinforcement generally observed only around of column (Fig. 16).

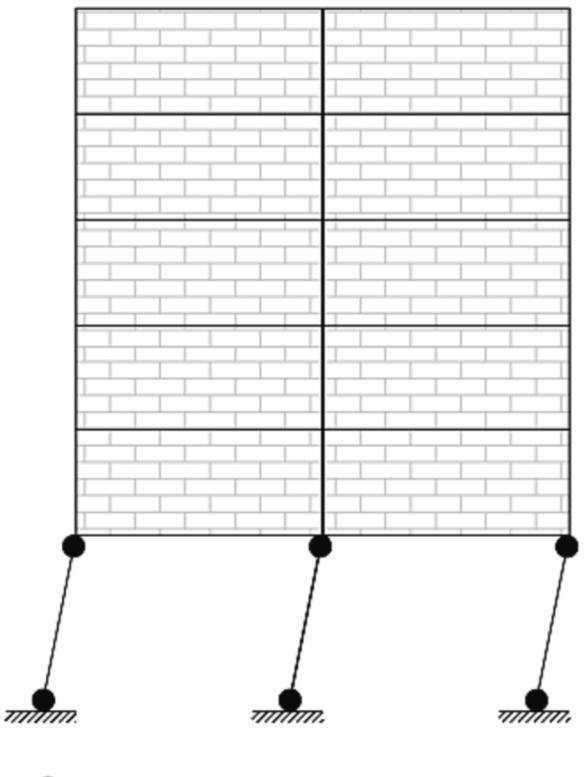
Soft and weak story irregularities are caused by the lower horizontal stiffness of any story than the other stories in multi-story buildings. Generally, in story used for commercial purposes, increasing the height of the first floors (up to 5.5 m) and removing the infill walls significantly reduces the rigidity of this floor. Earthquake damages are concentrated in this floor, which shows weak

Fig. 17. Soft and weak story damage mechanism.

## strength and more displacements (Fig. 17).

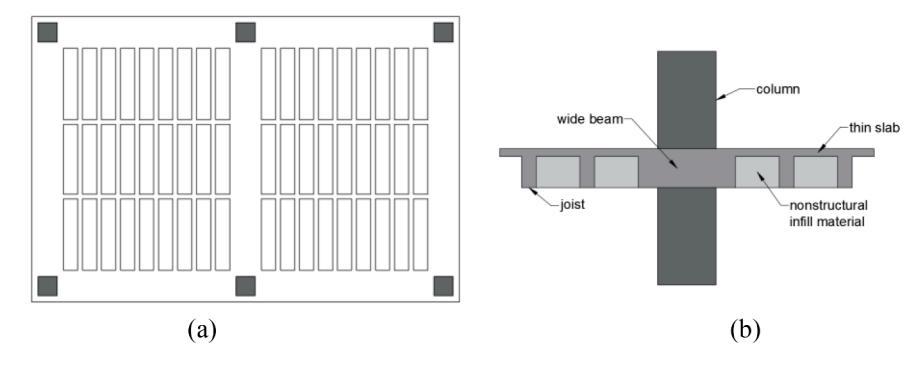
Using of one way joist slab is limited by Türkiye Earthquake Codes. TEC-1968 prohibited the construction of reinforced concrete buildings with one way joist slab in 1st and 2nd degree earthquake zones [28]. TEC-1975 allows to using of this slab type, in case the building height exceed certain limit, shear walls should used in this building. TEC-1998 and TEC-2007 allow to using of one way joist slab with condition of high ductility design or using of shear wall in 1st and 2nd degree earthquake zones. TBEC-2018 limits height of building designed with one way joist slab.

Reinforced concrete buildings with shallow beams are frequently used in Adıyaman. In field observations, it is seen that

Fig. 25. One way joist slab.

nonstructural infill material used in one way joist slab is generally chosen as heavy materials instead of light material. Using of the heavy filling material increases the weight of the building and thus negatively affects the earthquake performance.

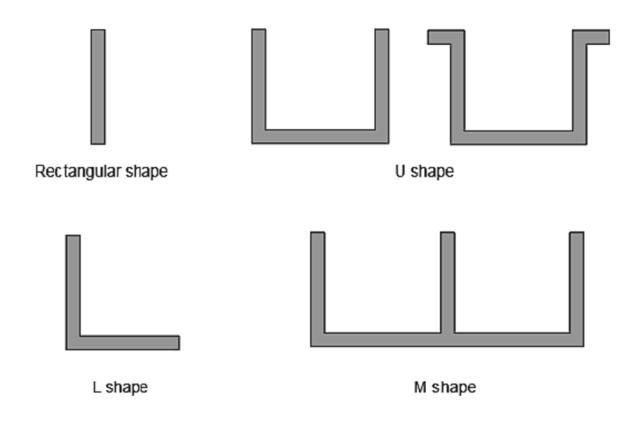
Fig. 27. Shear walls shapes commonly used in Türkiye.

Shear walls shapes commonly used in Türkiye can be seen in Fig. 27. U shaped shear walls generally preferred for elevator in buildings. Shear wall damages in buildings were commonly seen in U shape shear walls used for elevator. Because, these building commonly have only U shape shear wall for elevator. Therefore these wall carries most of lateral load.

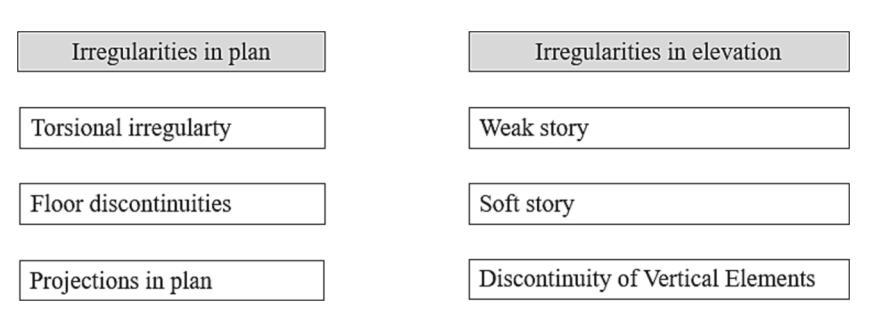
For earthquake resistant building design, Irregularities should be avoided. TBEC-2018 defines irregularity in plan and in elevation (Fig. 37). As depicted in Fig. 37, irregularities in plan divided in three sub-sections, torsional irregularities, floor discontinuous and projections in plan. The other type of irregularity is defined as irregularities in elevation which is detailed in the sub titles of soft and weak story and also discontinuity of vertical elements. Except these irregularities, there are some design mistakes that have a negative effect on earthquake performance of buildings such as discontinuous of frame elements.

Fig. 37. Buildings irregularities defined in TBEC-2018.

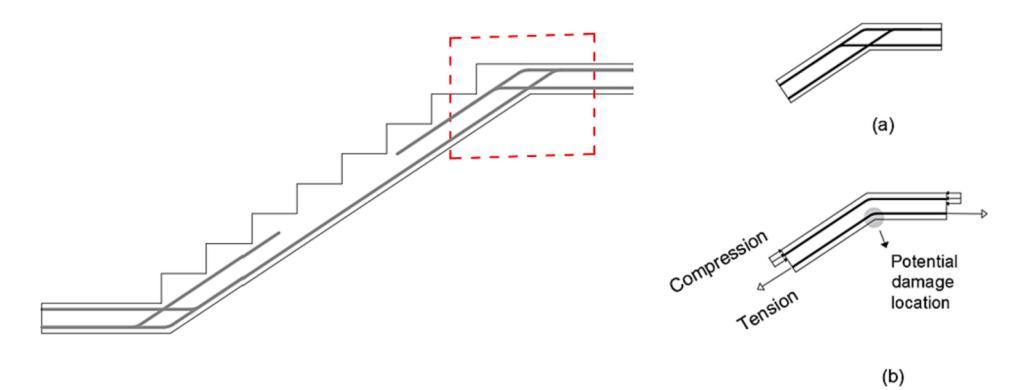
Reinforced concrete stairs are widely used in buildings from one floor to another. Stair landings should be supported by vertical bearing element to transfer their loads properly. Insufficient support condition could cause damages to stair or vertical element. In Fig. 40, it can be seen that a damaged shear wall because of stair. Also stair reinforcement details should be designed as in Fig. 41 to effective working of reinforcement. Incorrect reinforced details cause separation between concrete and reinforcement. In field investigations, stair damages widely observed by incorrect reinforcement detail (Figs. 42-43).

Fig. 41. Stair reinforcement detail a) proper b) incorrect.
