Full-Scale Cyclic Testing of a Low-Ductility Concentrically-Braced Frame

Conference Paper · July 2015

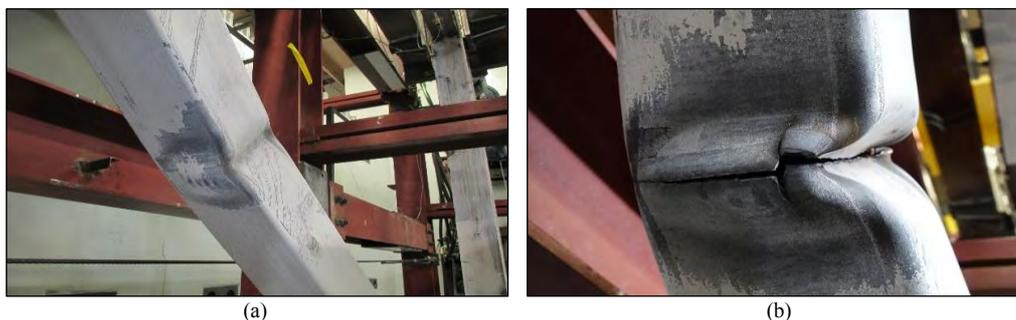
Figure 5. Story 2 North brace buckling: (a) initial buckling; (b) end of test.

The frame remained elastic during the first six cycles, P01-P06 (up to $\pm 0.30\%$ frame drift, or ± 27.4 mm [1.08 in] Level 3 displacement). While pushing the frame North to a target total displacement, δ_r , of 32 mm [1.26 in] in cycle P07n (see Table 1), global buckling occurred in the Story 2 North brace (Figure 2). The buckling limit state was brittle, resulting in a sudden drop in base shear from 2060 kN [464 kip] to 665 kN [150 kip]. This caused the frame to move forward past the target drift of 0.35% drift to nearly 0.45% drift. Upon cycling the frame back to zero load, permanent deformation was visible in the brace (Figure 5a). Significant flaking of whitewash was also apparent at the brace mid-span, identifying that it had yielded and buckled locally. This yielding and buckling were localized approximately to an area extending to one section width (203 mm [8 in]) in each direction from the mid-span.

Next, the original loading protocol was resumed in an attempt to fracture one of the buckled Story 2 braces in tension. The Story 2 drift reached peak positive and negative values of +2.00% and -1.50% before the half-cycles needed to be stopped as the braces had buckled over 300 mm [12 in] out of plane and were beginning to laterally bear on the test unit's stabilizing frame (Figure 1). Unable to further increase the drift, the frame was subjected to 33 fatigue cycles under *Loading Pattern P*, causing the braces to degrade significantly to a point where only a single face of the original HSS section remained (Figure 5b). However, the braces never fractured through the full section. As the brace sections deteriorated from repeated cycling (P10-P42), the gusset-to-gusset length of the braces effectively decreased, resulting in a Level 3 beam midspan deflection of -51mm [-2 in] at the end of the fatigue

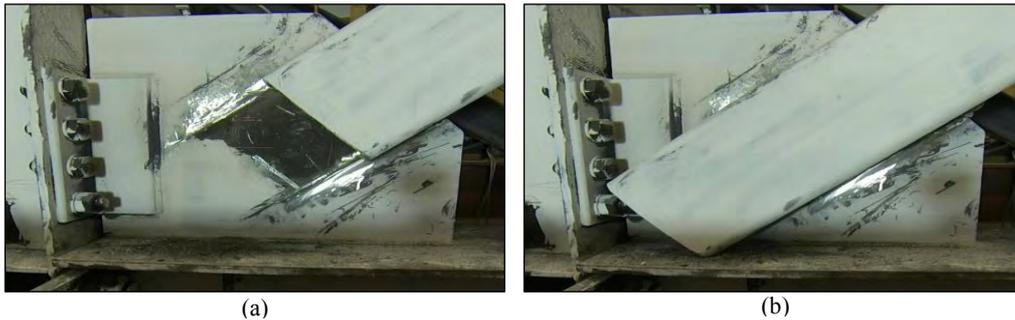
Figure 6. Story 1 North brace connection following weld fracture: (a) brace detachment; (b) brace re-engagement.

After weld fracture was induced, the frame was cycled in $\pm 0.5\%$ Story 1 drift increments, still from the Level 2 only (with $F_{A3} = 0$). In the positive (North) direction, the fractured Story 1 South brace was pulled in tension, only capable of transferring force through friction with the gusset plate (Figure 6a). As the fractured brace could not take much demand through friction, the Level 2 beam carried a significant amount of demand in these half cycles (P06n-P11n) through flexural hinging at the midspan. During these half cycles the frame exhibited behaviour similar to that of an eccentrically-braced frame (EBF); the half of the Level 2 beam corresponding to the side of the fractured brace underwent significant flexural deformations similar to those experienced by long “flexural links” found in EBFs. As shown in Figure 4, this behaviour was very ductile, with a stable strength plateau up to 6% Story 1 drift.

In the negative (South) direction, the frame remarkably retained nearly the entirety of its original stiffness, as the fractured brace re-engaged onto the gusset plate (Figure 6b), providing a mechanism for transferring load in compression. As the brace continued to bear on the gusset plate, the slot length grew from the gusset cutting through the brace. As the frame was pushed further and the gusset plate cut further through the brace, the bearing surface grew due to flattening of the deformed steel (Figure 7a), further increasing the capacity of the fractured brace in compression. Eventually, at large negative drifts (P09s), the gusset cut through the brace by such an amount that the brace began to bear on the flange of the beam, even further increasing the bearing surface. When Story 1 was pushed to a total of 3% positive drift (P10n), the brace slipped off the gusset plate and deflected out of plane, preventing any further studies on brace re-engagement. The frame was then pushed North the maximum amount possible, to $\delta_1 = 6\%$, ending the test. During this final cycle (P11n), significant column bending was observed, resulting in yielding at the base of the Story 1 South column (Figure 7b).

flange (Figure 6b). Another interesting observation from this test was the durability and longevity of the EBF-like behaviour following weld fracture. This mechanism withstood story drifts of up to 6% in this test, implying that there is significant reserve capacity through this combination of beam and column flexure.

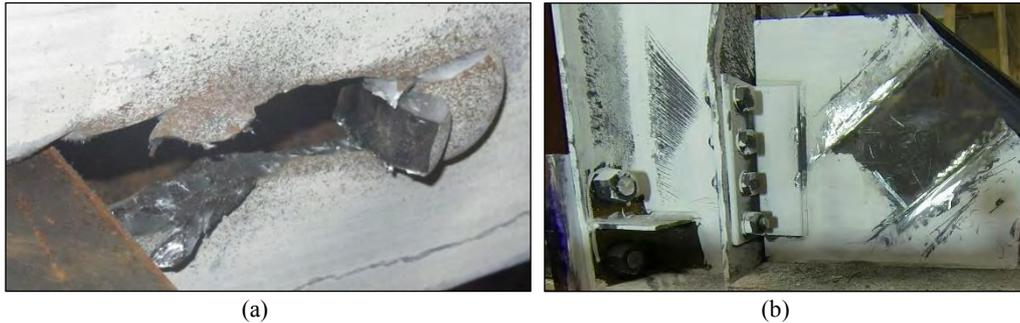
Figure 7. Post-test observations: (a) HSS bearing on the gusset plate; (b) column hinging from large story drift.

Hysteretic behaviour of Story 1 following an induced brace-to-gusset weld fracture revealed that the story regained nearly all of its original stiffness when the brace was bearing on the gusset plate (Figure 4). The bearing capacity was not simply capped by the original surface area of the HSS thickness acting over the gusset plate, but rather increased substantially throughout the test as the effective bearing surface of the brace increased due to local deformation (Figure 7a) and contact with the gusset plate and the beam
