## Bridges crossing fault rupture zones: A review

Shuo Yang, George P. Mavroedis\*

Several earthquakes over the past two decades have demonstrated that bridges crossing fault rupture zones may suffer significant damage due to the combined effects of ground shaking and surface rupture. Although it is widely recommended to avoid building a bridge across a fault, it is not always possible to achieve this objective, especially in regions with a dense network of active faults. This review begins by compiling two databases: one of fault-crossing bridges damaged in past earthquakes and another of bridges crossing potentially active fault rupture zones. The article then continues to review findings of experimental, analytical and numerical studies, and to summarize seismic design provisions and recommendations related to fault-crossing bridges. The review ends with suggestions for future research directions in this area.

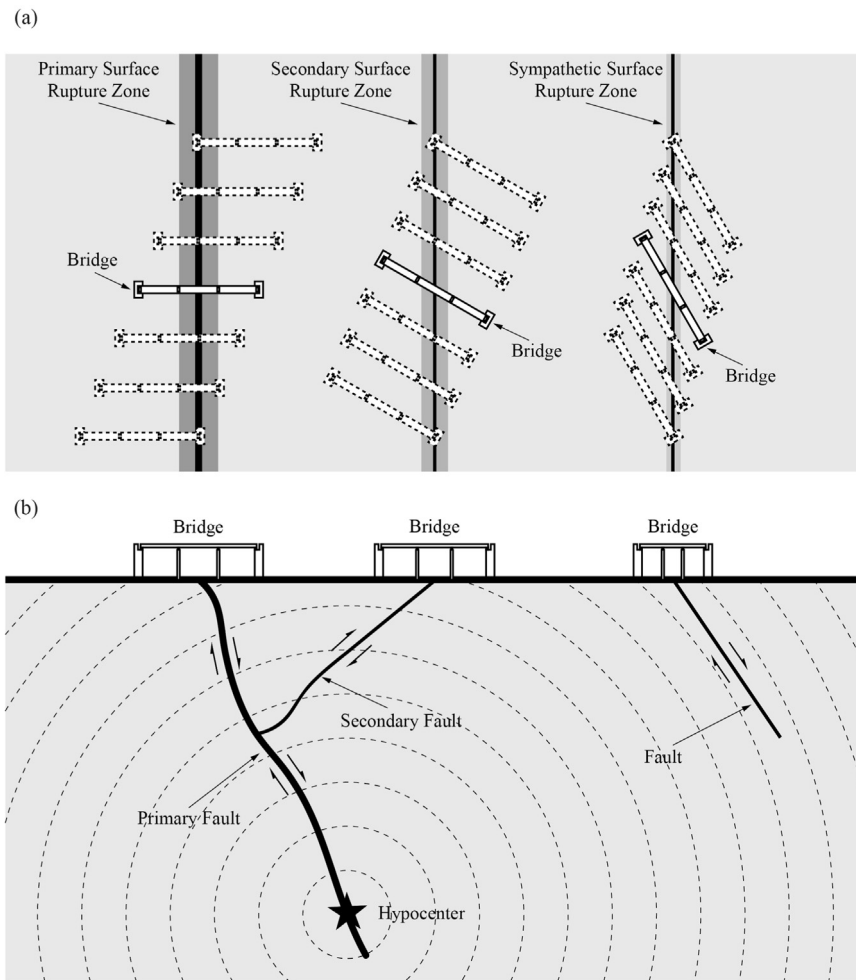
**Fig. 1.** Schematic of bridges crossing surface fault rupture zones: (a) plan view showing different fault crossing angles and locations; (b) cross-section showing different types of fault rupture (primary, secondary, and sympathetic).

the vibratory ground motion. It is noted that a surface fault rupture should not be viewed as a fault line, but rather as a fault zone with a finite width subjected to ground distortion. In this study, a fault-crossing bridge is defined as a bridge structure traversed by a surface fault rupture zone (primary, secondary or sympathetic) passing beneath any portion of the bridge (span, pier, abutment or approach road) (Fig. 1).

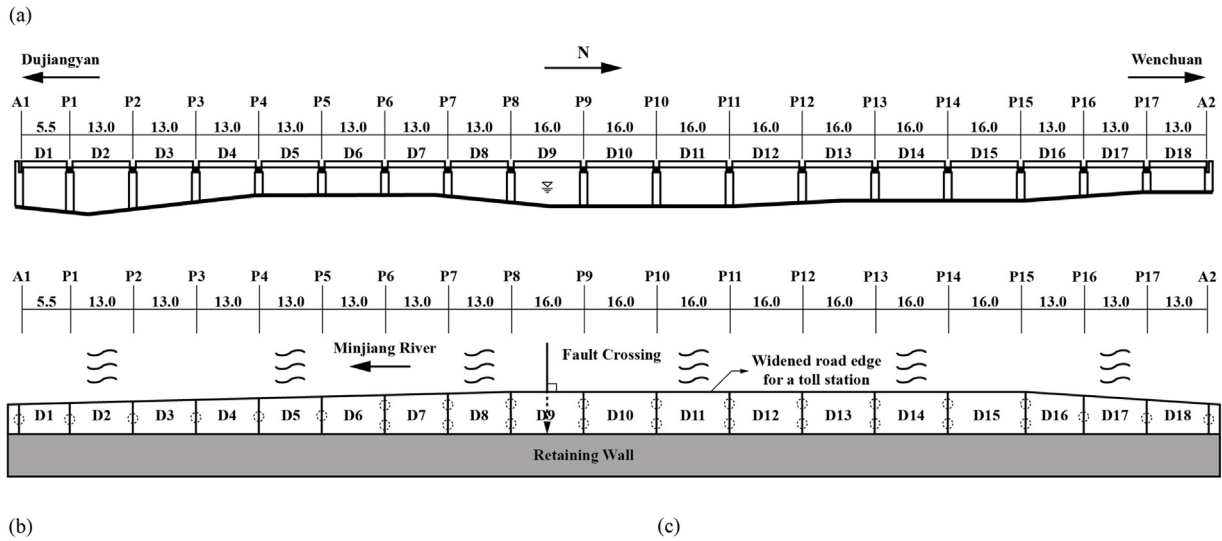
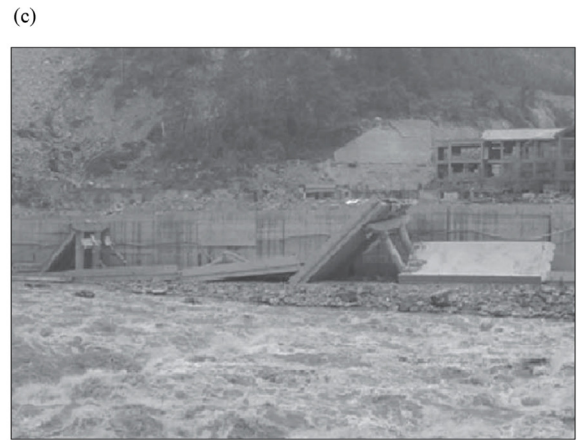
Fig. 14. Gaoshu Bridge during the 2008 Wenchuan earthquake: (a) elevation and plan views of original bridge (unit: m); (b) map showing bridge crossed by surface fault rupture; (c) collapsed bridge (Fig. 14a is generated based on information provided by Hui [53]; Fig. 14b is modified from Hui [53]; Fig. 14c is reprinted from Zhao and Taucer [149]).

The Gaoshu (Yingxiushunhe) Bridge – located in the town of Yingxiu and oriented parallel to the Minjiang River – was an approximately 248-m-long, 18-span, simply-supported, reinforced concrete hollow-slab bridge supported by single-column (A1, P1–P5, P16, P17, and A2) and double-column (P6–P15) piers on pile foundations (Fig. 14a) (e.g., [152,82,53]). With the exception of its deck that was under construction, the bridge was almost complete when the 2008 Wenchuan earthquake occurred. As shown in Fig. 14a and b, the surface fault rupture crossed the bridge between piers P8 and P9 at a nearly right angle [130,132,145,53]. The permanent ground displacements in the horizontal and vertical directions induced by the surface fault rupture were approximately 1 m and 0.5 m near the bridge. These significant residual displacements resulted in the collapse of span D1 followed by the collapse of the remaining spans, as shown in Fig. 14c [130,53]. In addition, flexural-shear failure was observed at the top of several piers [130].

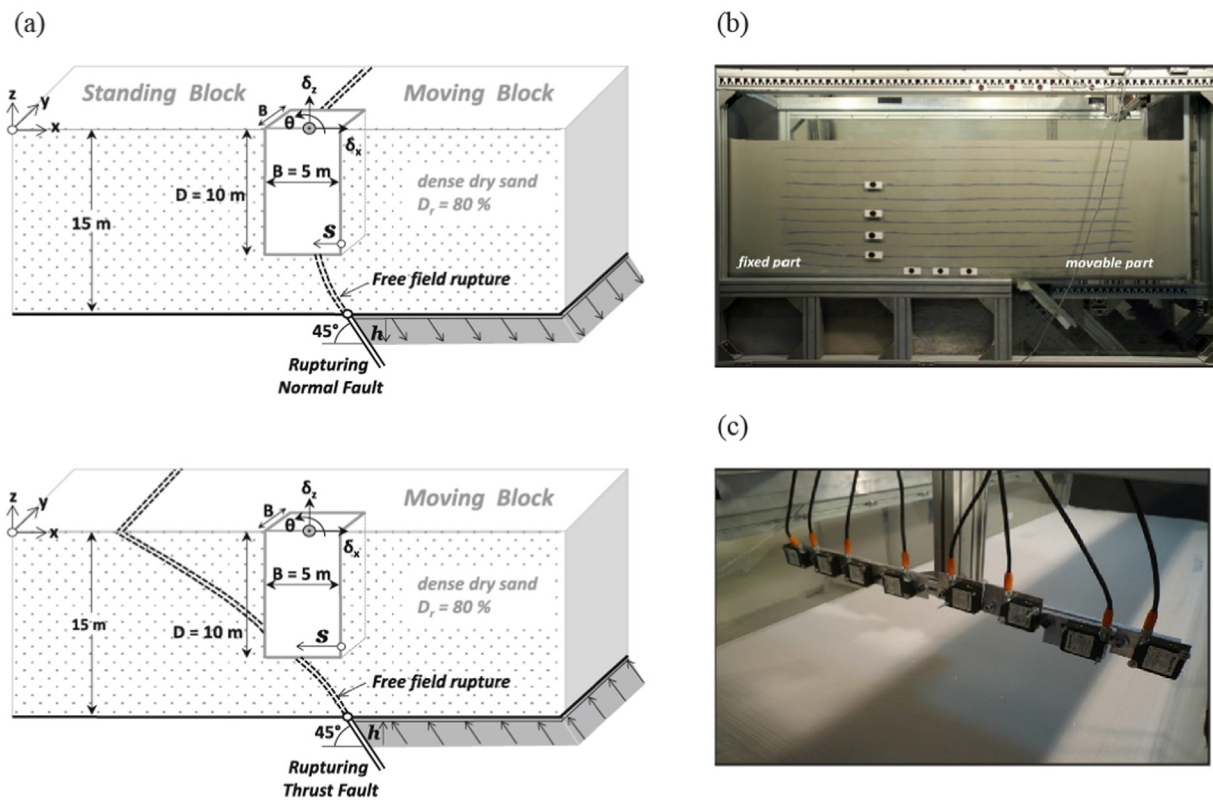
Fig. 18. Experiment of a small-scale (1/20) bridge-pier caisson foundation subjected to dip-slip (normal or reverse) faulting: (a) basic parameters and dimensions at prototype scale; (b) fault rupture box used for experiments; (c) moving row of laser displacement transducers used for scanning the deformed ground surface (all figures are reprinted from Gazetas et al. [35]).

Gazetas et al. [35] explored the key mechanisms affecting the response of a bridge-pier caisson foundation subjected to dip-slip (normal or reverse) faulting. A series of small-scale (1/20) physical model tests were conducted to investigate the response of a square in plan reinforced concrete caisson foundation of prototype dimensions  $5\text{ m} \times 5\text{ m} \times 10\text{ m}$ , fully embedded in a 15-m deep layer of dry dense sand. The bedrock was subjected to tectonic dislocation due to a  $45^\circ$  dip-slip (normal or reverse) fault with a vertical offset  $h$  (Fig. 18a). The tests were conducted in a fault rupture box equipped with a fixed and a movable part, which would simulate normal or reverse faulting by moving downward or upward (Fig. 18b). The fault offset  $h$  was imposed slowly in small consecutive increments. After each increment, a high-resolution digital camera was used to photograph the deformed physical model, and the digital images were then processed using the particle image velocimetry technique to compute the caisson displacements and the soil deformation. In addition, a moving row of 8 laser displacement transducers (Fig. 18c) was utilized to produce the surface topography of the deformed ground after each increment. The results showed that a fault rupture (whether normal or reverse) propagating into the soil interacted with the rigid caisson foundation producing new failure mechanisms (diversion, bifurcation, and diffusion). The developing failure mechanisms were shown to depend on the type of faulting, the magnitude of the fault offset, and the exact location of the foundation relative to the fault.
