## Experimental research on fire-damaged RC continuous T-beams subsequently strengthened with CFRP sheets

Qingfeng Xu<sup>a,\*</sup>, Lingzhu Chen<sup>a</sup>, Chongqing Han<sup>b</sup>, Kent A. Harries<sup>c</sup>, Zhimin Xu<sup>b</sup>

This paper presents experimental results of the structural performance of fire-damaged continuous reinforced concrete (RC) T-beams subsequently strengthened with externally bonded carbon fiber reinforced polymer (EB-CFRP) sheets. A series of seven specimens were tested with different fire exposure time and subsequent strengthening techniques. Experimental results showed that both the unexposed control beams and un-strengthened fire-damaged continuous RC T-beams exhibited flexure failure modes and significant redistribution of moment between hogging and sagging regions. The fire-exposed beams had notably degraded strength and stiffness attributable to the internal temperatures exceeding 500 °C for some portion of the exposure. The EB-CFRP strengthening of fire damaged beams was shown to mostly mitigate the effects of fire exposure. The EB-CFRP retrofit measures successfully restored the virgin capacity of the beam and were sufficient to also resto

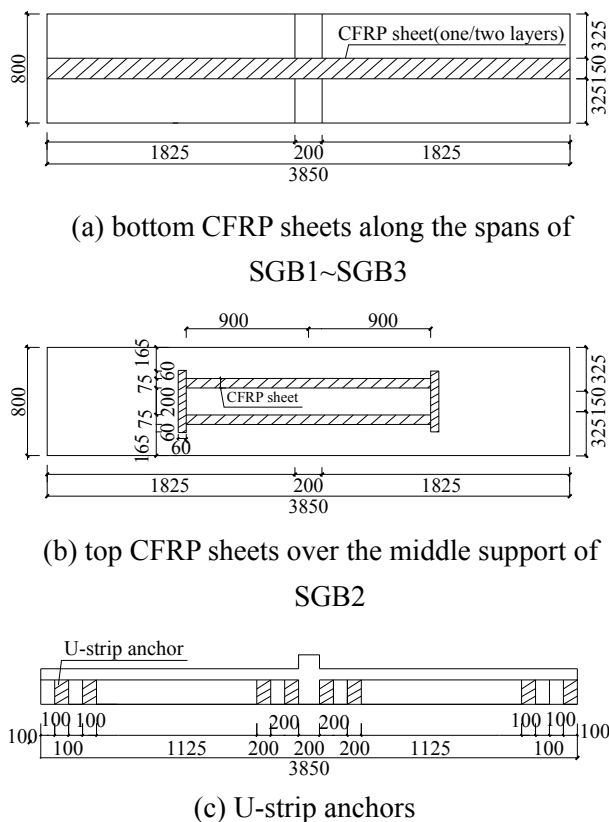
Fig. 2. Arrangement of EB-CFRP sheets.

cover concrete – following exposure to the standard fire for 60 and 90 min, respectively. Specimens SGB1 ~ SGB3 were repaired and strengthened with different arrangement of CFRP sheets following exposure to the standard fire for 60 or 90 min, and then loaded to failure. Specimen SGB1 (Fig. 2a) was strengthened with one ply of EB-CFRP at the bottom face (soffit) of the beam along the whole span following 60 min standard fire exposure. Specimen SGB2 was the same as SGB1 except for the additional provision of one ply EB-CFRP over the middle support (top of slab) as shown in Fig. 2b. Specimen SGB3 was strengthened with two plies of EB-CFRP sheets at the bottom face along the whole span following 90 min standard fire exposure. In all cases, the width of the bottom CFRP sheet was the same as the width of the girder stem: 150 mm (Fig. 2a). CFRP U-strip anchors, shown in Fig. 2c, were installed at each side support and at the middle support, to prevent premature peeling of the CFRP sheets. On the top surface of Specimen SGB2, two 75 mm wide and 1800 mm long EB-CFRP sheets were bonded at a distance of 200 mm (this replicates the need for the CFRP to be arranged outside of a column that would typically be at this location. These CFRP sheets were anchored with short CFRP strips as shown in Fig. 2b. A summary of specimen test parameters is provided in Table 1. As can be seen, the application of EB-CFRP increases the effective reinforcing ratio in the sagging region considerably (about 14% per ply).

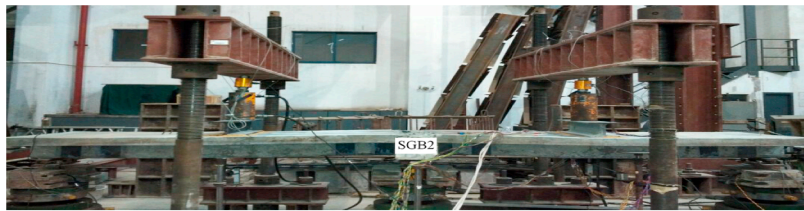
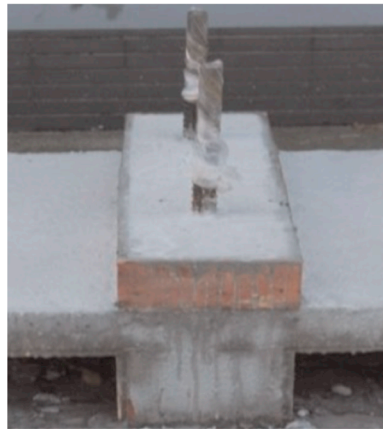
A: Load transducer B: Cushion block C: Steel rods D: End support E: Hydraulic load jack F: Steel box

(a) test setup

(b) photo of test setup

(c) detail of middle support

Fig. 3. Test setup and transducer locations.

Since the specimens must span the furnace, the middle support of specimens was inside the furnace exposed to fire directly. To permit the measurement of reaction force at the middle support (using force transducers outside the furnace) and to avoid effects of potential failure of the middle support, the middle support was suspended (anchored outside the furnace) as shown in Fig. 3(c), an approach successfully

The fire-exposure experiments were carried out in a horizontal furnace with the test setup shown in Fig. 3. The age of concrete during fire-exposure experiments was 60 days. Five specimens were exposed to fire for either 60 min or 90 min, with the furnace temperature programmed to follow the ISO 834 standard fire curve [18]. As shown in Fig. 4, the furnace temperature matched the standard curve very well. Specimens were cooled to ambient temperature following heating. During the fire exposure and for 180 min thereafter, a 41 kN load was applied at the middle of each (sagging) span as shown in Fig. 3. This load was selected as being 30% of the average ultimate load of the control specimens GB1 and GB2. The load was distributed evenly across the 800 mm width of the concrete slab using steel spreader beam laid below the loading jack. The tension in the middle rod (hogging region) required to maintain the condition of no deflection at this point relative to the end supports was 56.4 kN. The actual applied loads and reactions were recorded with load transducers placed at each support and each load point. Displacement transducers (LVDTs) were attached to the supports and the load points to monitor the vertical displacements at

these locations during fire exposure and subsequent cooling. The load tests to failure following fire exposure were conducted using the same test arrangement (Fig. 3) but with a simple support beneath the middle (hogging) region of the beam; this is seen in subsequent Figures describing test results.

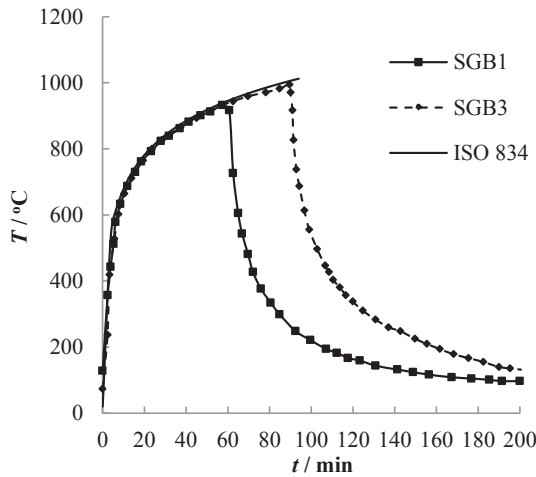
Fig. 4. Comparison between the measured furnace temperature and the ISO 834 standard fire curve.

Comparison between the measured furnace temperature and ISO 834 standard fire curve was shown in Fig. 4, highlighting a good agreement between the furnace temperature and ISO 834 standard fire curve. Fig. 7 presents the temperature development with time for specimens FGB2 and FGB3, having 60 and 90 min fire exposure, respectively. Temperature development in the SGB specimens was similar for specimens with the same exposure time. It can be seen that the temperature close to the surface of the concrete increases rapidly during the heating phase and decrease sharply once the fire was stopped. Internal temperatures increase slowly and continue to increase after the fire was stopped. Due to the effect of corner rounding and two-sided exposure, the temperature at the corner (measurement A1) was much higher than the temperature (measurement C1) at the same distance to the concrete surface at the flange. The temperature field in the flange plate was similar to that of a one-side fire exposed RC slab, and the temperature field of the web was similar to that of a three-side fire exposed RC rectangular beam.

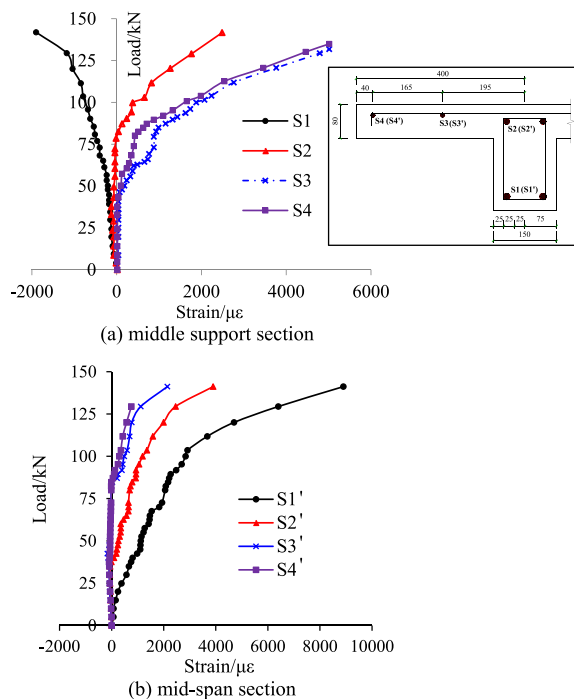
Fig. 11. Developments of steel reinforcement strains of GB1.

The strain data obtained from the internal reinforcing steel of specimen GB1 shown in Fig. 11 also confirm this interpretation of the

behaviour of these beams. At an applied load of 96 kN the primary reinforcement in the flange of the T-section (S3 and S4 in Fig. 11a) exceeded its yield strain (approximately  $2700 \mu\epsilon$ ) corresponding to the initial formation of the hogging region hinge. As seen in Fig. 9, the mid span deflection also began increasing at this stage as the internal forces are redistributed to the sagging moment region which retains some capacity; the bar strain at this stage in the sagging region (Fig. 11b) is approaching but remains below yield. As the applied load increased to about 104 kN, the primary reinforcement at the mid-span of the sagging region reached yield (S1 in Fig. 11b), indicating the formation of the second (and third) plastic hinge. Since concrete crushing ultimately controlled failure, the strain in the reinforcement at failure remained well below the fracture strain.

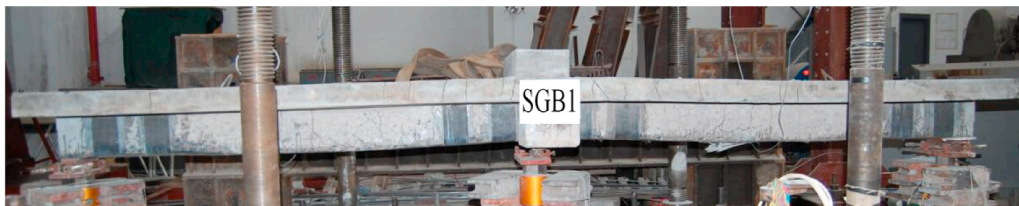
(a) deformed shape

Fig. 13. Failure mode of specimen SGB1.

Specimen SGB1 (Fig. 13), having a single ply of EB-CFRP reinforcing the sagging regions exhibited rupture of the CFRP in both spans (Fig. 13b and c). As seen in Fig. 13a, the beam did not develop a plastic hinge mechanism (spans do not have a V shape) although a hinge likely developed in the hogging region. Since this region was not strengthened, the capacity of the beam was limited and did not exceed the capacity of the virgin GB beams (Table 3). This observation confirms that the EB-CFRP was inadequate to develop the available capacity of the strengthened beam by facilitating sufficient moment redistribution.

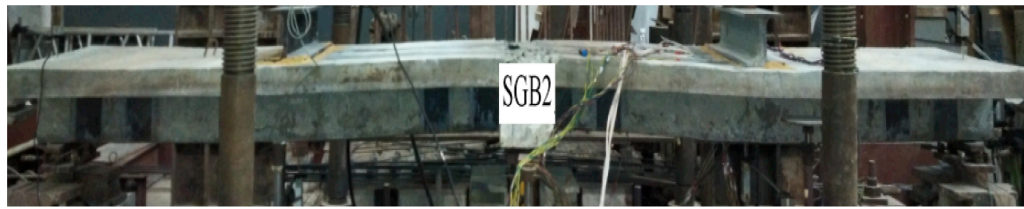
(a) deformed shape

Fig. 14. Failure mode of specimen SGB2.

The behaviour of SGB2 (Fig. 14), identical to the SGB1 with the exception of additional reinforcement in the hogging region at the top of the flange, supports the hypothesized explanation of behaviour of SGB1. At failure, the EB-CFRP sheets in the hogging region of SGB2 ruptured (Fig. 14b) followed horizontal cracks developing at the bottom of both sagging mid-span sections (Fig. 14c). The horizontal cracking is interpreted as a bond failure driven by the sudden redistribution of moment associated with the brittle rupture of CFRP in the hogging region. Peeling failure of concrete cover along the reinforcement level was prevented by restraint provided by the U-strip anchors.

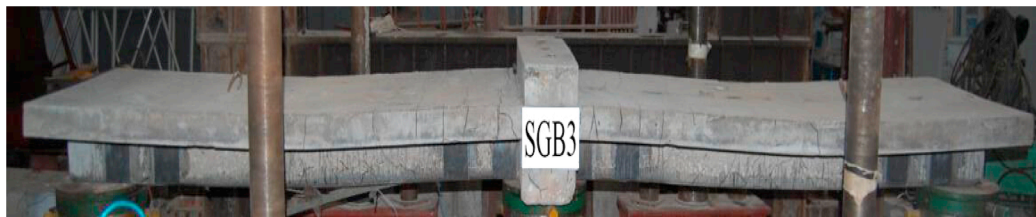
(a) deformed shape

Specimen SGB3 (Fig. 15) behaved in a manner similar to SGB1 but achieved a greater capacity (Table 3) resulting from the additional CFRP used in the sagging region. In SGB3, the failure was characterised as rupture of the CFRP. Due to the significant energy released, following rupture a length of about 1.1 m of CFRP peeled away from the substrate (Fig. 15b). The plane of this failure passed through the first few mm of repair mortar (seen in Fig. 15b) indicating a good adhesive bond was achieved both between the CFRP and repair mortar and repair mortar and substrate concrete.

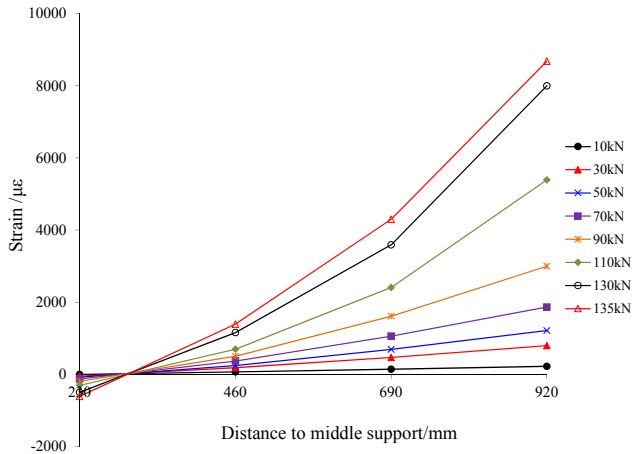
(a) bottom (sagging) CFRP sheet of SCB1

(d) top (hogging) CFRP sheet of SCB2

(b) bottom (sagging) CFRP sheet of SCB2

(c) bottom (sagging) CFRP sheet of SCB3

Fig. 16. Strain distribution of CFRP sheets along beam span.

The strain distribution in the CFRP sheets along the span is shown in Fig. 16. The distribution with increasing load illustrates a typical pattern and indicates a sound bond. The *in situ* rupture strain is observed to be approximately 8000  $\mu\epsilon$  (Fig. 16 a, c and d), approximately 55% of the tensile test rupture strain. This value is somewhat lower than expected; *in situ* rupture strain of anchored CFRP is often observed to approach the tensile test rupture strain [4]. This may be attributed to the fact that the strain gauges did not record the maximum strain along the span of the CFRP sheets because of there may be stress

concentration on the CFRP sheets and the limitation of the static data log system employed. In the sagging region of SGB2 where no debonding or rupture was observed, the CFRP strains only achieved about 6000  $\mu\epsilon$  indicating some reserve capacity likely remained at this

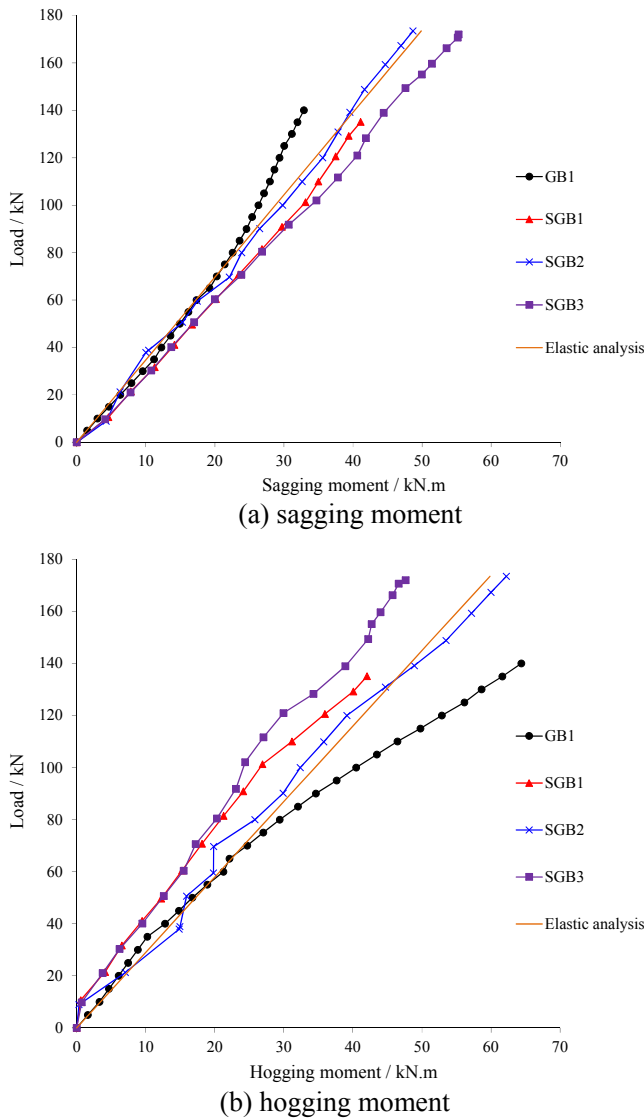
Fig. 17. Comparison of sagging and hogging moments from experiment and elastic analysis.

From the reaction forces measured during testing, the sagging and hogging moments were calculated as shown in Fig. 17 and Table 5. These were compared with the same moments calculated from an elastic analysis assuming uniform flexural stiffness along the span (Fig. 8). For control specimen GB1, at the early stages of loading, the measured sagging and hogging moments were close to those calculated

For strengthened specimens SGB1, SGB2 and SGB3, on the other hand, the hogging moments are mostly lower than the elastic predictions, while the sagging moments are mostly higher, even when the
