Composite box girder with corrugated steel webs and trusses – A new type of bridge structure

Composite box girders with corrugated steel webs and trusses is a new type of advanced bridge structure proposed recently. This kind of structure consists of a top concrete slab, corrugated steel webs and two bottom concrete-filled steel tubes connected by trusses. The resistance to torsion and overturning of this kind of structure is larger than that of composite bridges with a single concrete-filled steel tube. This kind of structure is able to satisfy the requirement of rapid construction, environment protection and cost effectiveness. Two composite box girder bridges with corrugated steel webs and trusses have been or are being constructed in China. This paper presents the design of these two bridges in detail, which will provide valuable engineering experience for the further promotion of this kind of new bridge structure. Experimental research has been carried out to study the flexural behavior and the flexural capacity of this kind of new bridge structure. The test results show that when the test beam is at the elastic stage, the cross-section can be viewed as a plane section if onl

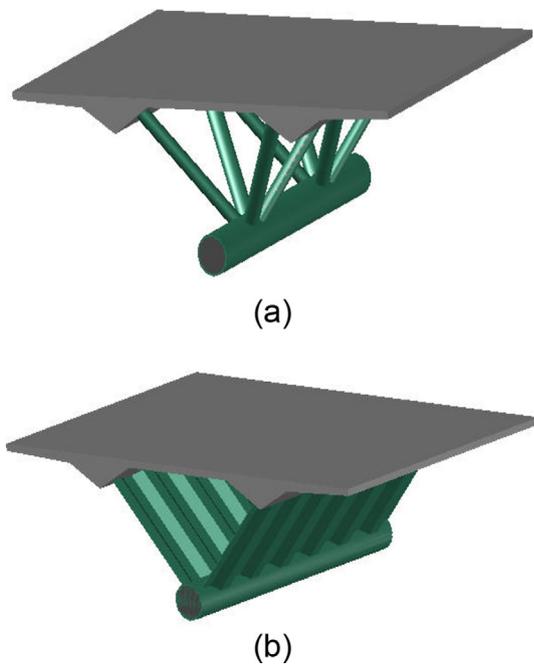
Fig. 1. Typical cross-section of (a) composite bridges with top concrete slab, trusses and bottom CFST; (b) composite bridges with CSWs and CFST.

The concrete box girder is one of the most commonly used structure forms for bridges because of its large flexural and torsional stiffnesses. However, with the increase of span length, the self-weight of a concrete box girder may increase rapidly, which restricts its use in long-span bridges [1]. One of the most promising ways to reduce the self-weight of bridges is to adopt steel–concrete composite structures. Nowadays, there are mainly three types of steel–concrete composite bridge structures: composite bridges with steel beams and top concrete slab, composite bridges with steel webs (or steel trusses) and top and bottom concrete slabs, and composite bridges with top concrete slab, steel trusses and bottom concrete-filled steel tube (Fig. 1(a)).

Concrete-Filled Steel Tube (CFST, Fig. 1(b)), where the trusses are replaced by corrugated steel webs so that the number of joints can be greatly reduced. The Maupré Bridge [2] constructed in 1988 in France is the first bridge of this kind. Chen and Gao [3] has shown that such an improvement increases the ultimate flexural capacity of the bridge by nearly 80%. Meanwhile, the adoption of corrugated steel webs significantly improves the mechanical performance of the structure (e.g. [4,5]). This has been shown in the comprehensive studies on the mechanical performance of composite girders with CSWs and top and bottom concrete slabs, including the flexural behavior (e.g. [6–9]), the shearing behavior (e.g. [10–12]), the torsional behavior (e.g. [13,14]), the dynamic properties (e.g. [15,16]) and so on.

However, there are still some limitations in the composite bridge with CSWs and CFST (Fig. 1(b)). First, as the cross-section is triangular, the torsional stiffness and the resistance to overturning is relatively small. Second, the space for some construction procedures such as the welding between the corrugated steel webs and the steel tubes is limited. To further improve this kind of structure, the composite box girder with CSWs and trusses is proposed. Fig. 2 shows a typical cross-section of this kind of structure. The most important feature is that the single concrete-filled steel tube in Fig. 1(b) is replaced by two bottom steel

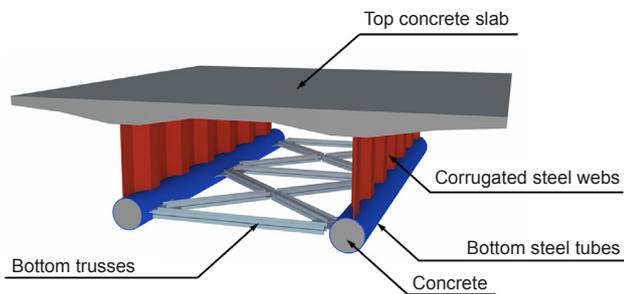
Fig. 2. Typical cross-section of composite box girders with CSWs and trusses.

tubes filled with concrete and connected by trusses, which may enhance the capability to resist torsion and overturning. The space for construction and maintenance within a bridge cross-section is also enlarged.

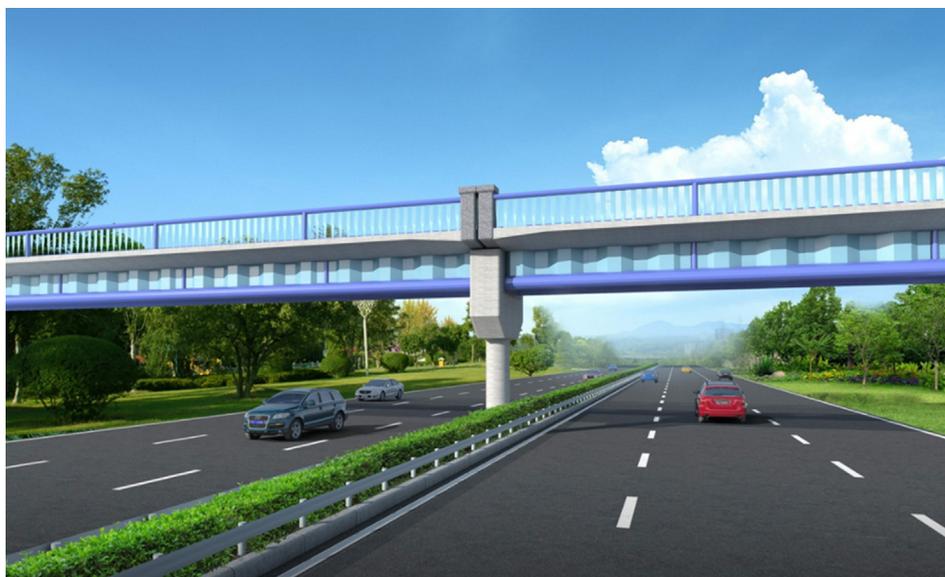
Fig. 3. A footbridge at Hebei Province, China.

The first composite box girder with CSWs and trusses that has been constructed is a footbridge located in Hebei Province, China, as shown in Fig. 3. It is a two-span simply supported girder bridge passing across the Beijing-Hong Kong-Macau Highway. This footbridge was designed by Shenzhen Municipal Design & Research Institute Co., Ltd.

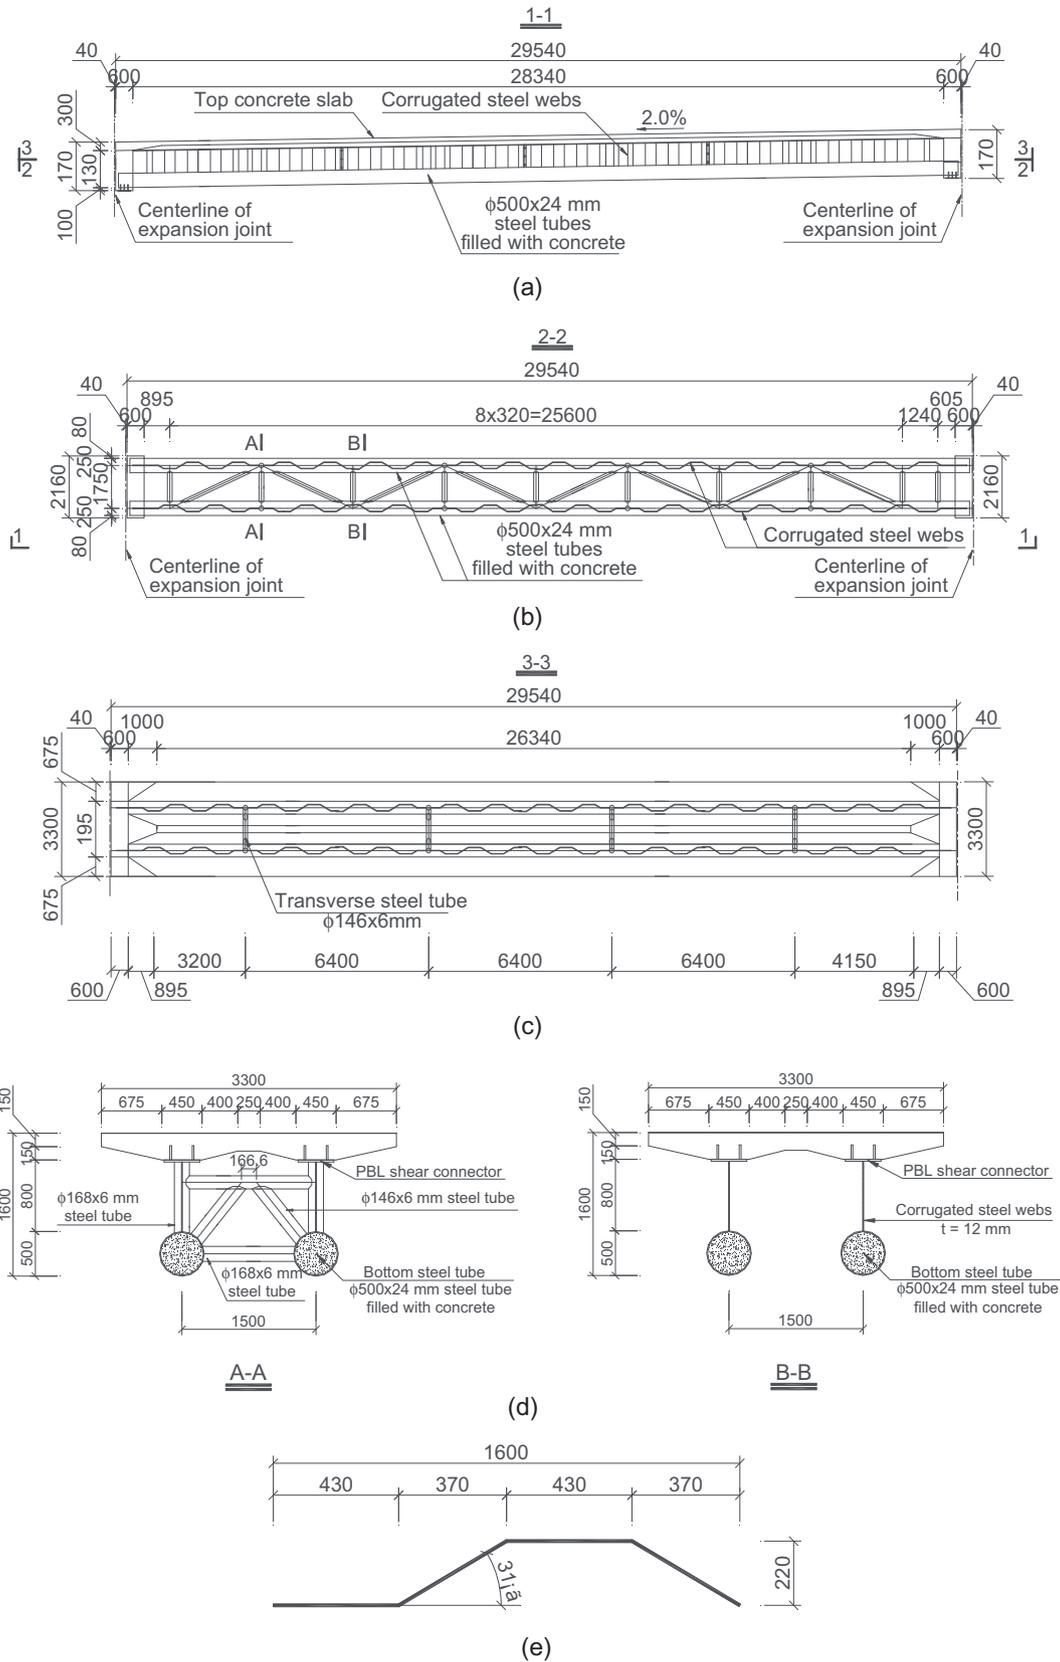
Fig. 4. Design of the footbridge (Unit: mm): (a) side view (Section 1-1); (b) Section 2-2; (c) Section 3-3; (d) typical cross-sections; (e) a corrugation of webs.

The structural designs of the two spans of the footbridge are basically the same. Fig. 4(a)–(c) demonstrate the structural design of one of the spans of this footbridge. The net length of each span is 29.54 m. The depth of the girder is 1.60 m. The width of the top concrete slab is 3.30 m. The slope along the longitudinal direction of the bridge is 2.0%. At the bottom of the footbridge are two bottom steel tubes connected by horizontal trusses consisting of transversal and diagonal braces. The distance between the centers of the two bottom steel tubes is 1.50 m. Vertical trusses are also set up every 6.40 m along the longitudinal direction to enhance the integrity of the footbridge.

The typical cross-sections of the footbridge are shown in Fig. 4(d). The footbridge is a single-box structure. The thickness of the top concrete slab is 0.15 m at the edge and at the center of the cross-section, and 0.30 m at the intersection with corrugated steel webs. Both the horizontal and the vertical trusses are made of steel tubes. The diameters of the tubes at the horizontal and the vertical trusses are 168 and 146 mm, respectively. The thickness of these steel tubes is 6 mm. The diameter and the thickness of the bottom steel tubes are 500 and 24 mm, respectively. All steel tubes are made of Chinese standard

Q345D steel with a minimum yielding strength and ultimate strength of 345 MPa and 490 MPa, respectively. Both the two bottom steel tubes are filled with concrete with a compressive strength larger than 50 MPa. Fig. 4(e) shows a corrugation of the corrugated steel webs of the

footbridge. The length and height of the corrugation are 1600 and 220 mm, respectively. The thickness of the webs is 12 mm. The corrugated steel webs are connected with the top concrete slabs by perfo-bond strip (PBL) connectors. For the connection between the corrugated

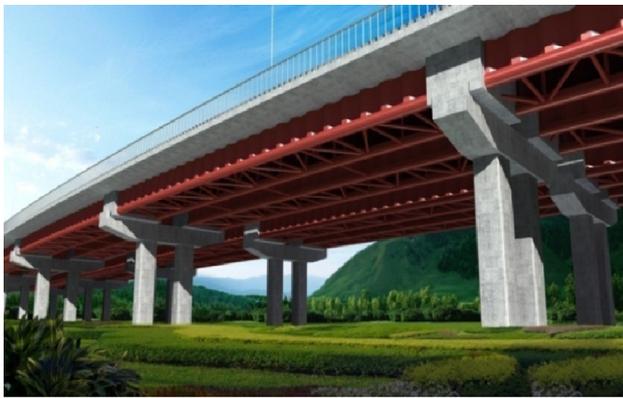
Fig. 5. Maluanshan Park Viaduct: (a) architectural rendering; (b) construction site.

Another bridge of this type that is being constructed is the Maluanshan Park Viaduct in Shenzhen, Guangdong Province, China. Several important factors were considered when designing the viaduct. First, it passes over a reservoir used for water supply, hence the influence of the bridge construction on the surrounding environment should be minimized. For example, the bridge should be constructed without the intensive use of temporary braces. Second, the bridge should also blend with the surrounding landscape. Finally, the bridge should be constructed rapidly, and the cost should not be too high. After careful consideration, it was decided to adopt the composite box girder with CSWs and trusses for this viaduct. The architectural rendering and the construction site of the viaduct are shown in Fig. 5. The viaduct is designed under the standard for an urban highway with a design speed of 80 km/h. The design of the Maluanshan Park Viaduct was also carried out by Shenzhen Municipal Design & Research Institute Co., Ltd.

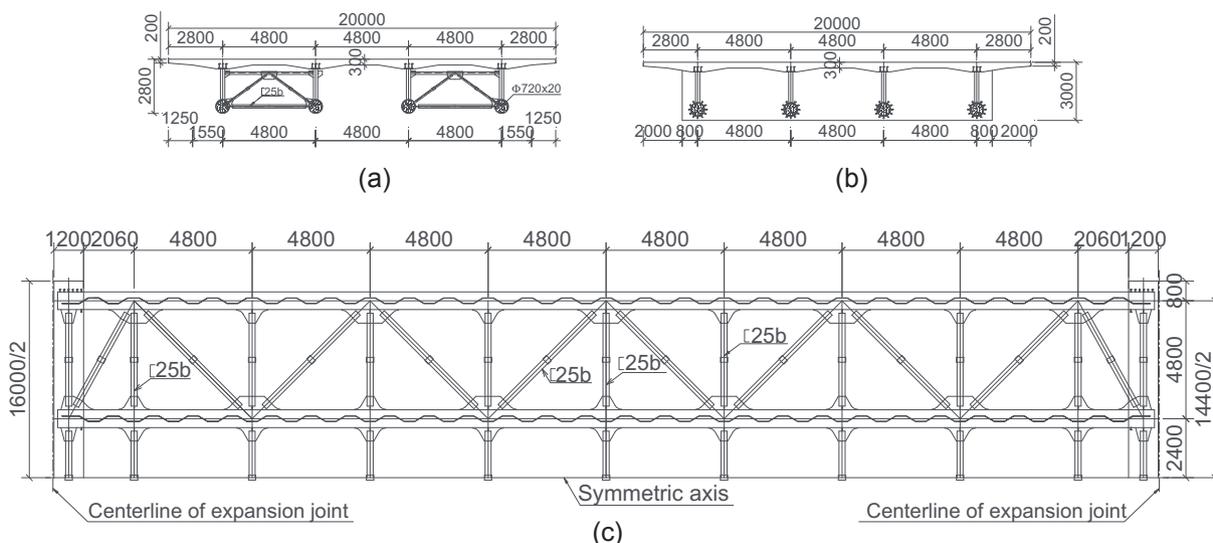
Fig. 6. Design of the left sub-bridge of the Maluanshan Park Viaduct (Unit: mm): (a) cross-section at the mid-span; (b) cross-section at a support; (c) arrangement of bottom truss structure.

The left sub-bridge is used as an example here to show the design of the viaduct in detail. The depth of the girder is 2.80 m. Two end diaphragms are set up at the support locations. The depth and thickness of the end diaphragms are 3.00 and 1.20 m, respectively. Fig. 6(a) and (b) shows the typical cross-sections of the left sub-bridge. It is comprised of two boxes, and each box consists of one single cell. The width of the top concrete slab is 20.00 m. The width of the cantilever part of the top concrete slab is 2.80 m. The thickness of this cantilever part varies from 0.20 m at the free end to 0.50 m at the intersection with the corrugated steel webs. One traffic lane of 16.00 m wide and two lanes for bridge maintenance of 2.00 m wide are set on the left sub-bridge. The transverse slope of the top surface of the top concrete slab is 2.0%. The width of the bottom of a box at the cross-section is 4.80 m.

As shown in Fig. 6(c), two steel tubes connected by trusses are

placed at the bottom of each box structure. The diameter and the thickness of the tubes are 720 and 20 mm, respectively. The tubes are filled with slightly expansive concrete. The compressive strength of the concrete is larger than 50 MPa. The trusses connecting the steel tubes are comprised of transverse and diagonal braces. Each of these braces was made of a steel channel with trapezoidal steel plates welded to its both ends. The trapezoidal steel plates were then welded to the bottom concrete-filled steel tubes. To enhance the torsional performance of the bridge, nine vertical trusses are placed with a 9.00 m interval along the longitudinal direction.

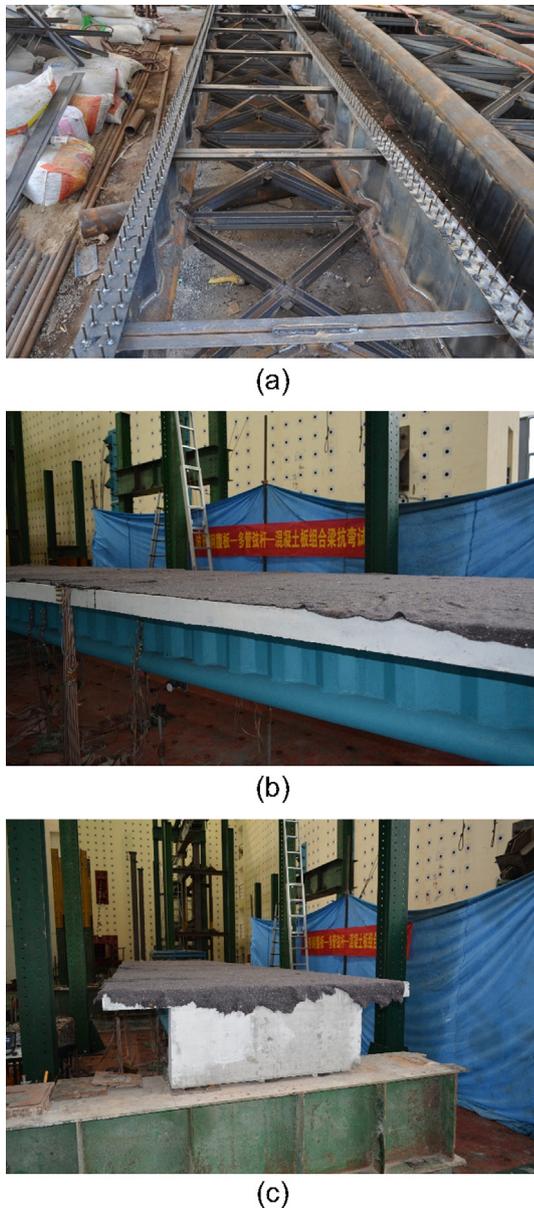
Fig. 7. Test beam under construction.

In this research, a scaled model of the Maluanshan Park Viaduct with a linear dimension scale factor (S) of 1/5 was designed and constructed for the experimental study. Fig. 7 shows the test beam under construction. The span length of the test beam, which is corresponding to the distance between the centerlines of two adjacent expansion joints

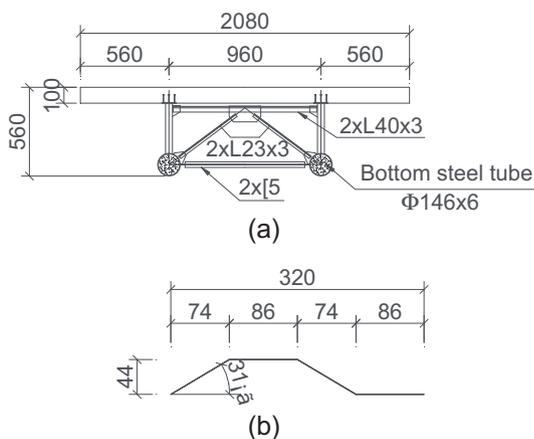
Fig. 8. (a) Typical cross-section; and (b) a corrugation of the webs of test beam (Unit: mm).

at the reference viaduct, is 9000 mm. The actual length of the test beam is 8984 mm, and the distance between the centerlines of two end supports is 8740 mm. The depth and width of the beam are 560 and 2080 mm, respectively. The typical cross-section of the test beam is shown in Fig. 8(a). Such a cross-section consists of a top concrete slab and two bottom steel tubes connected by trusses. The thickness of the top concrete slab is 100 mm. The diameter of each bottom steel tube is 146 mm, and the thickness of the tube wall is 6 mm. The steel tubes were filled with concrete. Fig. 8(b) shows a corrugation of the corrugated steel webs of the test beam. The thickness of the corrugated steel webs is 4 mm, and the length and height of a corrugation are 320 and 44 mm, respectively. The corrugation angle is 31°. Longitudinal and

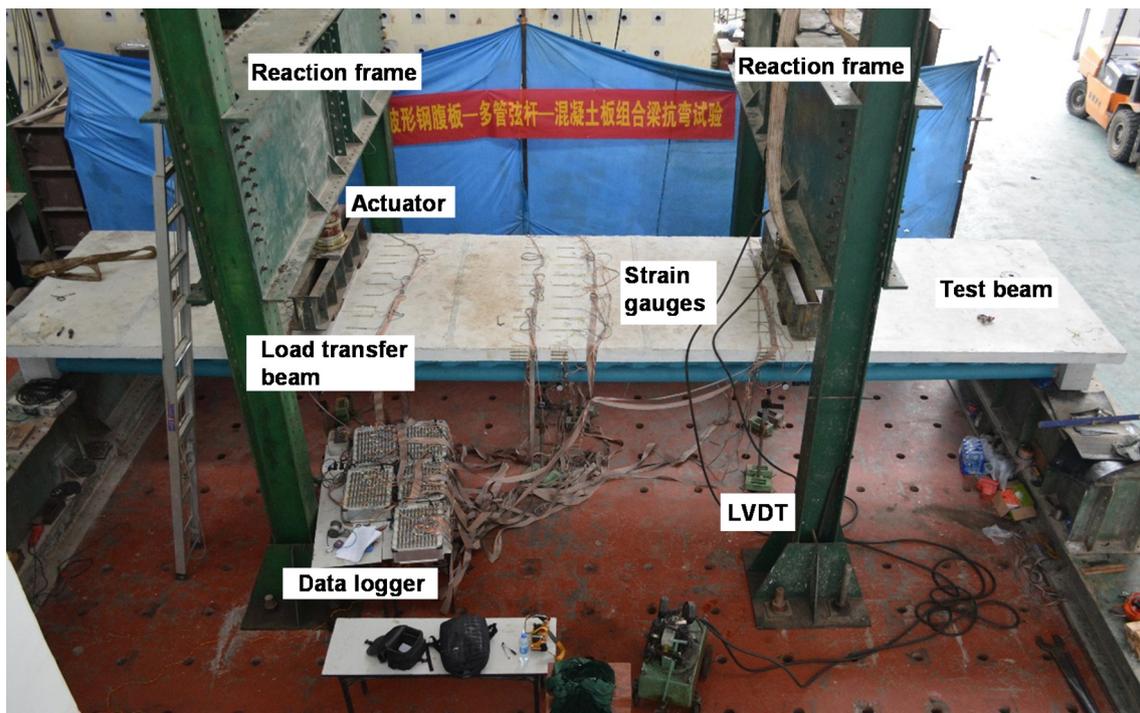
Fig. 9. Overview of test set up.

The loads applied to the test beam were determined by scaling the designed loads of the reference viaduct according to the scale rules of modeling tests [17] (Table 2) so that the resultant stress and strain of the test beam and the reference viaduct can be the same. During the test, two layers of concrete blocks (total height = 760 mm) were first placed on the top surface of the test beam to simulate the dead load. The live loads were simulated by applying a concentrated load of 30 kN at each of the $x = L/3$ and $x = 2L/3$ locations of the test beam (where x is the coordinate along the longitudinal direction, and L is the span of the test beam). The concentrated loads in the test were applied using a loading device comprised of two actuators with a capacity of 1000 kN and two reaction frames. A steel transfer beam was used to distribute the load at each of the two prescribed loading locations. Fig. 9 shows the overview of the test setup.

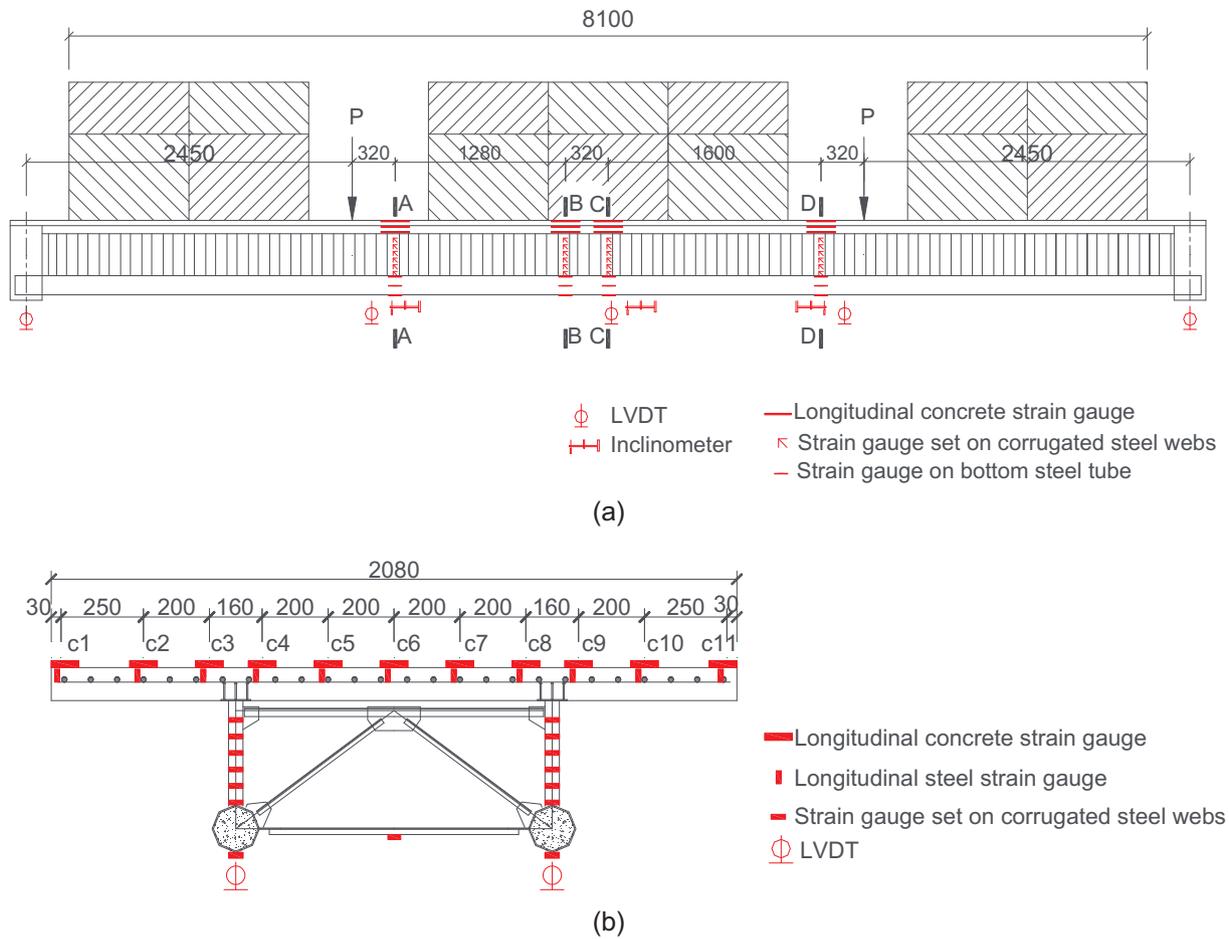
Fig. 10. Loading set up and instrumentation of the test beam (Unit: mm): (a) side view; (b) typical cross-section.

To measure the deflection of the test beam, 10 Linear Variable Displacement Transducers (LVDTs) were installed at the locations shown in Fig. 10. The LVDTs located at the two ends of the test beam were used to measure the settlement of the supports. The deformation of the top concrete slabs, the corrugated steel webs and the bottom steel tubes were measured by strain gauges set at the locations demonstrated in Fig. 10(a). Moreover, the steel reinforcement bars in the top concrete

slabs were also equipped with strain gauges. The arrangement of strain gauges and LVDTs at a typical cross-section of the test beam is shown in Fig. 10(b).

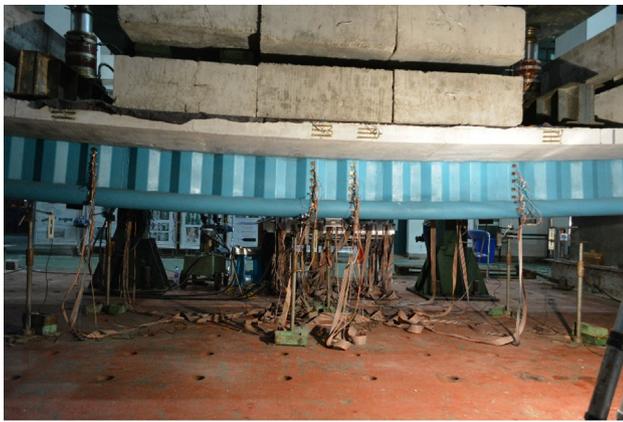
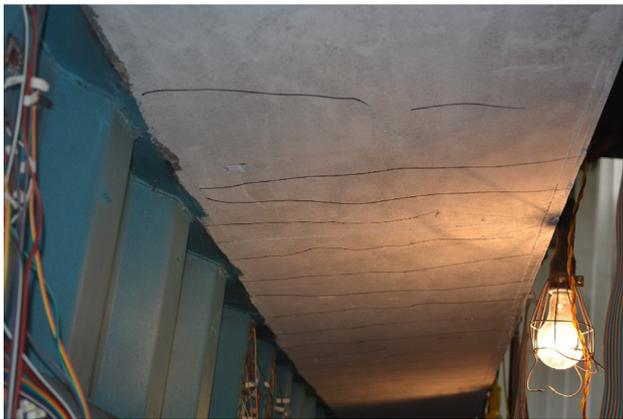
Fig. 11. Failure mode of the test beam: (a) overview; (b) observation at the bottom of the top concrete slab.

Fig. 11 shows the observed failure mode of the test beam. The deflection at the mid-span cross-section was 199.7 mm, which exceeds 1/50 of the span length of the test beam. Transverse cracks were observed at the bottom of the top concrete slab, as shown in Fig. 11(b). The materials in the test beam had reached their yield strength before it failed. Neither local buckling of corrugated steel webs nor local failures of structural elements have been observed.

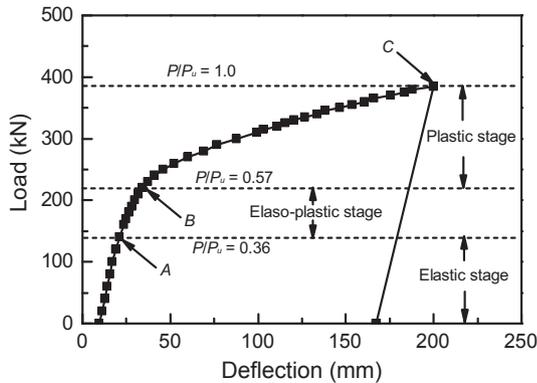
Fig. 12. Load-deflection curve measured at mid-span of test beam.

Fig. 12 shows the measured load–deflection curve of the test beam. According to the curve, the test beam shows good ductility. The deformation of the test beam can be divided into four stages based on the deflection and the strains at the mid-span.

The very first stage of deformation is an elastic stage in which the deflection increased almost linearly with the flexural load. Point A in Fig. 12 is defined as the ending point of this stage because at this point the longitudinal normal strain of the bottom of the bottom steel tube reached its proportional limit strain (1042 $\mu\epsilon$). The deflection of the test beam at this stage was small, which is only 1/450 of the span length.

The stage following the elastic stage is regarded as an elasto-plastic stage where the bottom steel tubes started to yield by tension and the load–deflection curve became nonlinear. At the ending point of this stage, Point B in Fig. 12, the longitudinal normal strain of the top of the

bottom steel tube achieved the yielding strain ($1558 \mu\epsilon$). The deflection of the test beam at Point B is 1/300 of the span length.

At this stage, the deflection increased rapidly with the flexural load. Cracks started to occur at the bottom of the top concrete slab when the test load was 270 kN, indicating that the neutral axis of the cross-section has shifted to within the top concrete slab. When the test load reached 385 kN, the cracks extended upward from the bottom of the concrete slab to a height of 1/3 of the slab thickness. Deformations of the test beam at this moment were visibly perceptible to the researchers. The deflection at the mid-span was 199.7 mm (1/46 of the

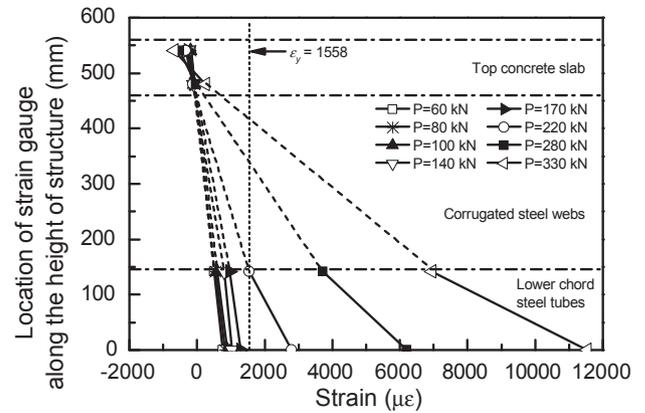
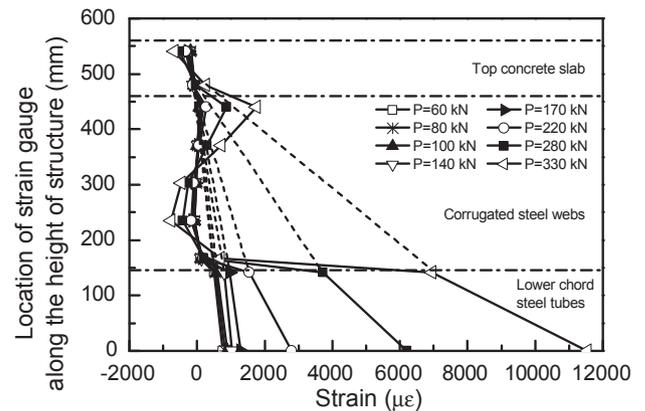
Fig. 13. Longitudinal normal strains of (a) the top concrete slab and the bottom steel tubes; and (b) the corrugated steel webs.

The distribution of the longitudinal normal strain of the top concrete slab and the bottom steel tubes along the height at different load steps are shown in Fig. 13(a). At the elastic stage ($\epsilon < \epsilon_y$), the measured strain data points can be approximately connected by a straight line, indicating that the cross-section can be approximated as a plane section when only the top concrete slab and the bottom steel tubes are concerned. When the strain exceeds the yielding strain ϵ_y , the data points can no longer be connected by a single straight line, so the assumption of plane section remaining plane seems not valid at this stage. Fig. 13(b) shows the longitudinal strain of the corrugated steel webs. If the corrugated steel webs are considered, the assumption that “plane sections remain plane” is no longer valid. At the elastic deformation stage, the strain of the corrugated steel webs is small compared with those of the concrete top slab and the bottom steel tubes. Therefore, the flexural load is mainly sustained by the top concrete slab and the bottom steel tubes.
